CAI-2015-09

#### **REPORT OF INVESTIGATION**

Fatal Machinery Accident September 16, 2015

Onton #9 Mine Sebree Mining LLC Sebree, Webster County, Kentucky ID No. 15-18547

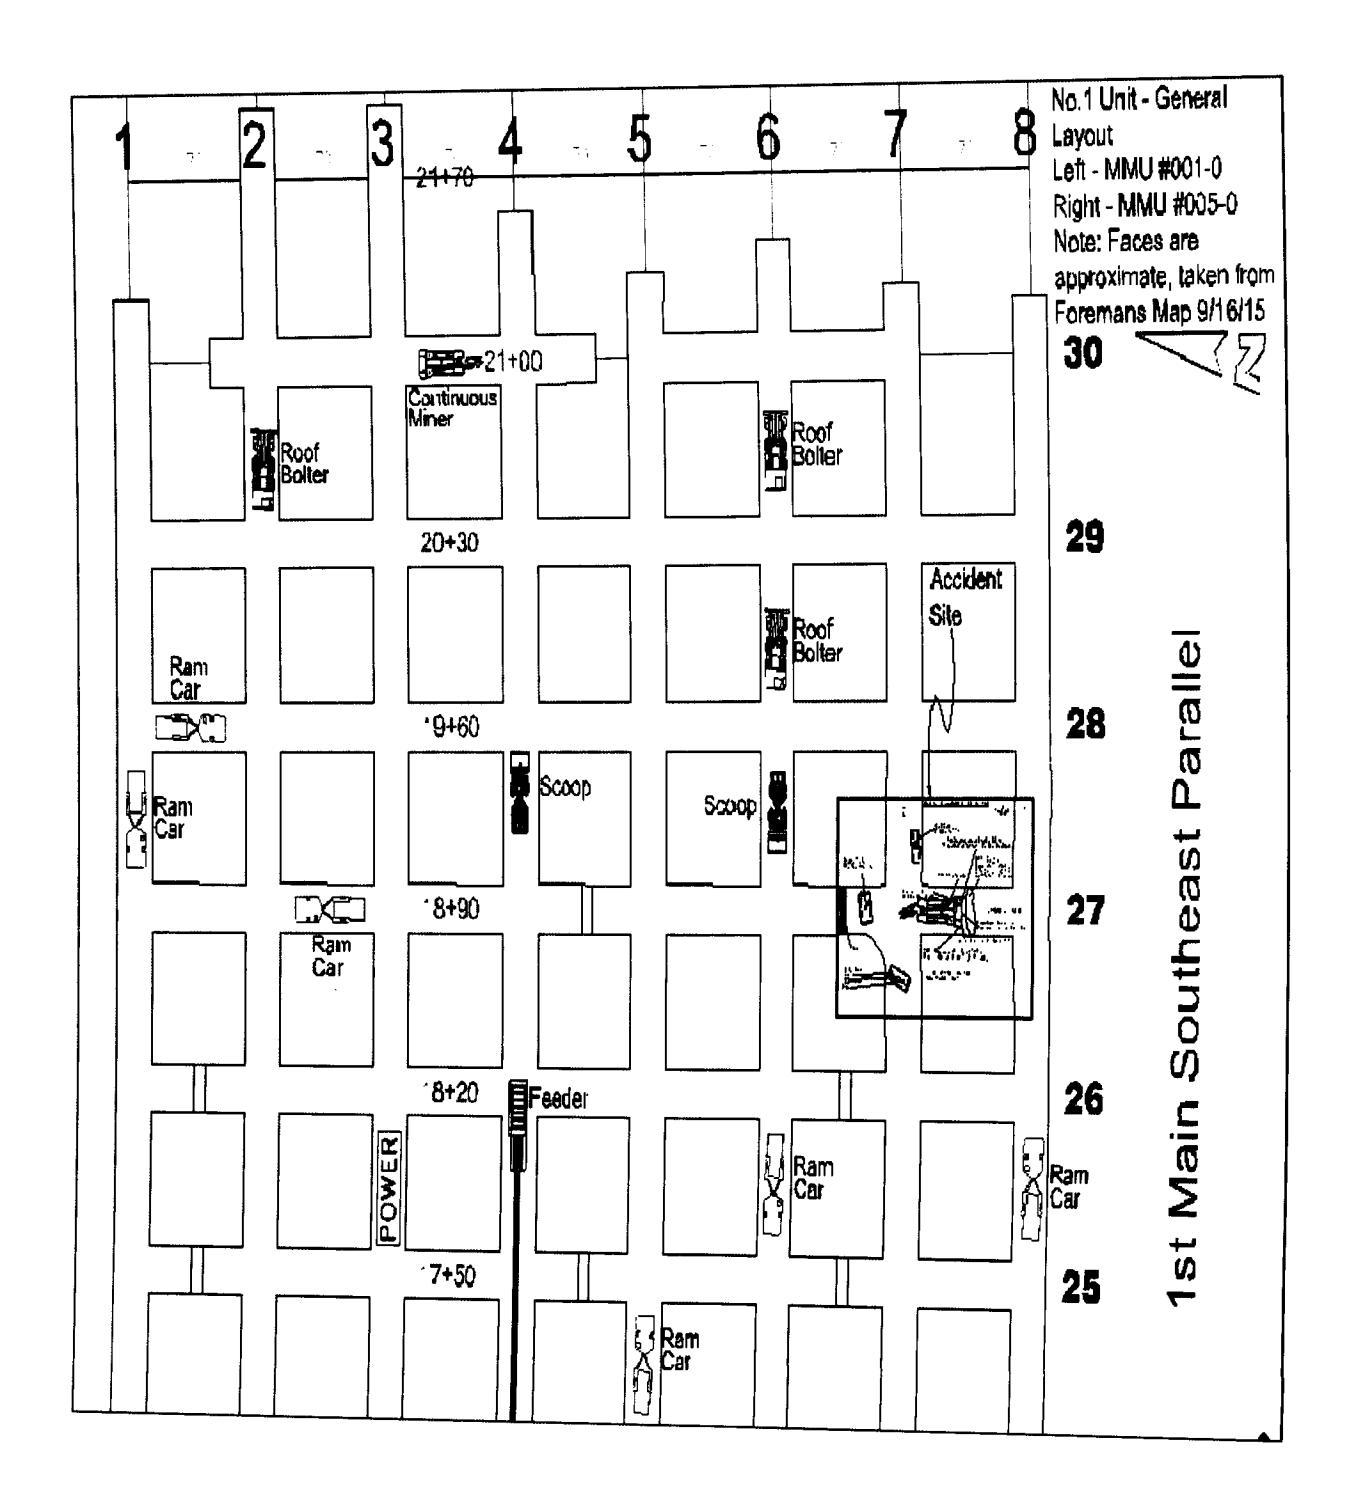
#### Sketch of the No. 1 unit (Not to scale)

On Tuesday, September 15, 2015, Rickey A. Thorpe, Jr. (victim), Electrician, started his maintenance shift at approximately 11 p.m. at the Onton # 9 Mine. Thorpe left the surface at 11:13 p.m., traveling underground on a mantrip with No. 3 unit miners to be dropped off at his golf cart. A layout of the No. 1 Unit is shown in APPENDIX A. Thorpe arrived on No. 1 unit at 12:33 a.m. Lead electrician Nicky Stevens assigned maintenance responsibilities to electricians James Maynard and Rickey Thorpe. The third shift maintenance crew waited until approximately 1:00 a.m. for the second shift crew to conclude production before beginning their normal activities.

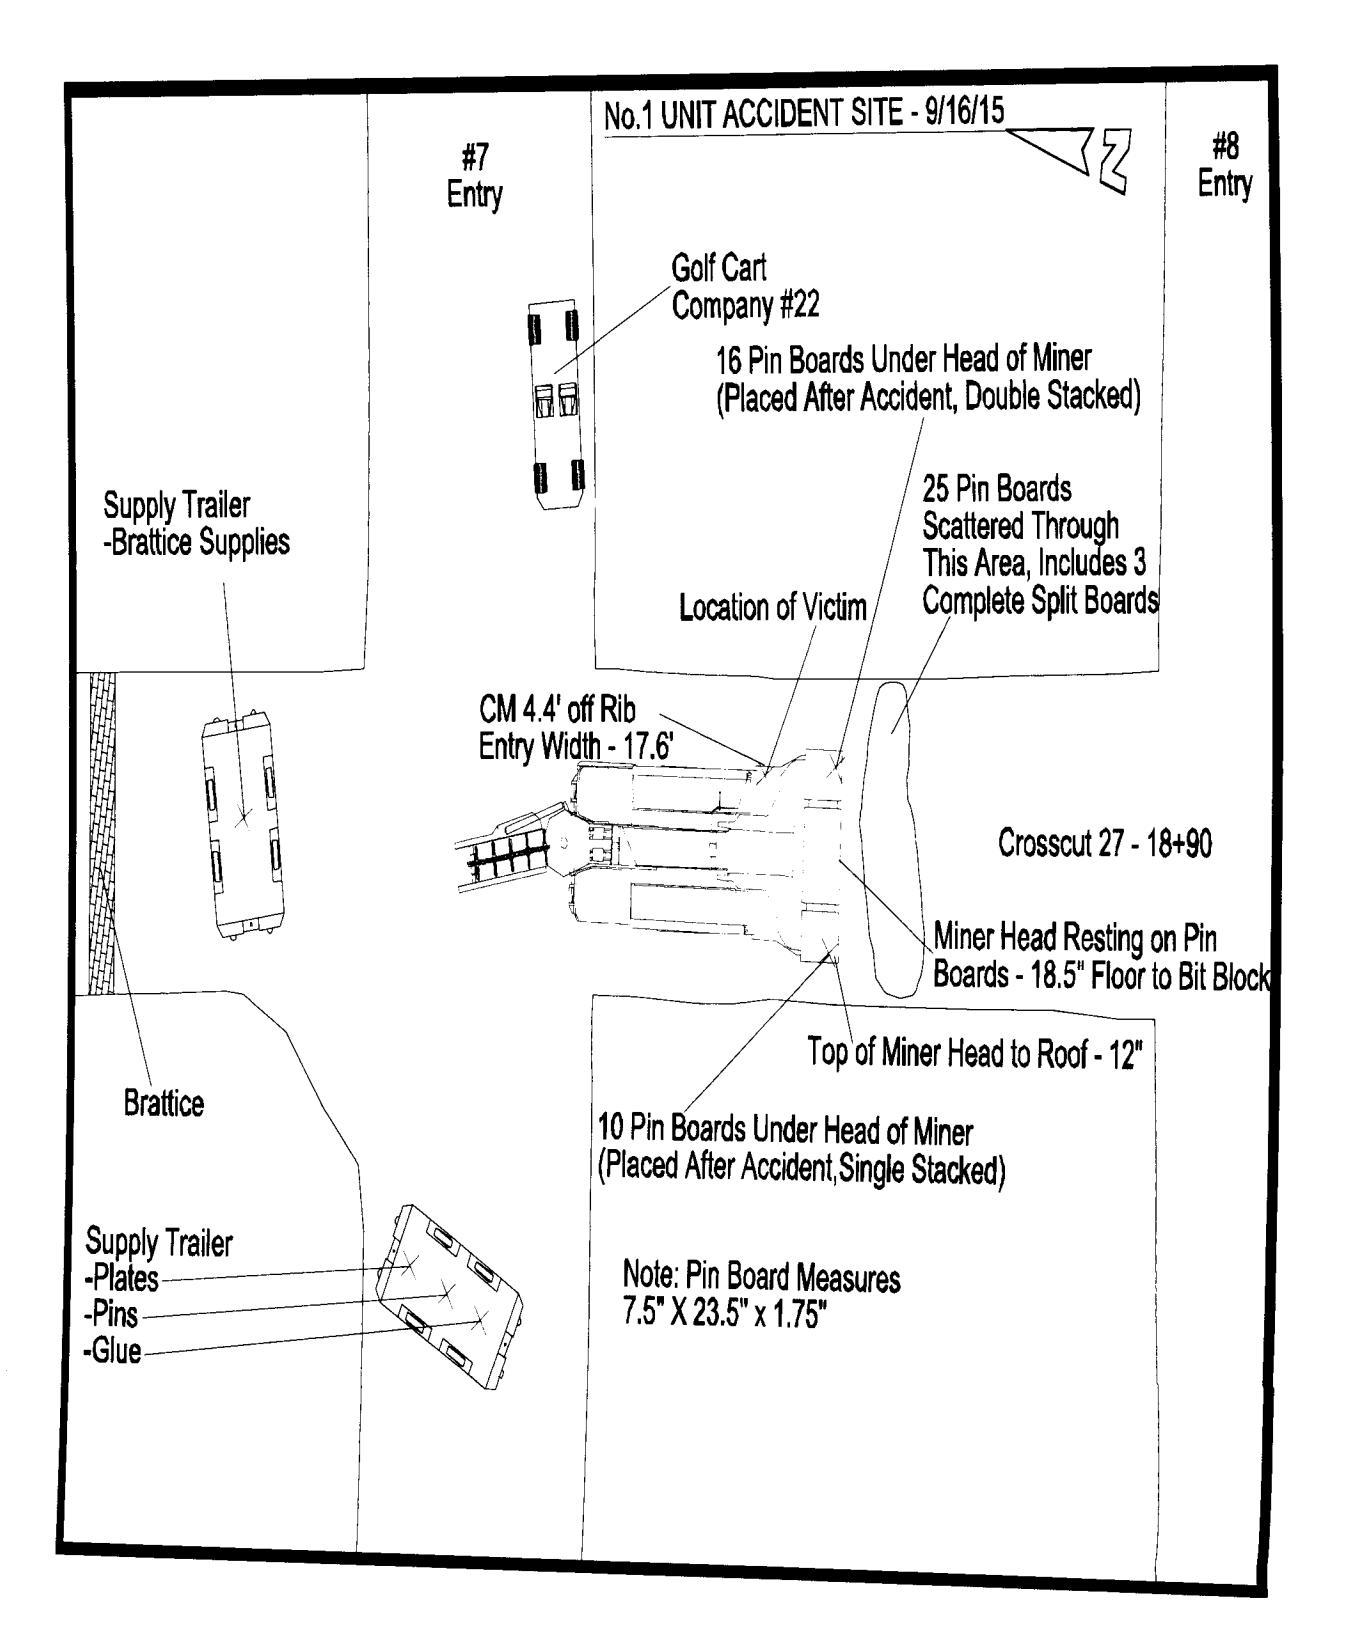
## Sketch of the Accident Scene (Not to scale)

Thorpe leaned in from the operator's side of the continuous mining machine between the raised cutter head boom and the pan and removed the load locking valve . A sketch of the accident scene is shown in APPENDIX B. Thorpe then waited beside the continuous mining machine while Stevens retrieved a new load locking valve. With the replacement valve in hand, Thorpe leaned back underneath the cutter head boom into the pan of the continuous mining machine at approximately 2:00 a.m. to install the new device. At that time, Stevens was standing next to Thorpe on the operator's side of the continuous mining machine and Maynard was standing in front of the cutter head of the machine. Both miners stated there was a loud popping noise and then the cutter head boom dropped onto the victim, crushing him between the pan and cutter head boom of the continuous mining machine.

The accident occurred on the right side of the No. 1unit, (MMU 005-0) 1<sup>st</sup> South East Parallel Mains, between the No. 7 entry and the No. 8 entry at survey station 18+90, crosscut No. 27. The accident site was in an area where draw rock had been removed from the mine roof. The actual height in the area where the cutter head of the continuous mining machine was located was approximately 6 feet. The entry width was 17.6 feet and the offside of the continuous mining machine where the accident took place was 4.4 feet from the left rib.

The cutter head of the machine was facing towards the No. 8 entry and approximately 10 feet of the tail of the machine was in the intersection of the No. 7 entry. Also located at the accident scene were 51 pin boards. There were 16 pin boards located under the cutter head on the operator's side (left side) of the machine, 10 pin boards located under the right side of the cutter head, and an additional 25 pin boards scattered in front of the continuous mining machine. These pin boards were used in the recovery efforts of the victim.

The pin boards were stacked as single boards on top of one another. The single stacked wooden boards were not stable or sturdy enough to support the weight on the cutter head boom, approximately 18 tons. The boards used as support gave way, allowing the victim to be crushed between the pan and cutter head boom of the continuous mining machine causing fatal crushing injuries. Stevens knowingly allowed and visibly observed a miner working in an unsafe condition.

*Corrective Action:* Management has developed and implemented a written "Plan of Action for Blocking Equipment from Motion". All underground miners will be re-instructed regarding proper blocking procedures while performing repairs or maintenance under machinery.
