### UNITED STATES DEPARTMENT OF LABOR MINE SAFETY AND HEALTH ADMINISTRATION

#### **REPORT OF INVESTIGATION**

Surface Dredge Coal (Bituminous)

Fatal Drowning Accident December 29, 2018

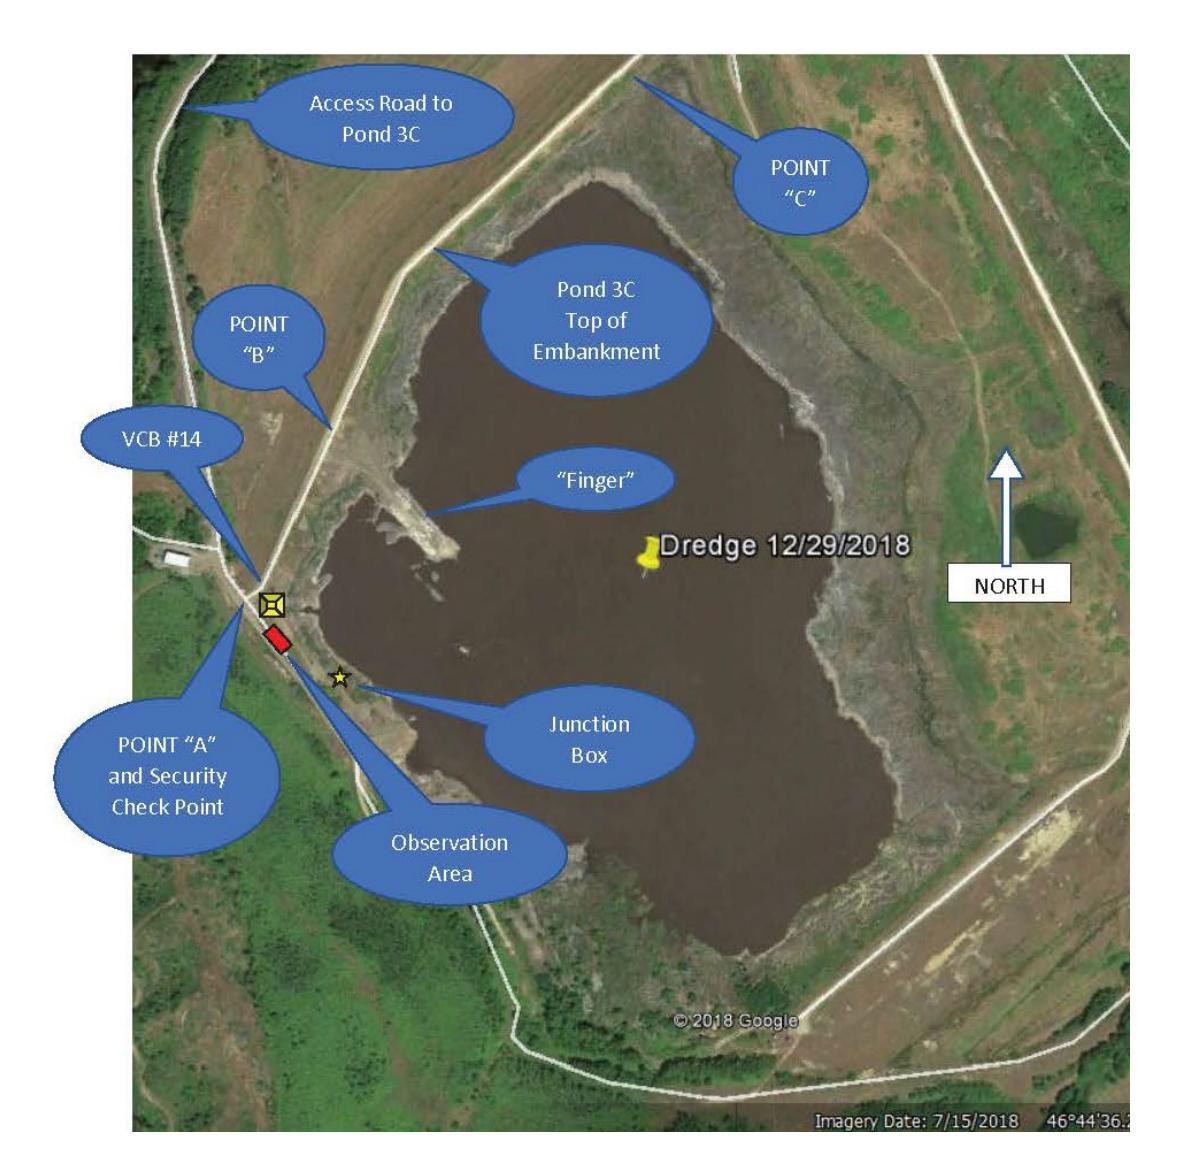
# APPENDIX A Diagram of the 3C pond

The accident occurred in a coal refuse impoundment identified as pond 3C. The maximum depth of the pond is approximately 30 feet and investigators estimate the depth where the dredge sank was 21 feet.

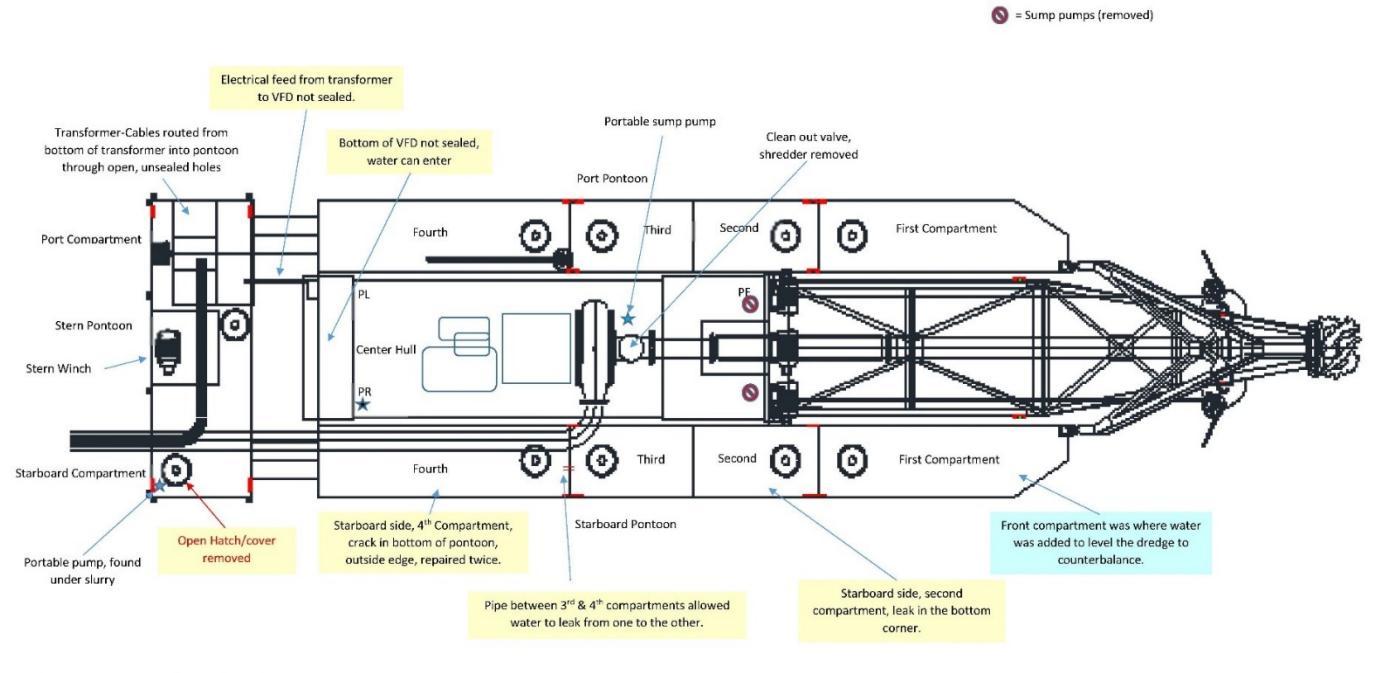
APPENDIX B Diagram of pump and leak locations

Approximately 6:53 p.m., Raley radioed Brown to relay flow information, and Brown told Raley that he was going to see clear water, because he was going to pump out the pontoon. The investigators found a portable bilge pump in the starboard compartment of the stern pontoon. (See Appendix B) Based on the location of the portable pump, the investigators concluded that Brown intended to pump the stern pontoon.

Investigators determined that the first and fourth compartments on the starboard pontoon leaked. A pipe with a valve that did not fully close allowed water to flow between the third and fourth compartments. Pontoons should be kept independent of each other in case if one pontoon fails the other pontoons would continue to float.

The number four compartment of the starboard pontoon had an area of deterioration on its bottom outside weld seam that measured 31 inches long. Within that 31 inches of affected area, there were two, approximately 6.5 inches long cracks, and an approximately 0.5 inch hole located between the cracks. The hatch that secured the starboard compartment on the stern pontoon was missing. Brown appears to have been pumping water from the starboard compartment using a portable electric sump pump, as investigators found the pump with electrical cord and discharge hose here. Testing did not reveal any leaks in this compartment. The other nine hatches were in place and secured.

Two of the three built-in, float-equipped bilge pumps in the center hull were missing. The port and starboard bilge pumps on the bow end of the hull had been removed. The third portside aft bilge pump was not functional. Appendix B shows the three pumps with labels PF (Pump Forward), PL (Pump Left), and PR (Pump Right).

Typical water level (freeboard) on Starboard side @ back (stern), 6 inches.

Typical water level (freeboard) on Port side @ stern, around 12 inches.

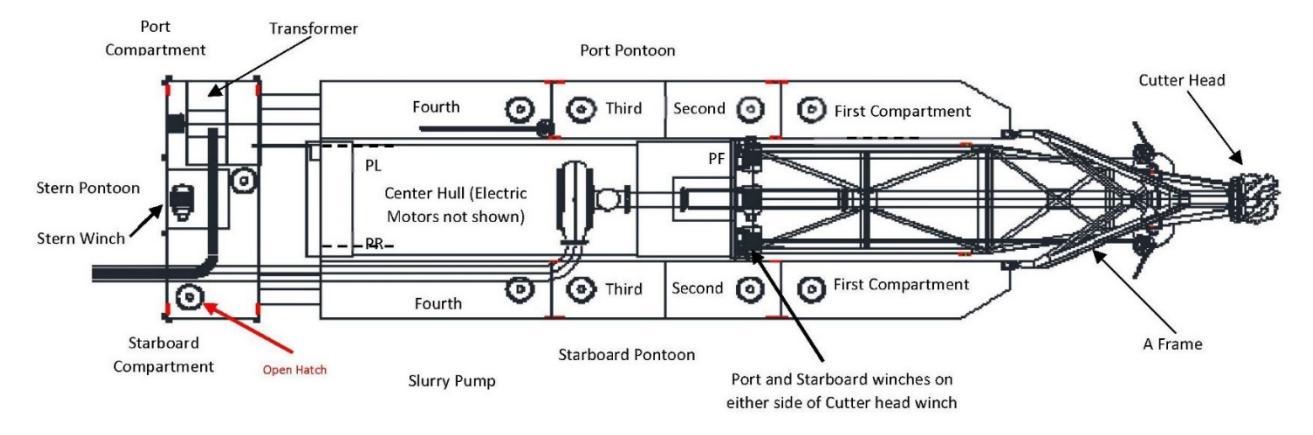
# Dredge Diagram

Coalview purchased the suction dredge in 2015, from Dredge Central of Goodlettsville, Tennessee. It is approximately 72 feet long and 17 feet wide. It consists of four sections with flotation: the starboard pontoon; the port pontoon; the stern pontoon; and the center hull (See Appendices B and D). The starboard and port pontoons had four sealed compartments each. The stern pontoon had two sealed compartments. The center hull does not seal. Other major components include the cutter head assembly, the A-frame that supports the cutter head, and the dredge operator's compartment.

Figure 2: Overhead view of dredge. Major components and compartments are shown. Small round circles indicate hatch covers. Red circle indicates hatch open at time of accident. The operator's Compartment is not shown.
