CAI-2018-12

REPORT OF INVESTIGATION

Fatal Machinery Accident November 29, 2018

WMPI Waste Management & Processors Inc. Gilberton, Schuylkill County, Pennsylvania ID No. 36-07805

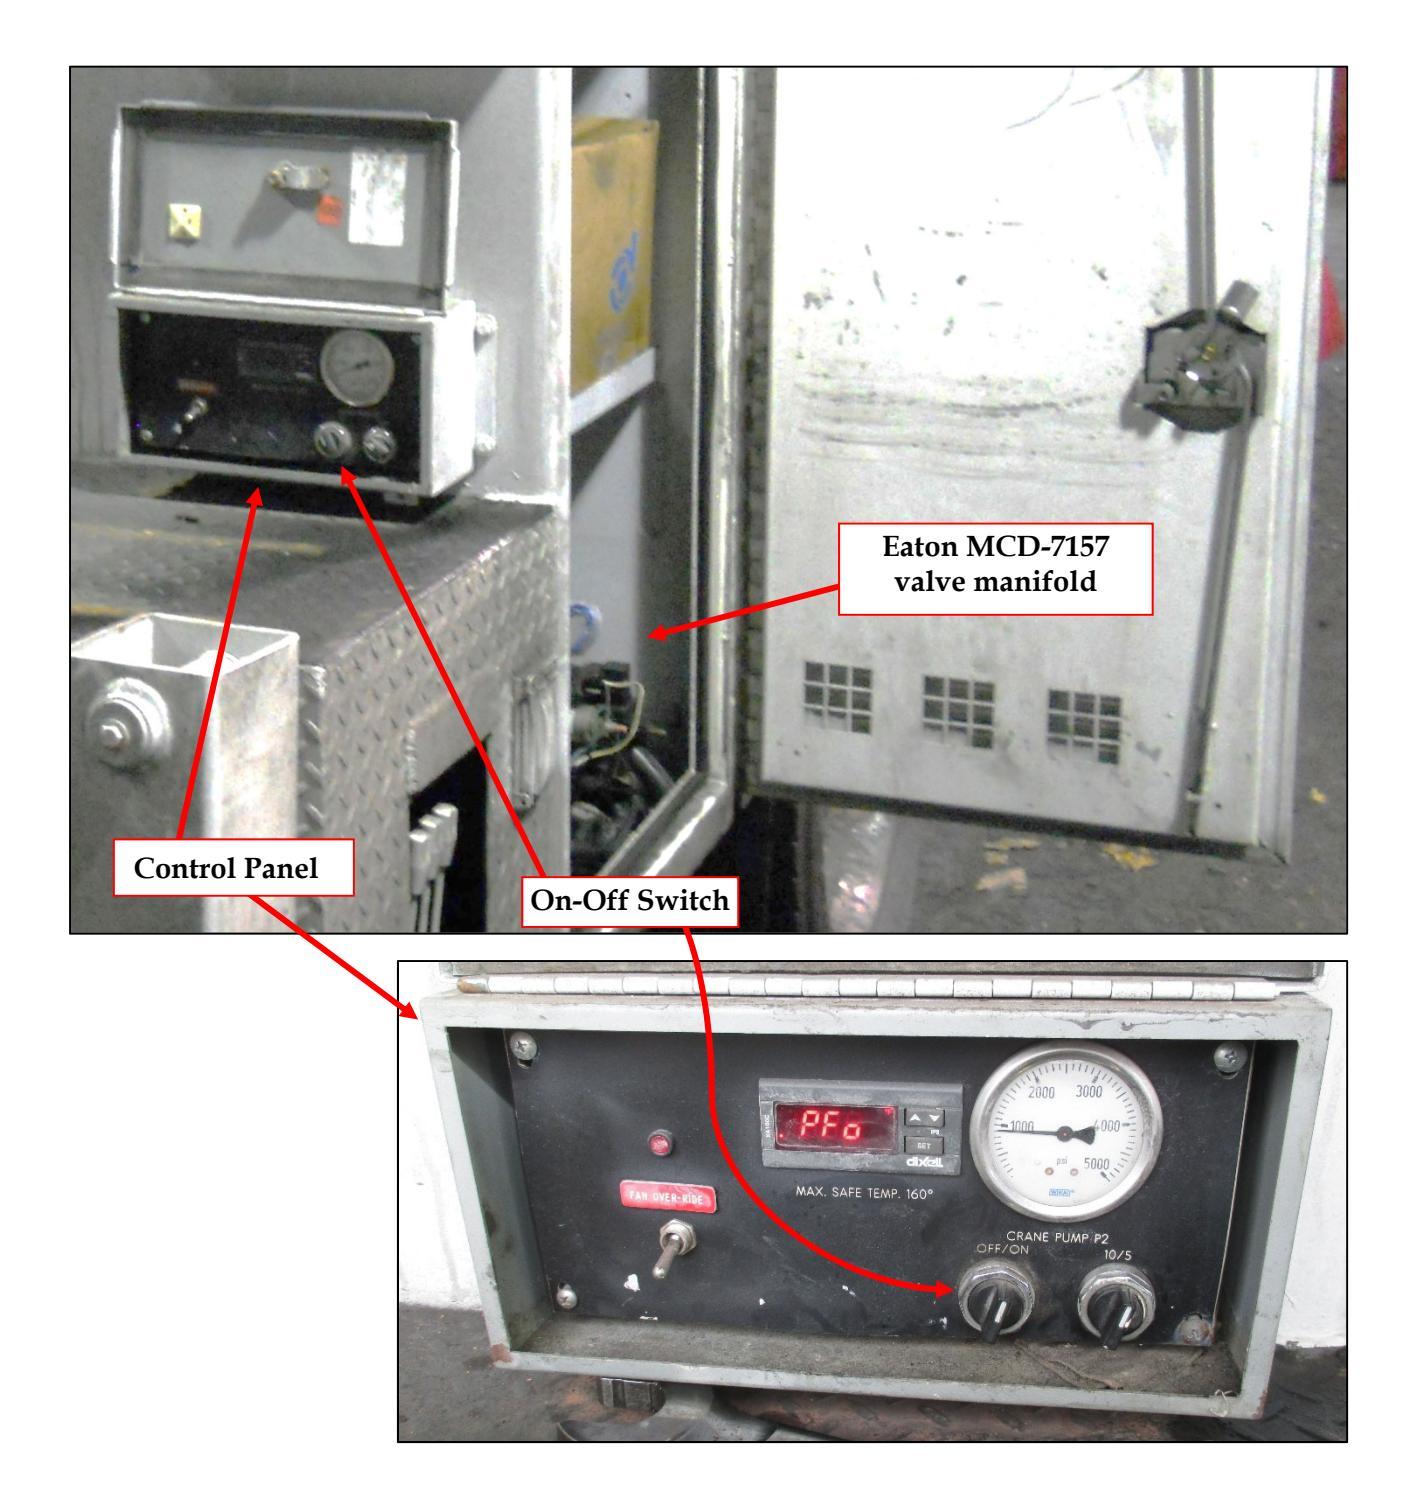
Appendix B Control Panel and On-Off Switch

An "on-off" switch on a panel near the rear of the truck controlled whether hydraulic pressure was directed to the hose reel or the crane. The "on" position typically sent up to 200 psi to the reel while the "off" position sent up to 3,000 psi to the crane (see Appendix B). On the day of the accident, Morgan had modified the hydraulic system to direct 3,000 psi to the reel instead of the typical 200 psi when the switch was in the "on" position. He told investigators that he modified the hydraulic system to remove components that were not needed for operation of the crane.

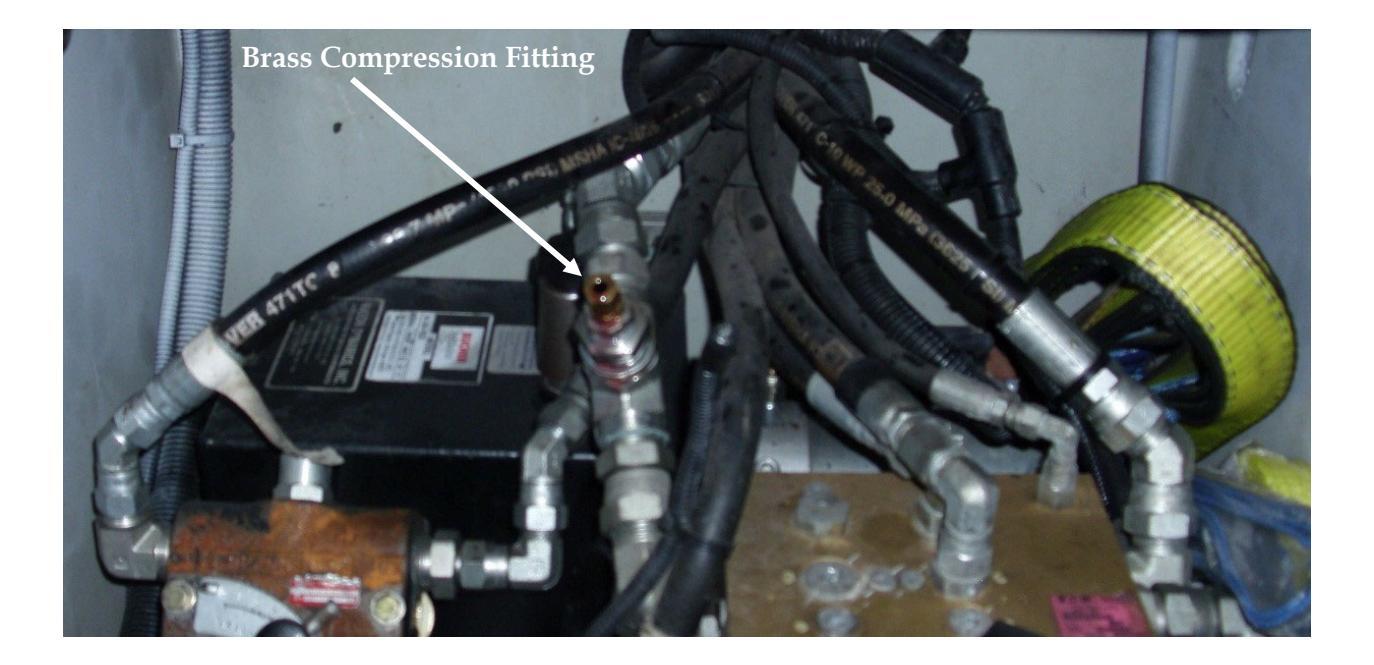
Appendix C Brass Compression Fitting

The hydraulic reel circuit included a brass compression fitting that held a temperature sensor (see Appendix C). The fitting had a maximum rating of 800 psi which is significantly less than the 3,000 psi it was subjected to after Morgan modified the hydraulic system. Ney was examining this area at the time of the accident (see Appendix D).

Based on a review of the evidence, inspectors believe it is most likely that Ney turned the on-off switch partially to the "on" position while examining the hydraulic system at close range. This would have directed excessive pressure to the hydraulic reel, causing the temperature sensor to burst from the fitting and strike the victim in the head.

<u>Corrective Action</u>: The mine operator developed new task training incorporating best practices. The operator provided new task training to miners who maintain and/or repair hydraulic systems. This training included safe work procedures when working on hydraulic systems, with instruction to not pressurize hydraulic systems prior to the completion of repairs.
