REPORT OF INVESTIGATION

Fatal Slip or Fall of Person Accident August 5, 2023

Superior Silica Sands San Antonio Plant Superior Silica Sands LLC San Antonio, Bexar County, Texas ID No. 41-01126

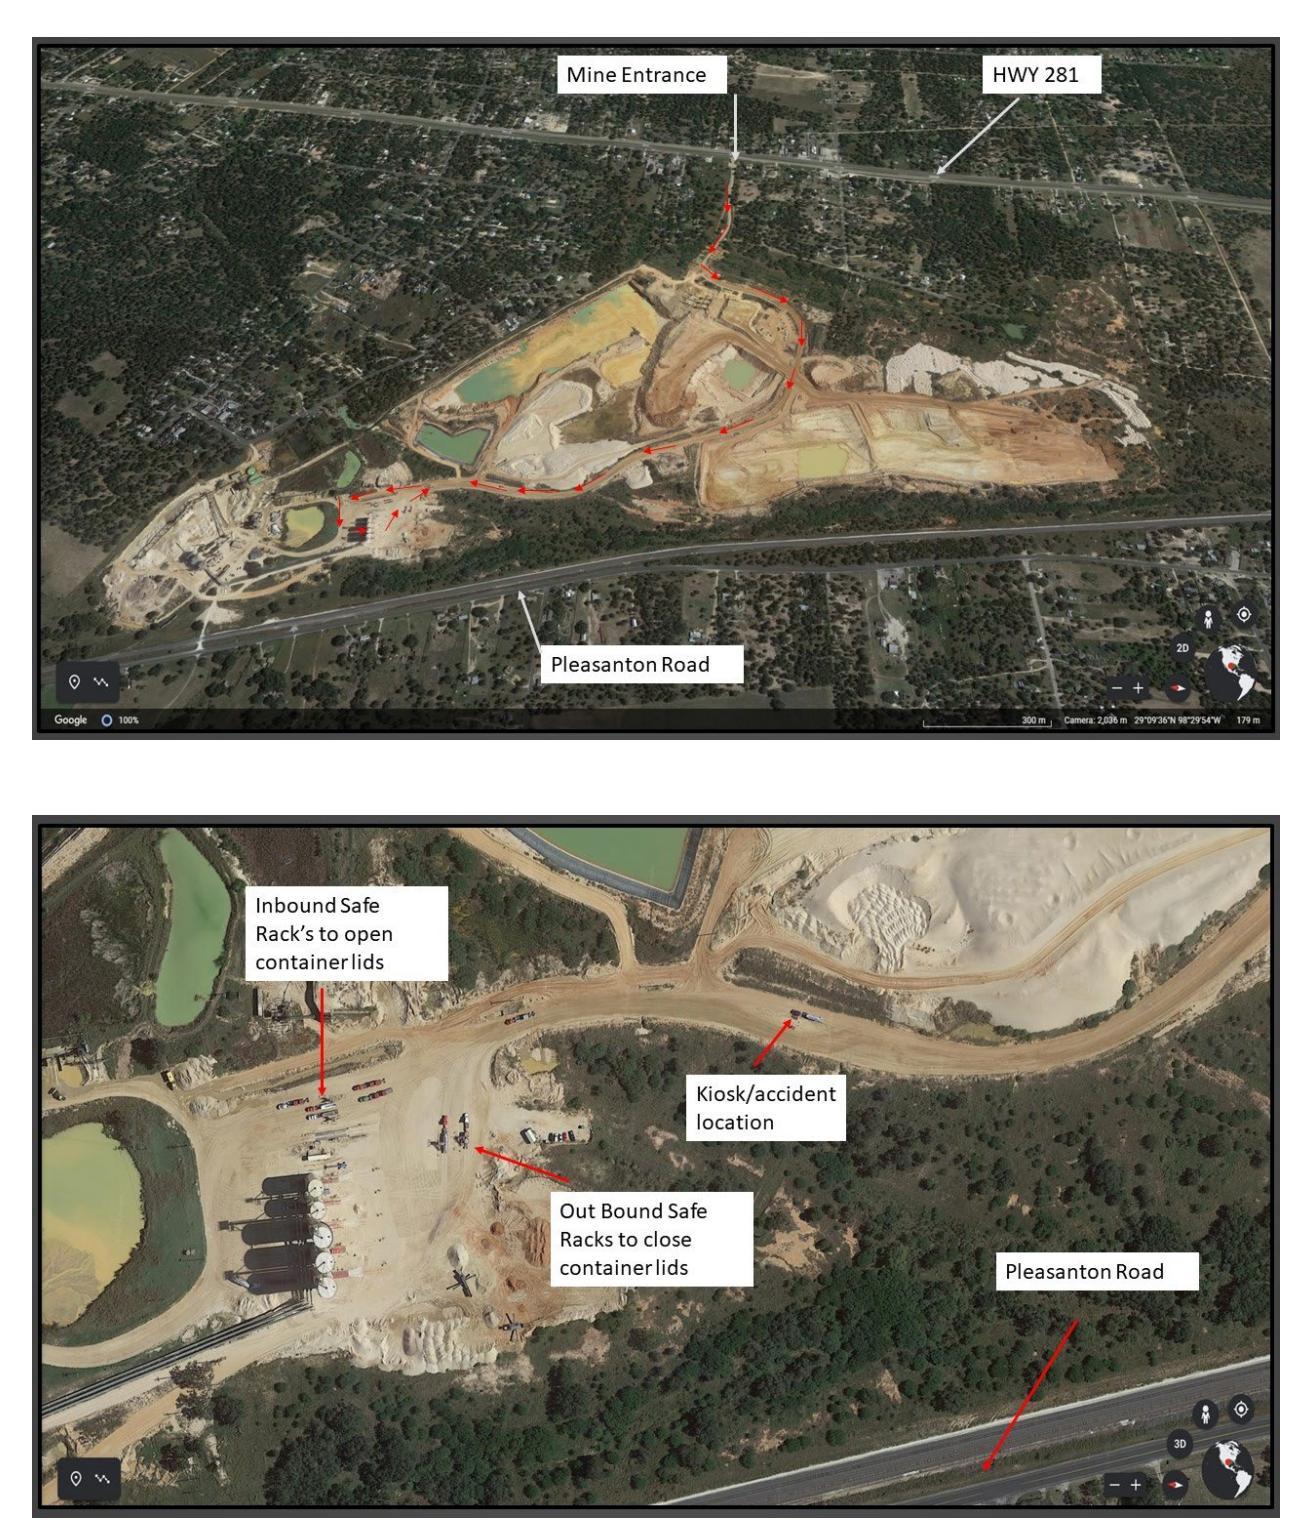
APPENDIX B – Aerial View of Mine and Accident Location

The accident occurred at the inbound customer truck check in-kiosk (see Appendix B).

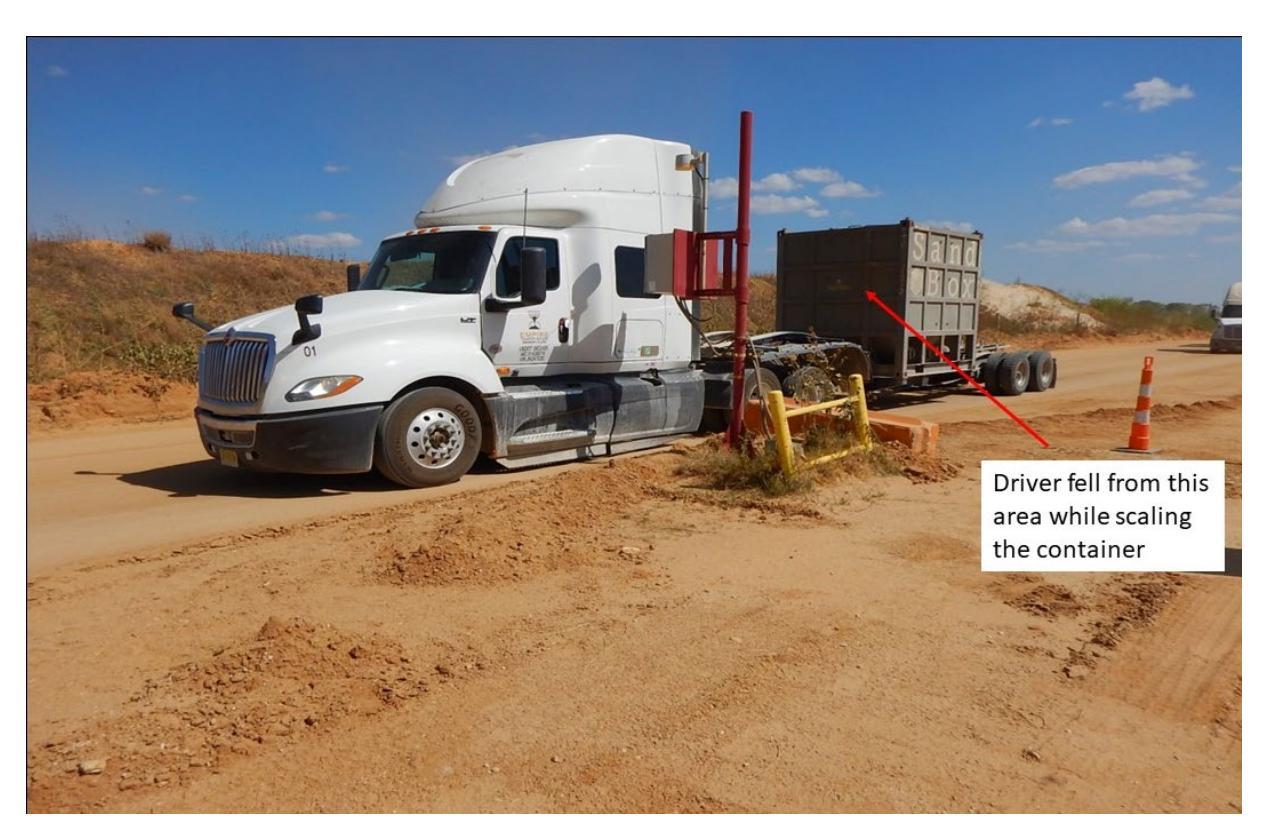
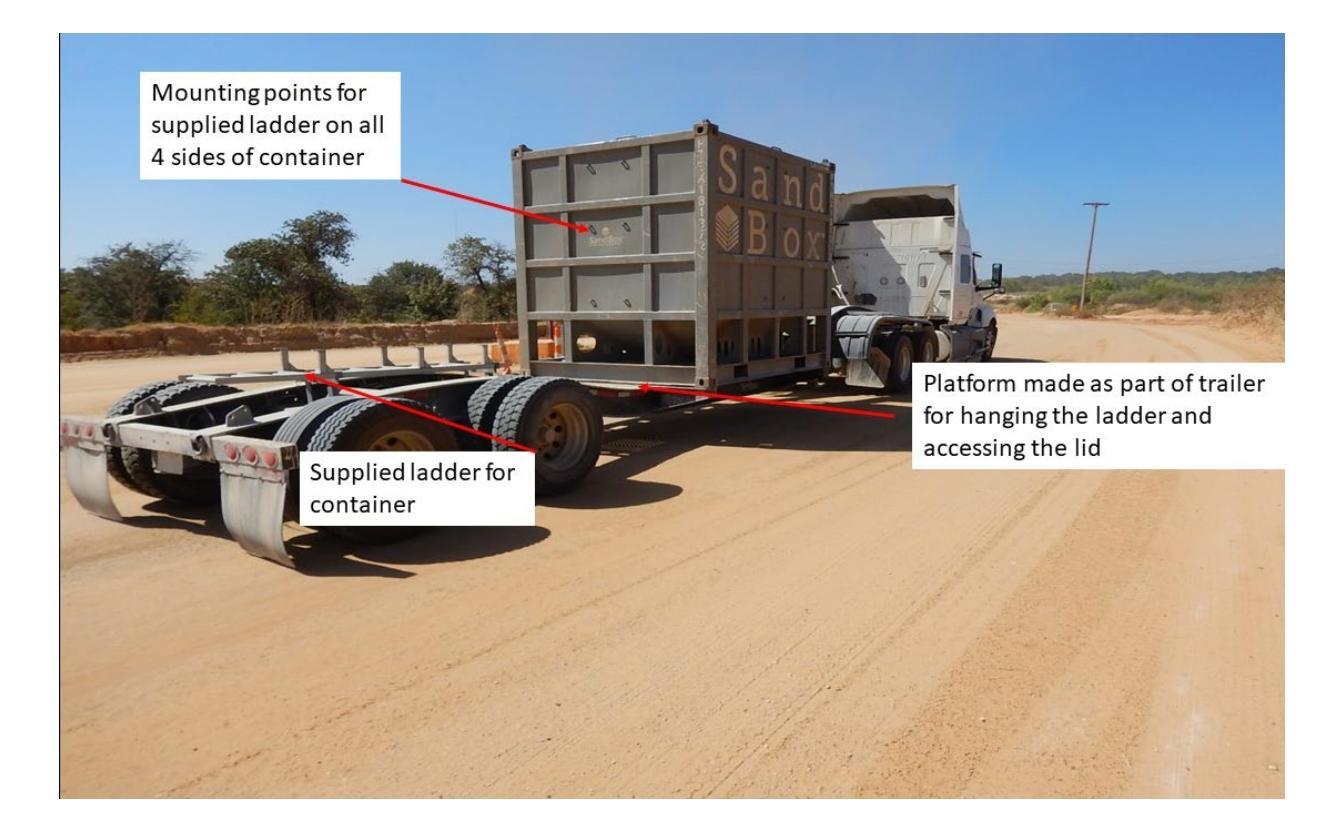
APPENDIX C – Truck and SandBox

The SandBox involved in the accident was mounted on a Pratt trailer chassis, Model DDL 382 AL-R001, which was being towed by a 2018 Navistar Tractor, Model LT 625 (see Appendix C).

The SandBox can transport approximately 40,000 pounds of sand per load and is loaded through a lid-covered opening located on top of the box. The SandBox was nine feet, three inches tall and the trailer it mounts onto was two feet, three inches above ground level. The SandBox had an aluminum ladder that was in a stowed position on the trailer frame behind the SandBox. The ladder had six attachment points that aligned with six receptacles on the sides of the SandBox and was designed for use to access the top of the SandBox. There were six receptacles on each of the four sides of the SandBox. Investigators found no safety defects when they removed the ladder from its stowed position and set up the ladder on each side of the SandBox.

The SandBox had two vertical support channels and three horizontal support channels located on each side of the SandBox. According to the mine operator's surveillance video, Garcia used the horizontal channels and the ladder receptacles to aid in climbing up the side of the SandBox while wearing slide-on shoes. Investigators did not identify any safety defects to the truck or the SandBox that contributed to the accident.

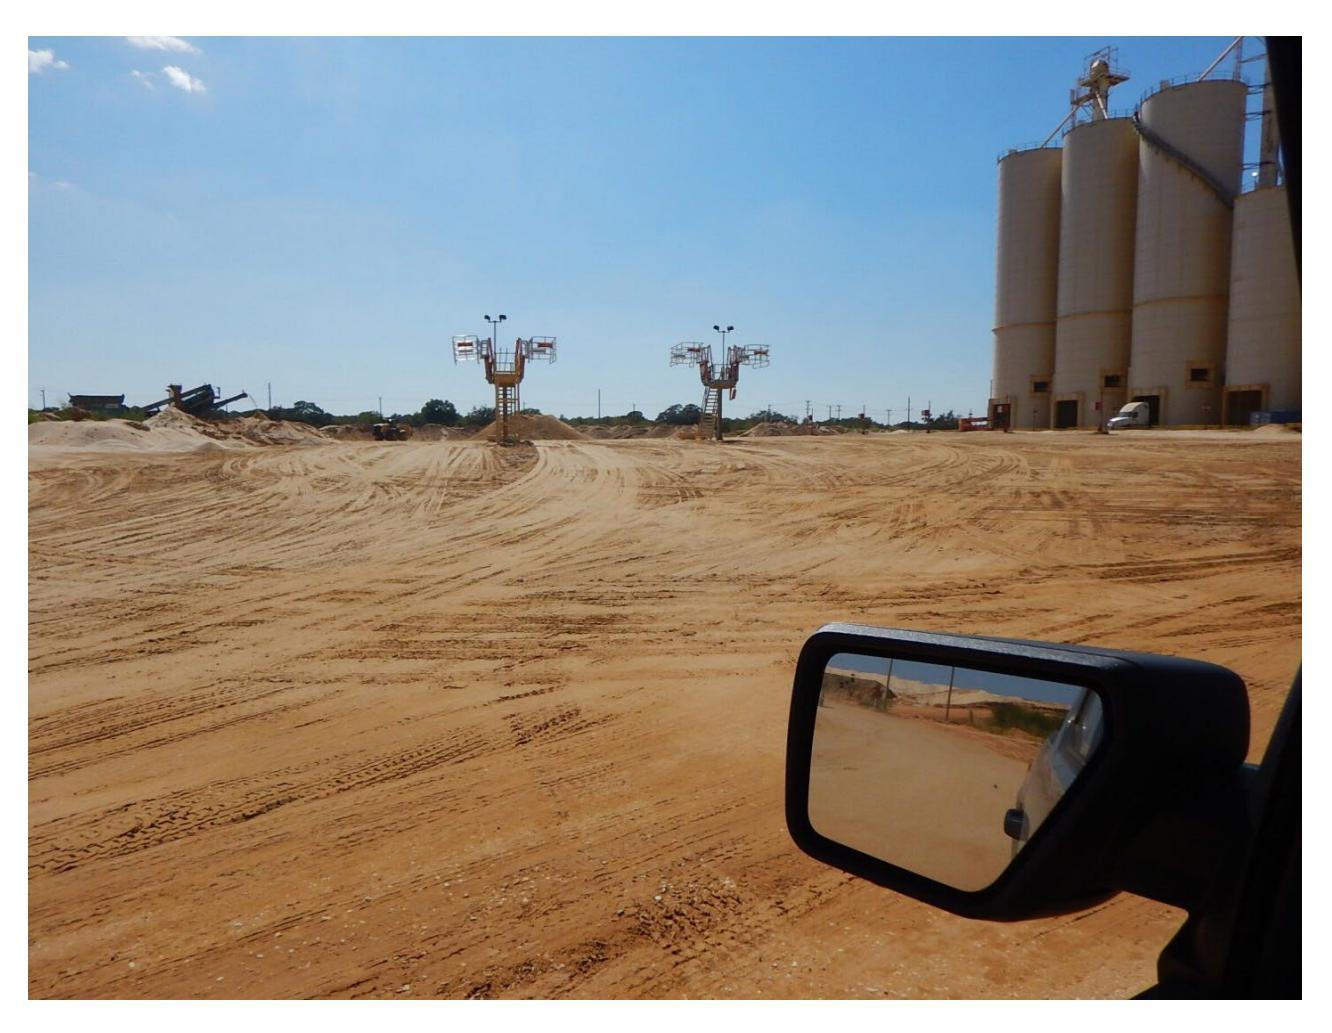
APPENDIX D – Photo of Outbound Safe Rack System

Investigators determined that when a customer truck leaves the inbound customer truck check-in kiosk, the scale house attendant calls them forward to a stop sign and holds them there to prevent congestion at the inbound Safe Rack system location (see Appendix D). Once congestion has cleared, the scale house attendant instructs the customer truck driver to proceed to the inbound Safe Rack system location which is staffed by mine employees for the purposes of opening the lids on the cargo trailers.

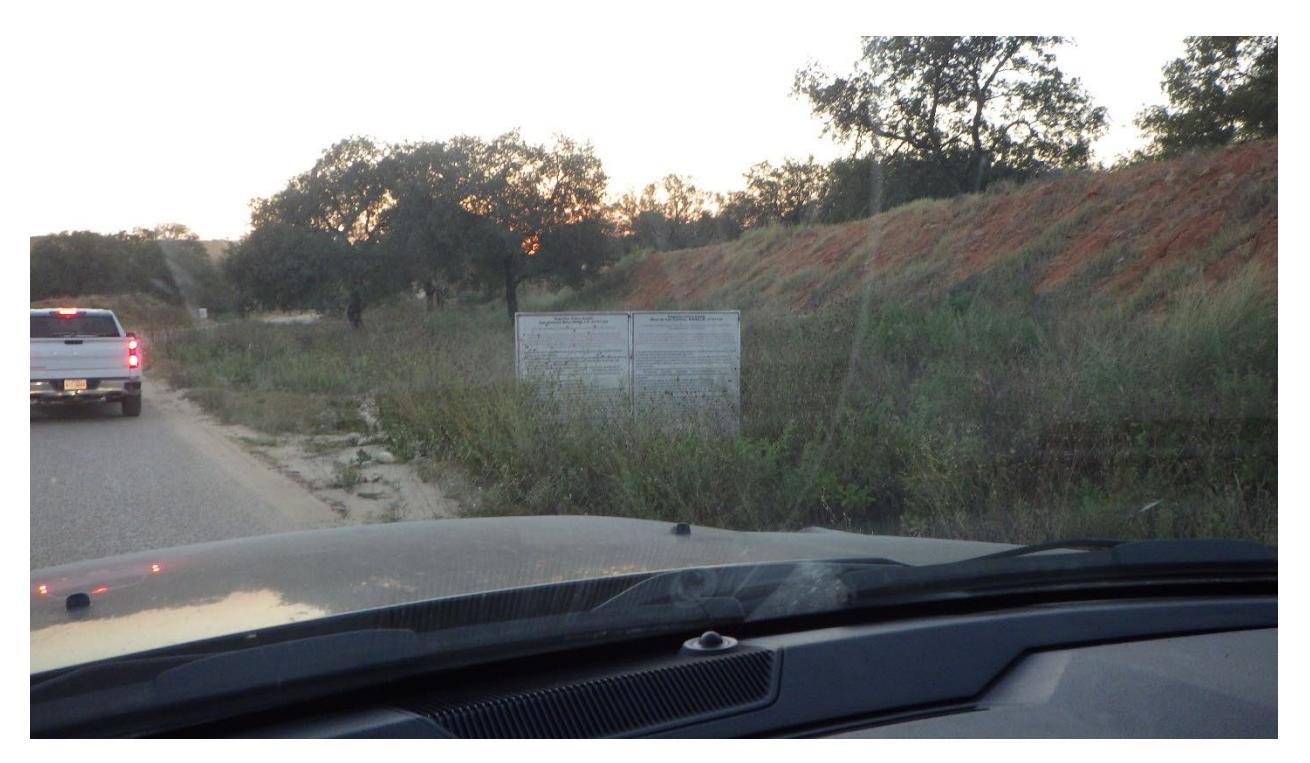
APPENDIX E – Sign at the Kiosk

the inbound customer truck check in kiosk. However, the signs had small letters, were low to the ground, and in some instances obstructed by vegetation (see Appendix E). The investigators determined that the mine operator did not provide Garcia with site-specific hazard awareness training, which contributed to the accident.

<u>Corrective Action</u>: The mine operator has taken several steps to ensure the safety of all employees, visitors, sub-contractors, and customer truck drivers. The operator has installed larger hazard awareness signs in both English and Spanish to indicate the rules and hazards for the mine. Additionally, the operator has developed a standard operating procedure on how the hazard awareness training is given to all employees, visitors, sub-contractors, and customer truck drivers. This procedure includes an audit of the customer truck drivers on their knowledge of the hazard awareness training.
