UNITED STATES DEPARTMENT OF LABOR MINE SAFETY AND HEALTH ADMINISTRATION

REPORT OF INVESTIGATION

Fatal Powered Haulage Accident August 5, 2024

Leer Mine ACI Tygart Valley Thornton, Taylor County, West Virginia ID No. 46-09192

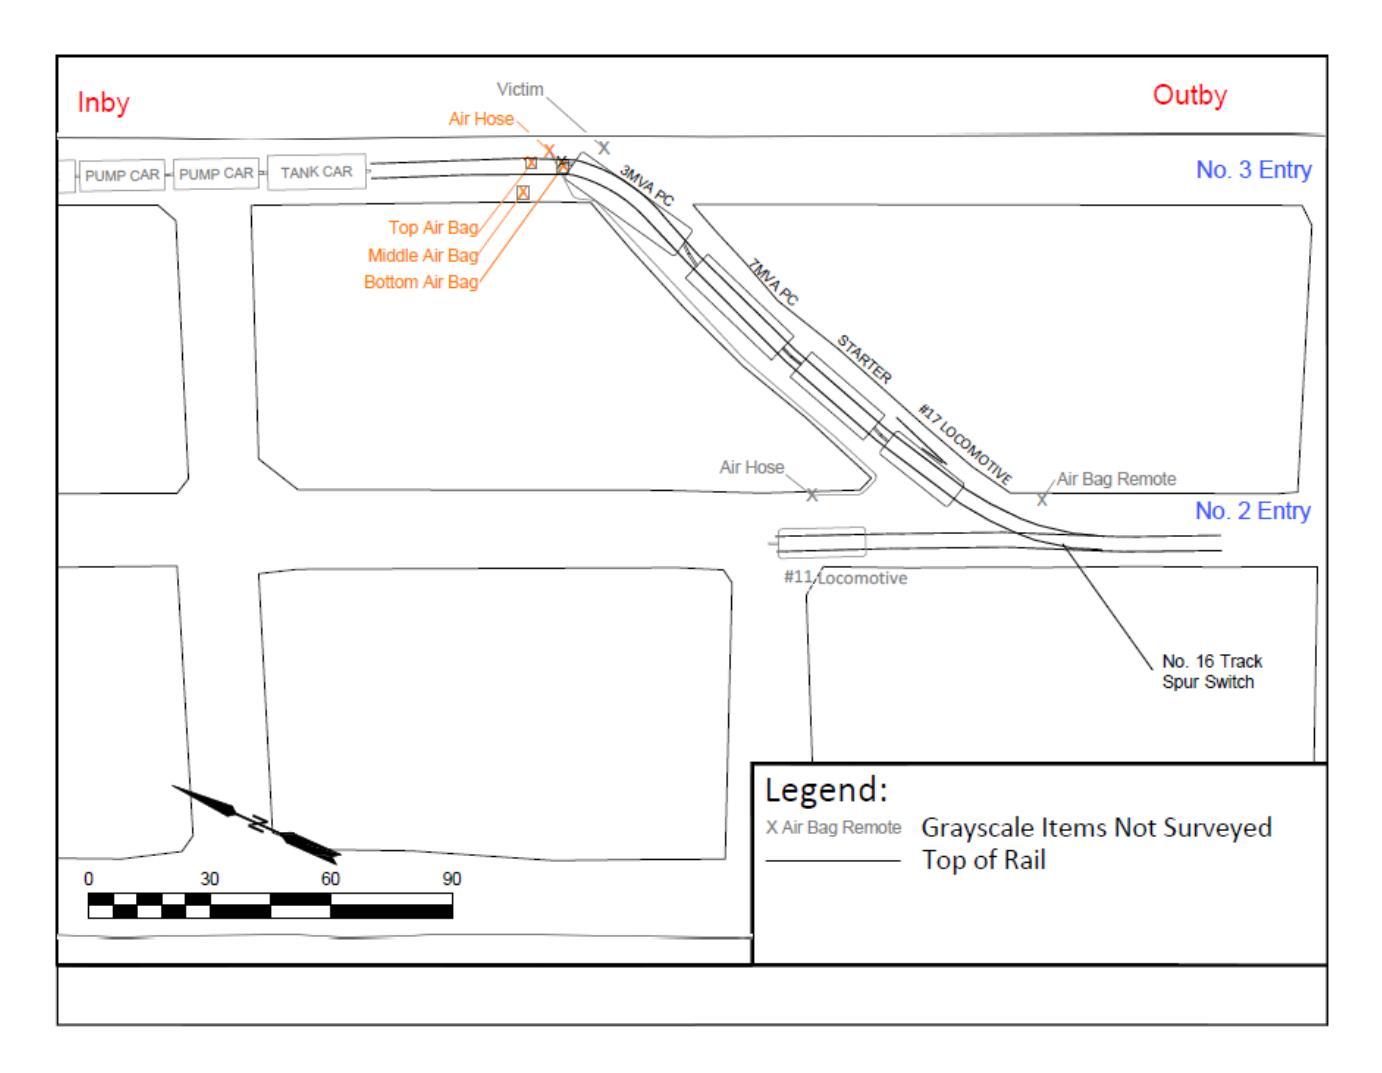
APPENDIX A – Map of the Accident Scene

The accident occurred in the 10 Left No. 16 track spur. The track installation in the spur was completed on August 1, 2024. The track was elevated above the mine floor and adequately blocked. The grade of the mine floor within the spur is relatively flat and did not contribute to the accident.

The track spur traveled through the No. 16 crosscut and curved into the No. 3 entry. The curve radius was too tight for the longwall electrical power car's length and mobility, causing it to derail. Four shorter pump cars were pushed into the spur earlier in the shift with no issue. The investigators determined that the installation of the track curve in the spur contributed to the accident.

Note: The airbags are located where the investigators found them after the accident.

<u>Corrective Action</u>: The mine operator performed track repairs to increase the radius of the curve to accommodate all equipment that will use the track.

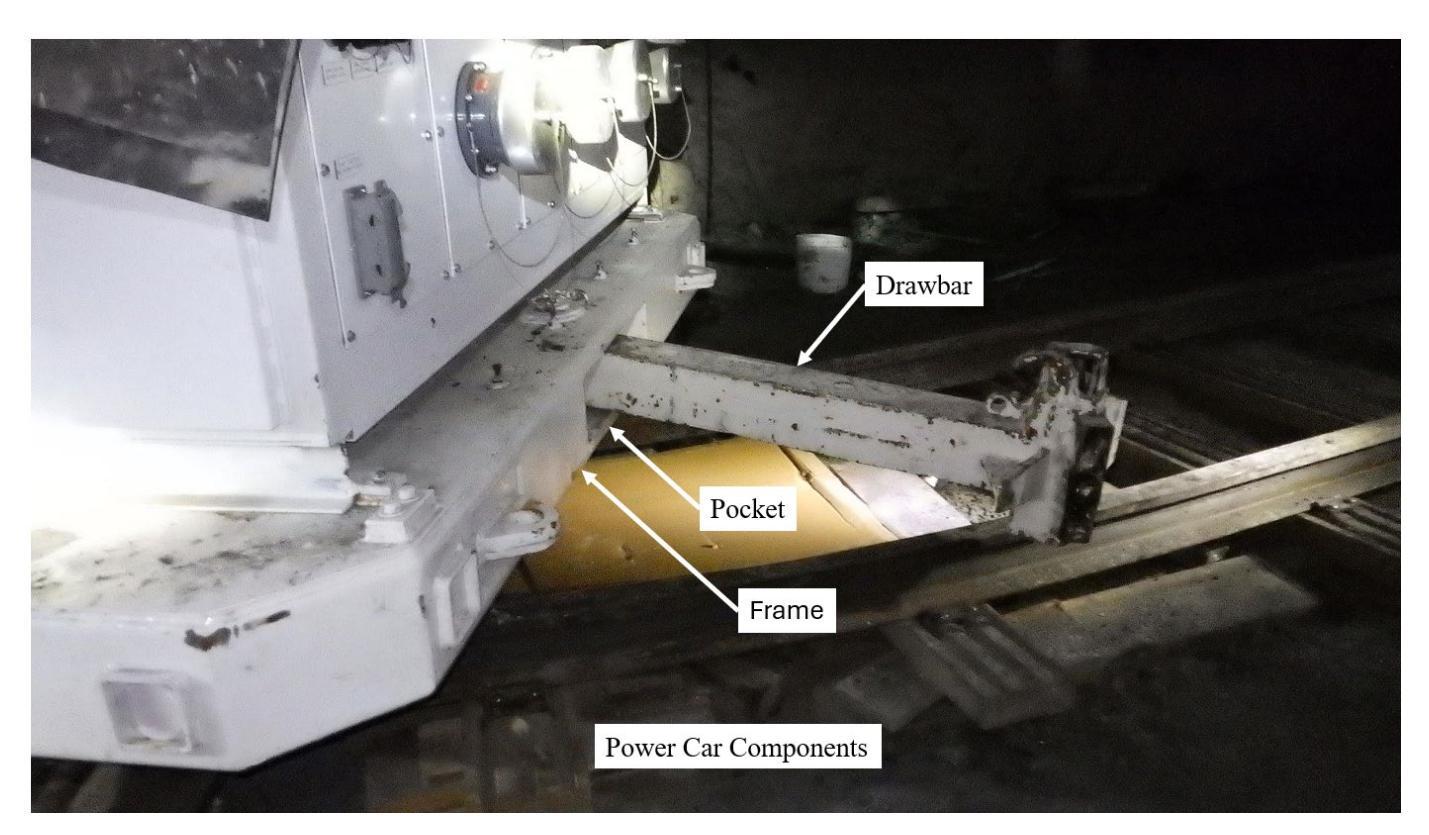
APPENDIX C – Longwall Electrical Power Car Components

The power car was equipped with a drawbar and coupling on both ends to facilitate connections between cars. The drawbar was attached to the frame of the car with a pin inside a pocket. The pin allowed the drawbar to swing from side to side in the confines of the pocket as the car traversed track curves in the mine (see Appendix C).

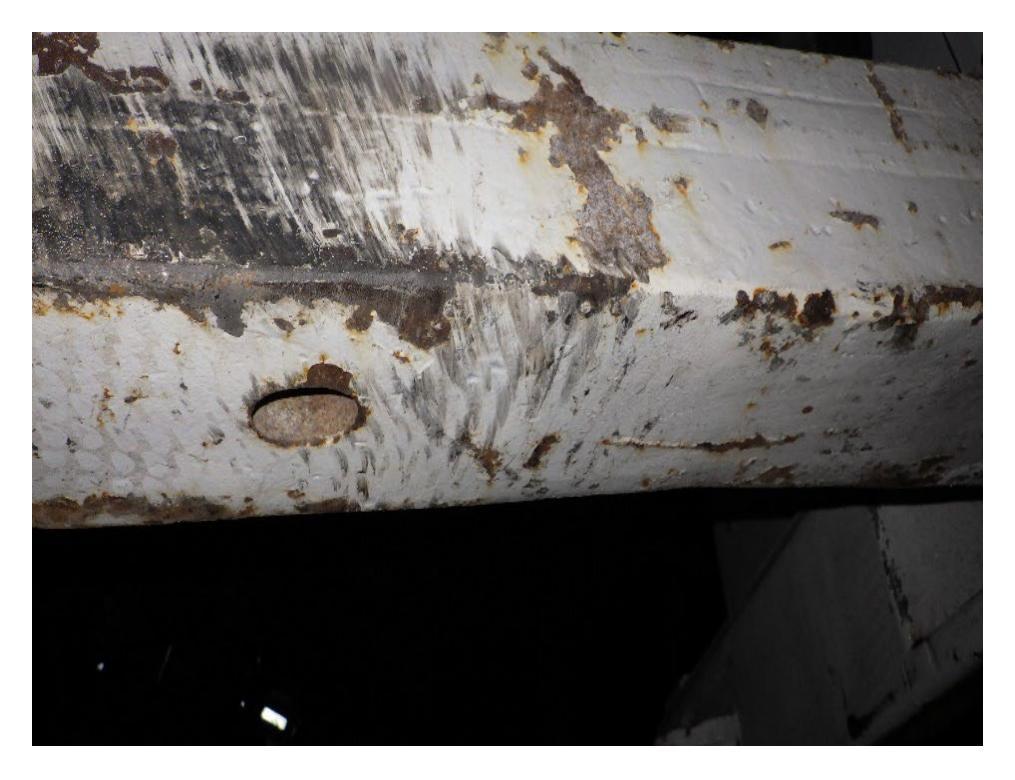
- 1. There were multiple rubber scuff marks on the underside of the power car frame and drawbar. There were also scuff marks on the side of the drawbar indicating sudden movement of the airbags.

Rubber Scuff Marks on Drawbar

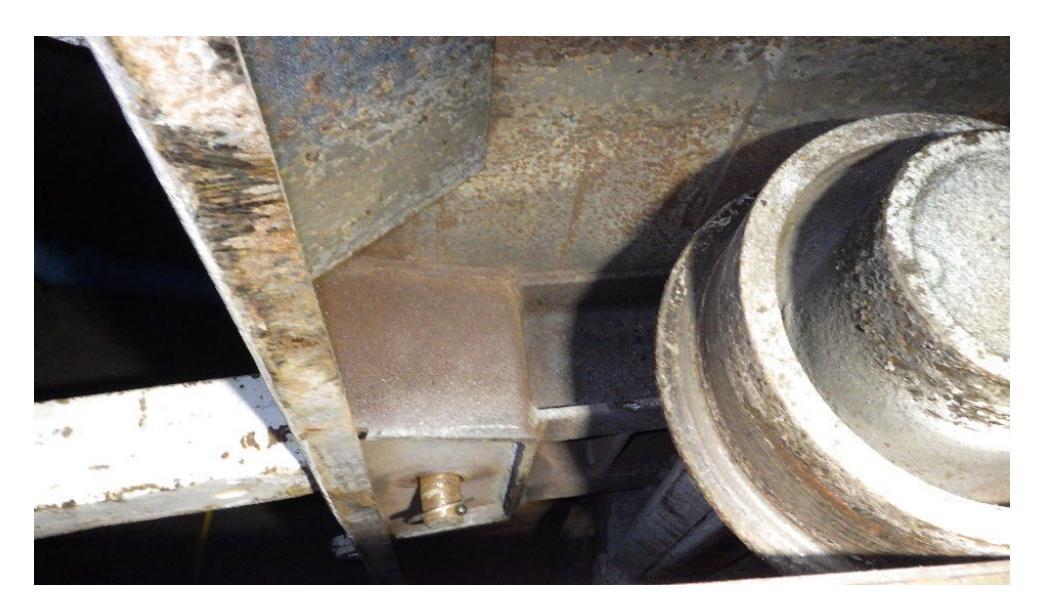
Rubber Scuff Marks on Power Car Frame

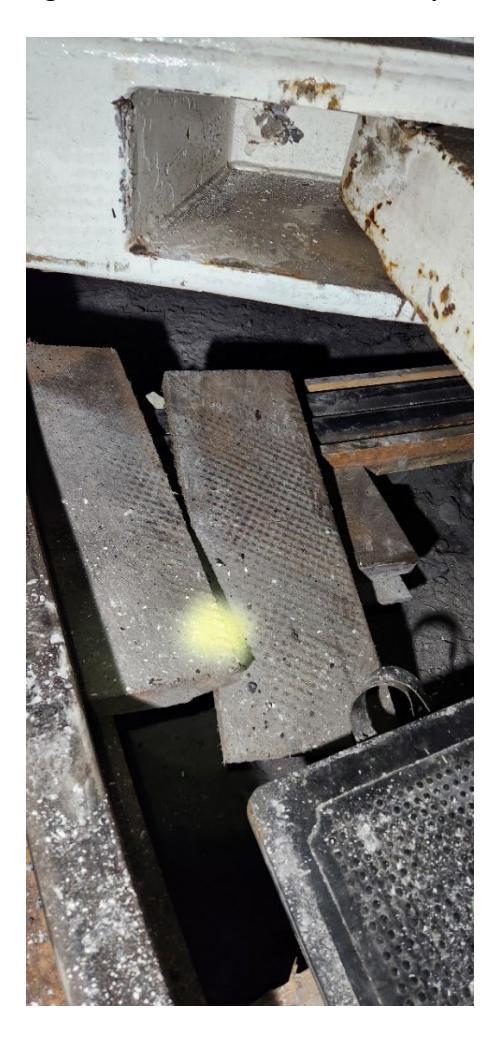
- 2. The power car was recently painted during its electrical component modification. A distinct mark was identified on the drawbar where it contacted the edge of the pocket. The paint on the pocket was loose and flaked off with little to no effort when touched. Flakes of matching paint were present on the mine floor and on the wooden blocking that was used for the airbags.

Impact Mark on Pocket with Paint Chips Below

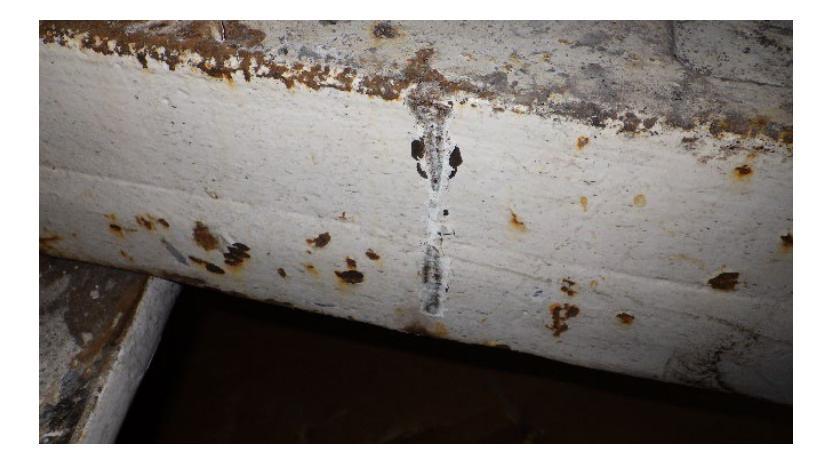
Impact Mark on Drawbar Where it Contacted the Pocket
