REPORT OF INVESTIGATION

Surface Metal Mine (Copper)

Fatal Fall of Person Accident September 1, 2008

at Freeport-McMoRan Morenci Inc. Freeport-McMoRan Morenci Inc. Morenci, Greenlee County, Arizona Mine I.D. No. 02-00024

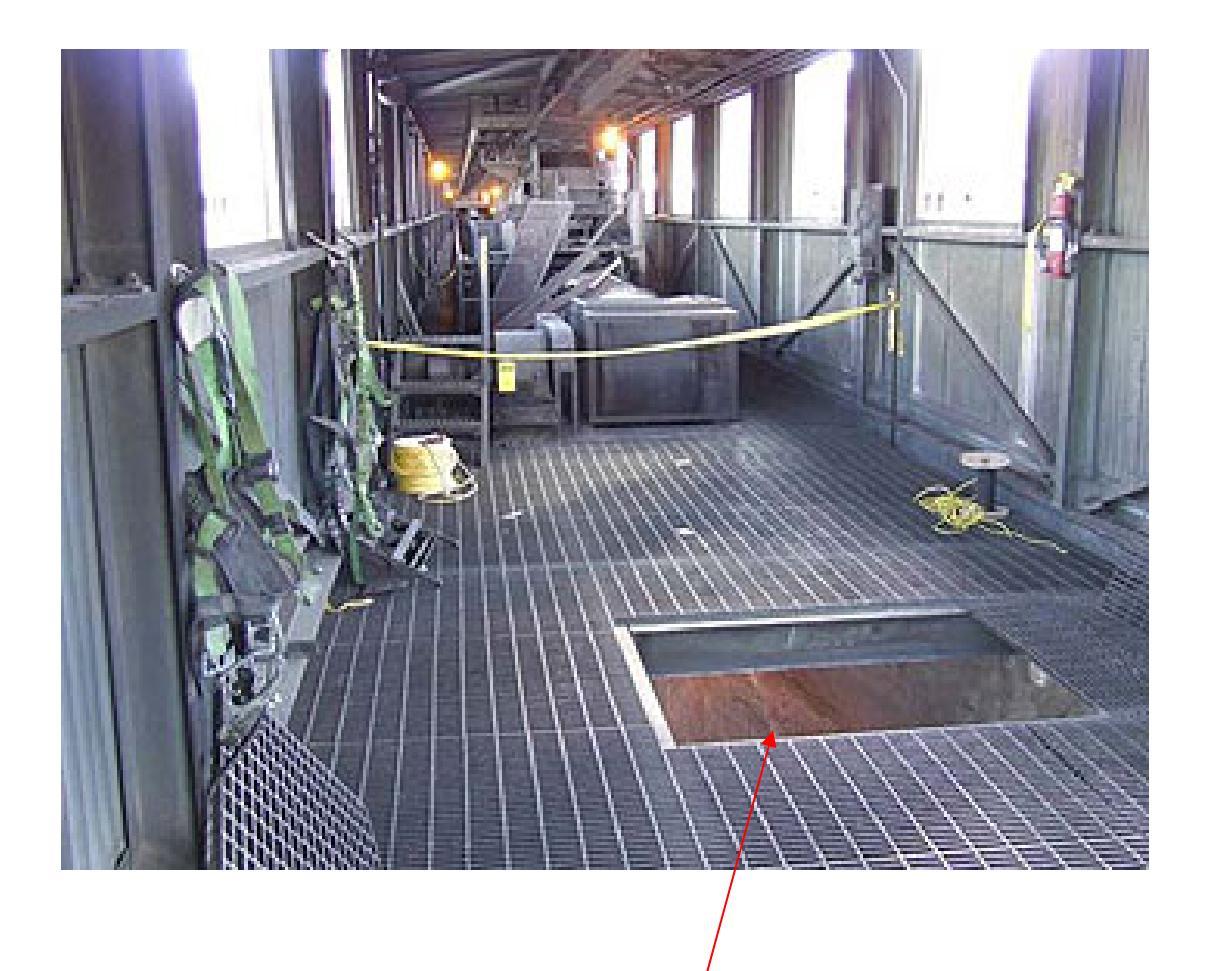
Opening victim fell through

The accident occurred because management policies and controls were inadequate and failed to ensure that the opening in the travelway was provided with railings, barriers, or covers when not in use.

The accident occurred near the BC belt conveyor located in the #6 bedding area building at the mill. This area was located 28 feet above the ground. Two sections of grating had been removed to lower tools and equipment to the ground, creating a 4-foot by 5-foot opening.

CORRECTIVE ACTION: Management should establish policies and controls to ensure that persons can safely travel near openings in elevated travelways. Specifically railings, barriers, or covers should be provided to protect persons from falling.

The citation was terminated on September 22, 2008. Management reinstalled the gratings which covered the opening. Employees were also retrained on fall hazards and the required use of fall protection.
