MAI-2013-22

UNITED STATES  
DEPARTMENT OF LABOR  
MINE SAFETY AND HEALTH ADMINISTRATION  
Metal and Nonmetal Mine Safety and Health

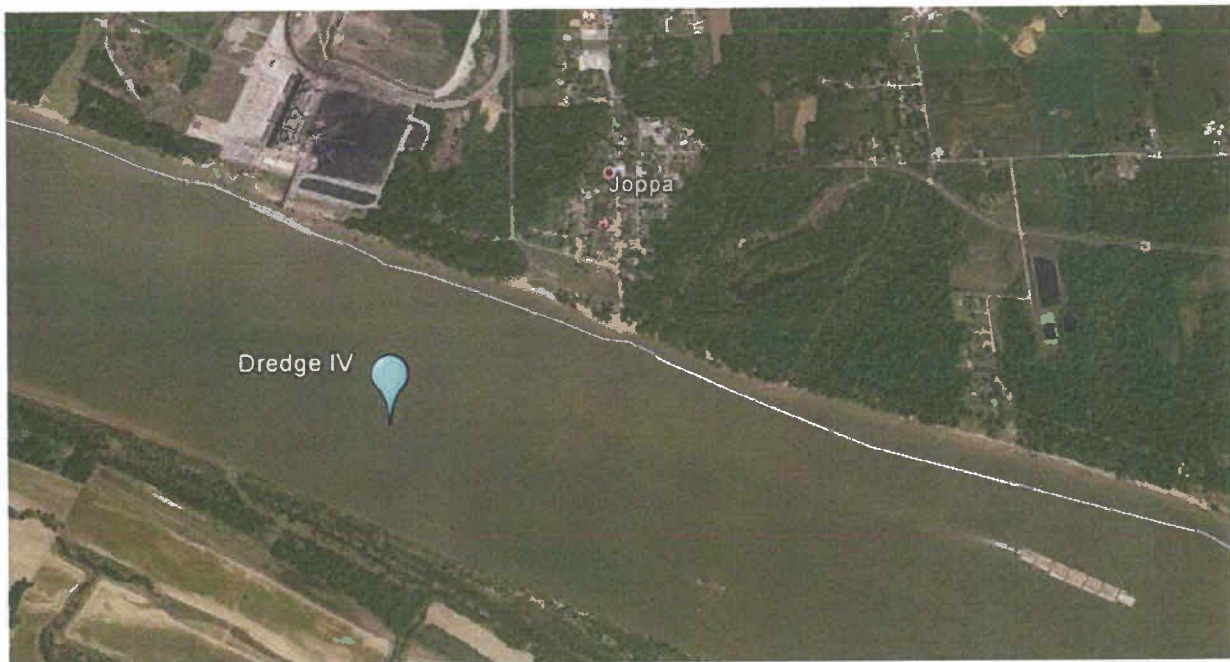
Dredge IV is located outside Joppa, Illinois, approximately 21 miles downstream on the Ohio River from the mine office in Ledbetter, Kentucky (32 miles by road).

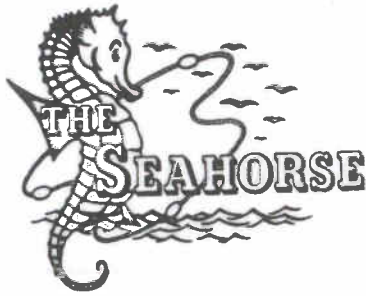
16152 E. Club Deluxe Rd., Hammond, LA 70403 (985)542-6266,  
(985)542-6371 fax, sales@taylor-tec.com

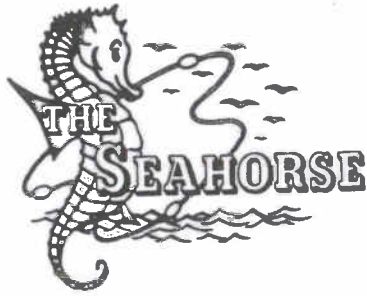
16152 E. Club Deluxe Rd., Hammond, LA 70403 (985)542-6266,  
(985)542-6371 fax, sales@taylor-tec.com
