#### MAI-2016-05

#### **REPORT OF INVESTIGATION**

Surface Metal Mine Titanium Ore

Fatal Machinery Accident April 11, 2016

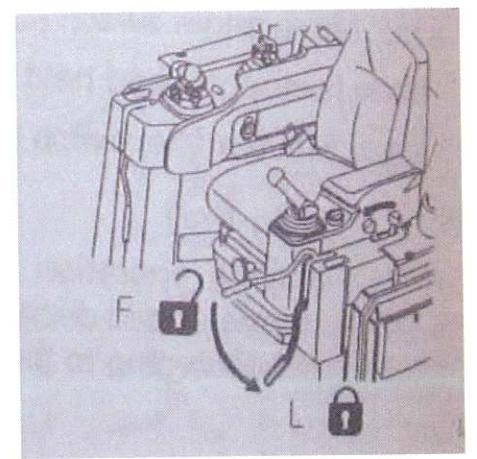
Figure 1 – Parking Brake Lever

During normal operation, the parking brake lever and work equipment lock lever are placed in the FREE position. These two levers are completely separate and they partially block egress from the machine when in the FREE position. The figures below show the parking brake lever on the operator's left side and the work equipment lock lever located on the operator's right.

When the parking brake lever was moved fully down into the LOCK position to engage the parking brake, the tip of the lever was 3.5 inches above the floorboard. When the lever was pulled upward into the FREE position to release the parking brake the tip of the lever was 19 inches above the floorboard.

With the engine running and the dozer on the 11.5% grade, investigators slowly raised the parking brake lever from the LOCK position to test functionality. The dozer started to coast when the lever was raised approximately half way through its range of travel, indicating the point where the parking brake was released. This amount of lever travel was also approximately the point at which the parking brake lever will continue, by spring force, to the full "up" position when released. To duplicate the conditions found after the accident, the transmission lever was in neutral and the dozer blade was in the raised position during this test.

Henderson was performing haul road maintenance when, for an unknown reason, he stopped the dozer at or near the top of the slope and, apparently, was attempting to exit the cab through the left door. The dozer was found at the bottom of the slope with left door locked open, the engine running with the transmission in neutral, the fuel control dial in the MIN position, and the blade locked 6 to 8 inches above the ground. The parking brake was in the released (FREE) position.

*Corrective Action:* Employees were retrained in proper parking procedures.

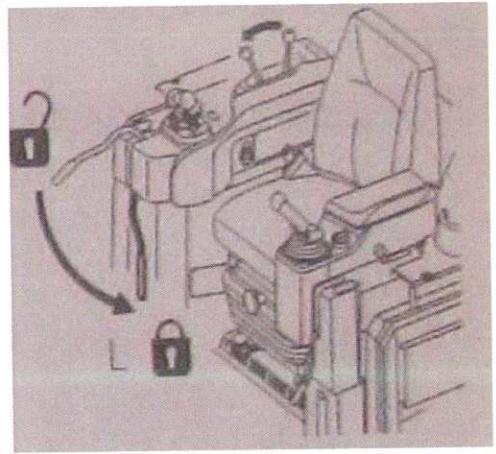
Figure 2 – Work Equipment Lock Lever

After the accident, the left side door was found in the open and locked position. The work equipment lock lever was found in the LOCK position, the fuel control dial was found in the MIN position, and the transmission was in neutral. These control positions are consistent with the recommended control positions for an operator about to leave the machine. The parking brake lever, however, was found in the FREE position, which is not consistent with the recommended control positions for an operator about to leave the machine. In the FREE position, the parking brake lever partially blocked egress and forced the operator to go around it in order to exit through the left side door. In addition, testing showed that the dozer would immediately begin coasting where the accident occurred if the parking brake lever was placed in the FREE position and the service brake was released. Witnesses reported that the dozer blade was found in a raised position, approximately 6 to 8 inches off the ground, and the engine was running. The "Operation & Maintenance Manual" recommends lowering the blade and stopping the engine when parking the dozer and to park the dozer on level ground if at all possible.
