#### **REPORT OF INVESTIGATION**

Underground Mine (Limestone)

Fatal Hand Tools Accident May 21, 2020

Bluff City Minerals Bluff City Minerals LLC Alton, Madison County, Illinois ID No. 11-00122

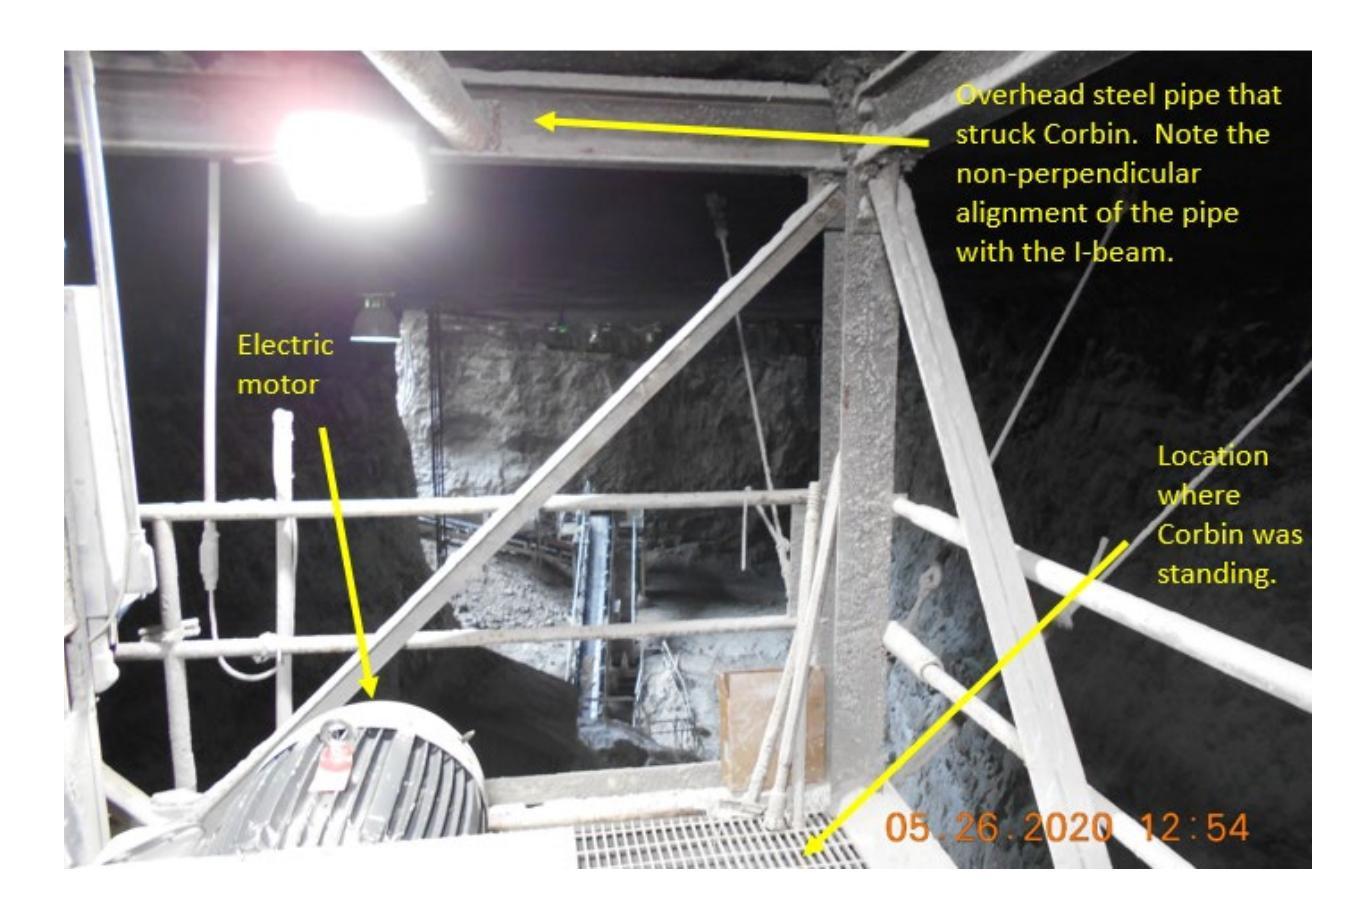
## APPENDIX A Photograph of locations of the pipe and motor prior to the accident

The steel pipe that struck Corbin was approximately 11 feet long by  $4\frac{1}{2}$  -half inches in diameter, and weighed approximately 225 pounds. The pipe had been used as a lifting anchor since at least 2003, and was located overhead between the I-beams of the framework of the platform for the

number 11 belt conveyor. The pipe had square steel plates welded on each end, which were positioned on the 2  $\frac{1}{2}$ -wide horizontal flanges on each of the I-beams.

Typically, miners would slide the steel pipe to different positions inside the I-beams to use as an anchor when lifting heavy components on the platform. In this case, miners could not position the steel pipe squarely over the lifting eye on the defective electric motor due to the placement of two overhead area lights. As a result, the miners oriented the steel pipe at an angle in relation to the I-beams, rather than perpendicular to the I-beams. See Appendices A, C, and D.

Miners normally would install "C" clamps adjacent to the steel pipe if they thought lateral pulling motion could move it out of position. Miners discussed movement of the steel pipe on the morning of the accident, but they had not been trained to recognize the hazard of the unsecured overhead steel pipe sliding out of the I-beams. Therefore, they did not secure the steel pipe against hazardous lateral movement.

When the two miners were moving the electric motor, the overhead steel pipe, as shown, slid to the right, fell out of the I-beam channel, and struck Corbin. At the time, Corbin was standing in the corner, with his back turned to the pipe, operating the chain hoist.

<u>Corrective Action</u>: The mine operator installed a new lifting and anchor system for handling heavy components at the head drive of the number 11 belt conveyor.
