REPORT OF INVESTIGATION

Surface
(Sand and Gravel)

Machinery Accident
August 21, 2023

Portable Crusher #2
A & S Construction Co
Gunnison, Gunnison County, Colorado
ID No. 05-03808

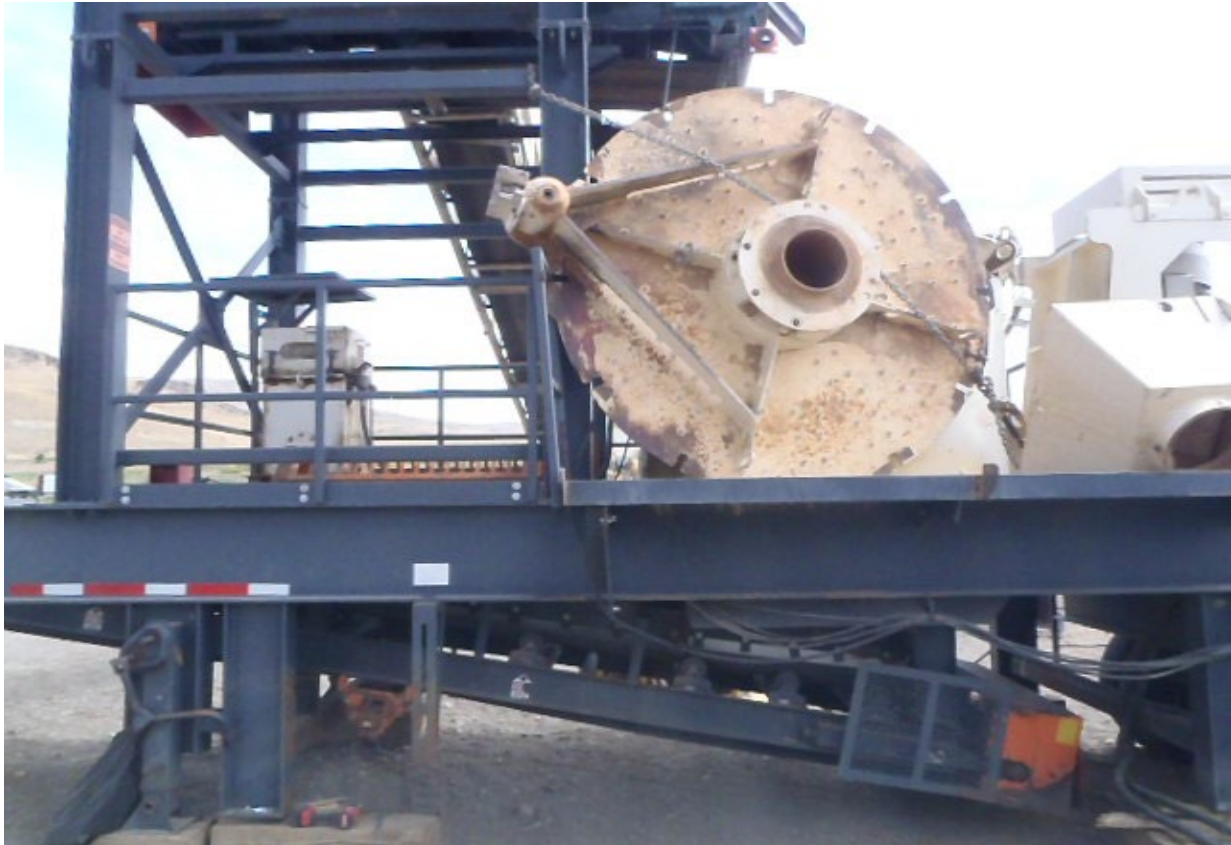
The VSI crusher involved in the accident was a 2018 Terex/Canica Model #2000. At the time of the accident, the hydraulic ram lift was not functioning. The ram is designed to safely lift and swivel the crusher lid out of the way during the replacement of the internal wear parts. A & S Construction Co purchased the crusher from Colorado Quarries, Inc. on January 4, 2023, and used it at one previous job prior to moving to Gunnison, Colorado. When Colorado Quarries, Inc. owned and operated the crusher, they modified the crusher lid by extending the central hub portion approximately five inches. This raised central hub had a sharp edge that cut through the nylon lifting strap, causing it to fall and strike McCaghren. If the central hub had not been raised, it would not have contacted the strap.

The lifting strap involved in the accident was a one-inch-wide by six-foot-long Equiprite Eye to Eye, Type Three, nylon sling. Investigators determined that the lifting strap was in good condition before the accident. However, the lifting strap was one inch away from a sharp edge on the raised central hub of the crusher lid, and was able to slide along the hook's surface, which occurred as the lid was being moved into place (see Appendix A). The sliding of the lifting strap through the hook allowed the strap to contact the sharp edge of the lid, cutting it, and causing it to break. Steel lifting chains were available but not used. The mine operator did not use a suitable lifting strap to hoist the lid, which contributed to the accident.

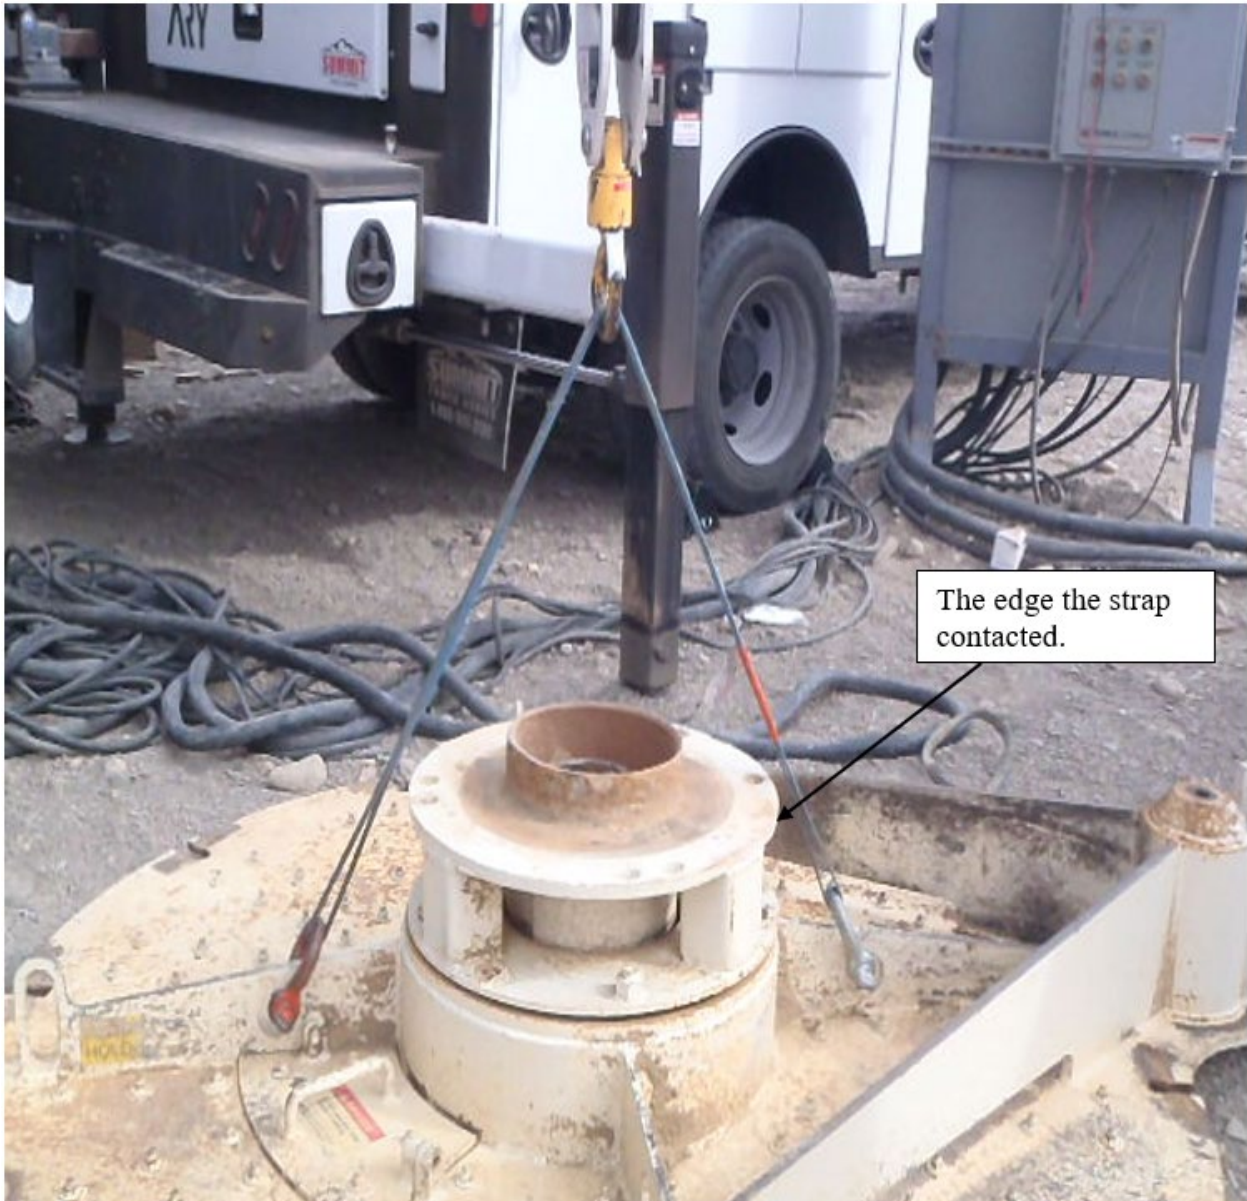
APPENDIX A – Nylon Lifting Strap Attached to the Lid

Herrell conducted pre-operational inspections of the chain hoist and rigging and determined they were safe to use. Herrell should have recognized that the nylon strap was not adequate for this lift due to the proximity of the sharp edge on the raised central hub of the lid.

Corrective Action: The mine operator developed and implemented a new written procedure for the use of suitable rigging devices for suspended loads. The mine operator put selected miners through training to be certified riggers who will be present during all lifts.

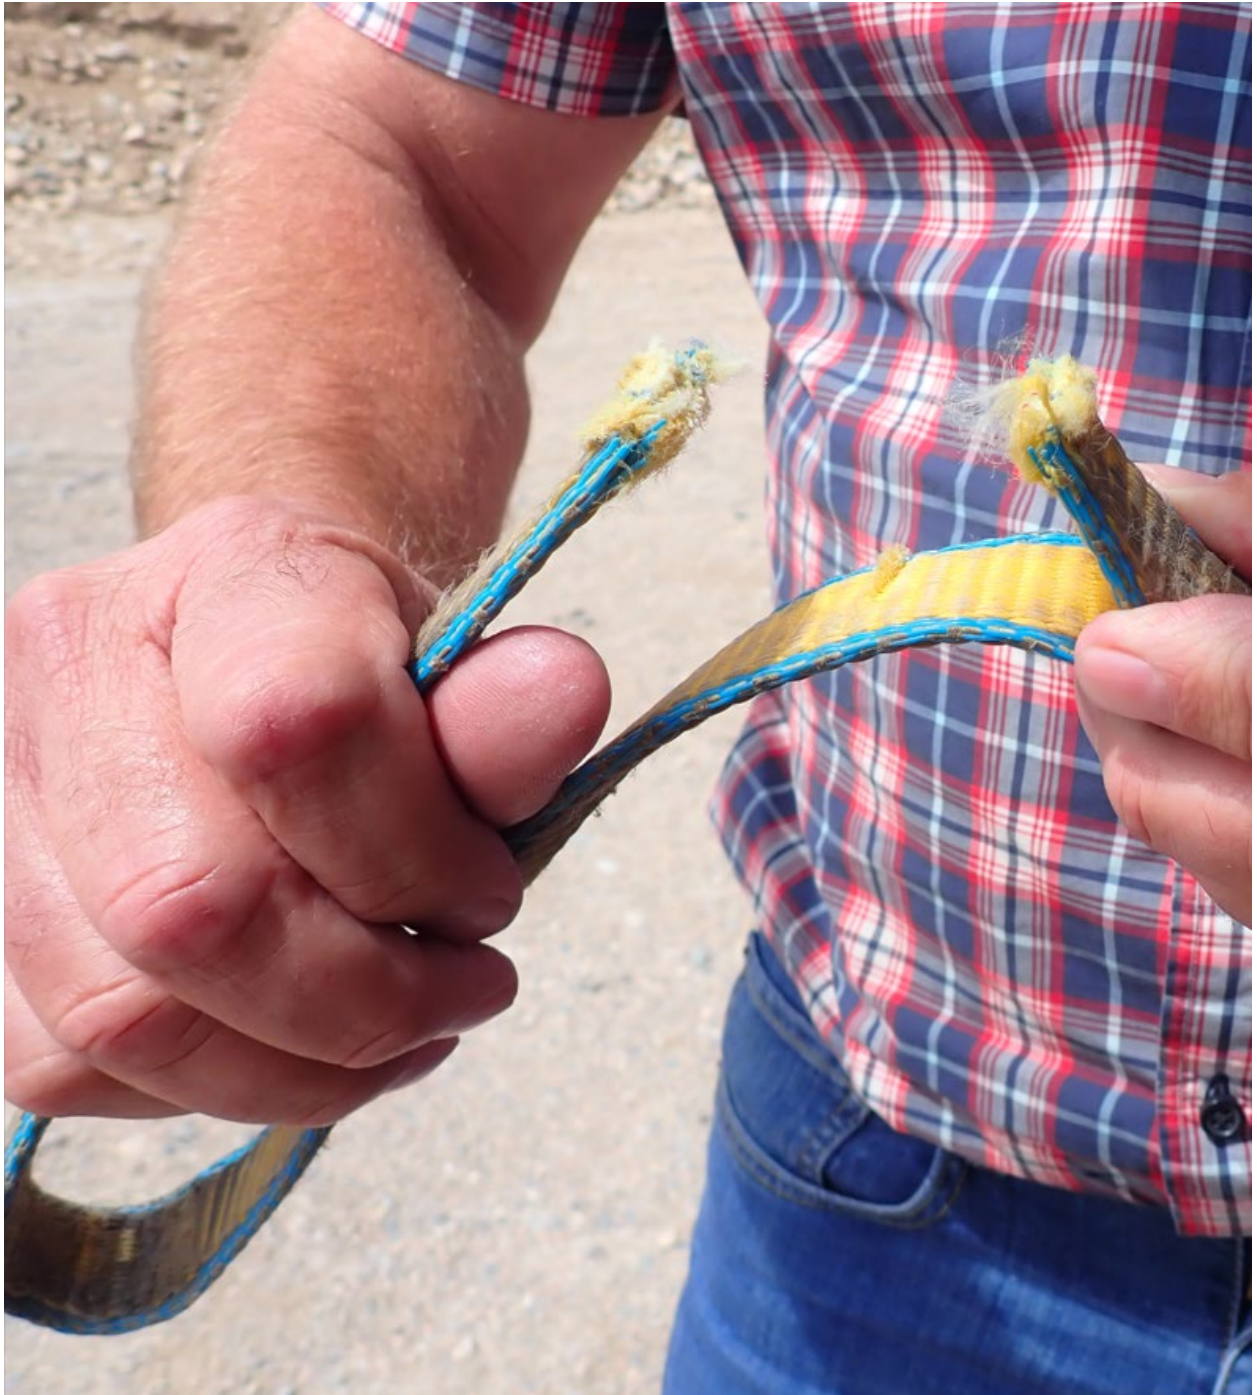
APPENDIX B – Damaged Lifting Strap

Herrell and Whittemore were also manually guiding the lid into place, but were on the opposite side (south side) of the lid as McCaghren. Fedriko was in the front-end loader. As Fedriko was pulling the lid back into place, the lifting strap came into contact with a sharp edge on the crusher lid which cut the strap (see Appendix B). This caused the lid to fall and hit the top of the crusher, bounce off, and fall to the crusher's walkway on the west side. Herrell and Whittemore asked each other if they were okay and yelled out to McCaghren asking if he was okay. After receiving no answer, they moved around to the west side of the crusher and found McCaghren injured and unresponsive. He was pinned between the edge of the lid and the mid-rail of the
