REPORT OF INVESTIGATION

Fatal Falling, Rolling, or Sliding Rock or Material of Any Kind Accident
August 5, 2023

Echols Mill Quarry 1 and 2
Savannah Valley Quarries, LLC
Lexington, Oglethorpe County, Georgia
ID No. 09-01187

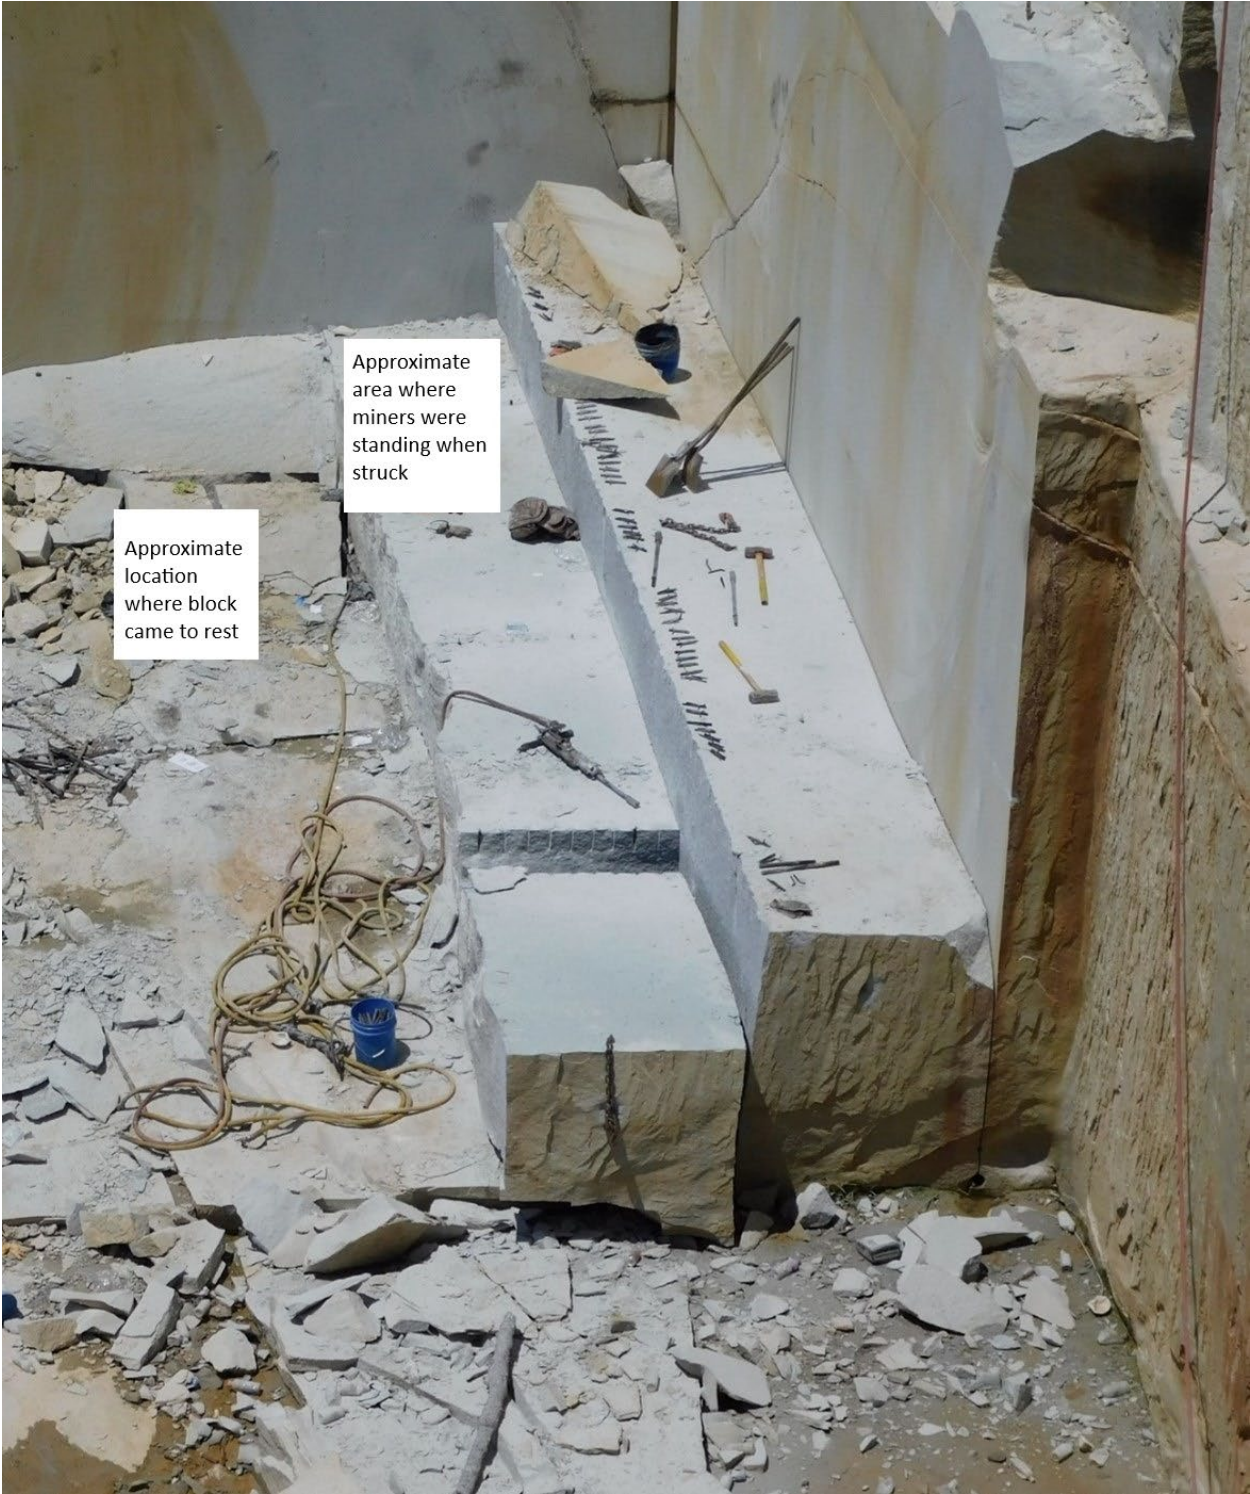
APPENDIX C – Overhead View of Accident Scene

The accident occurred in the quarry in an area known as the "small hole," on the second granite wall. At the time of the accident, miners were working on a block of granite on the East-Northeast end of the quarry wall which was 34 feet long, 54 inches wide, and 34 inches high (see Appendix C).
