# Pillar Collapses in Underground Limestone Mines

**William J. Gray, Chief  
Roof Control Division  
Mine Safety & Health Administration,  
Directorate of Technical Support  
Pittsburgh Safety and Health Technology Center  
Pittsburgh, PA  
Gray.William@dol.gov  
412.386.6301**

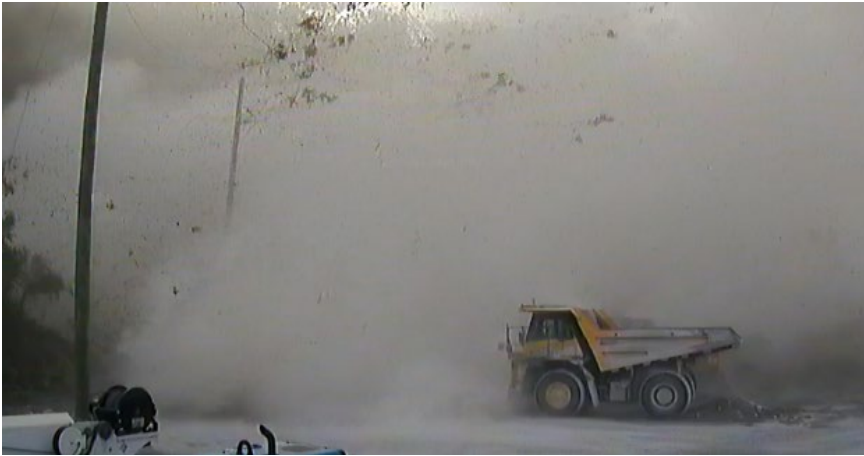
# August 2021 Pillar Collapse

Airblast

Surface Sinkhole

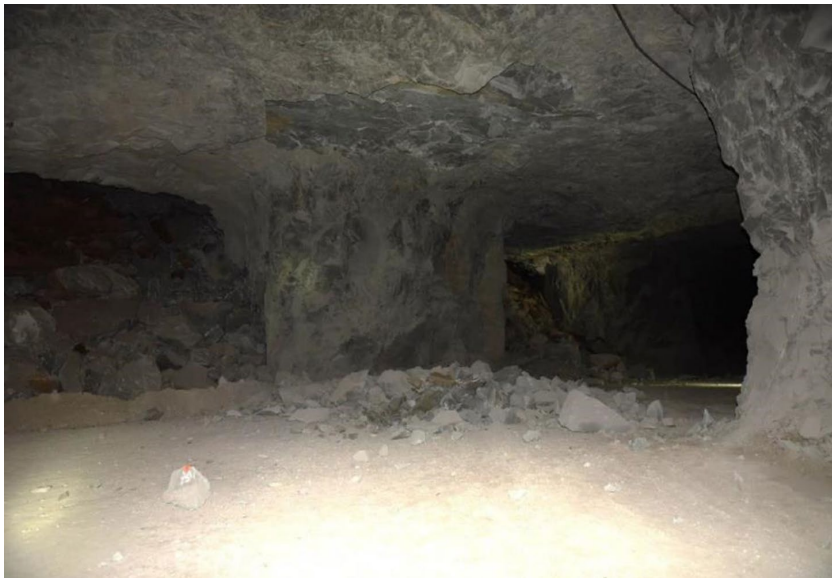
PA Limestone Mine: Newly Benched Area  
(October 2020)

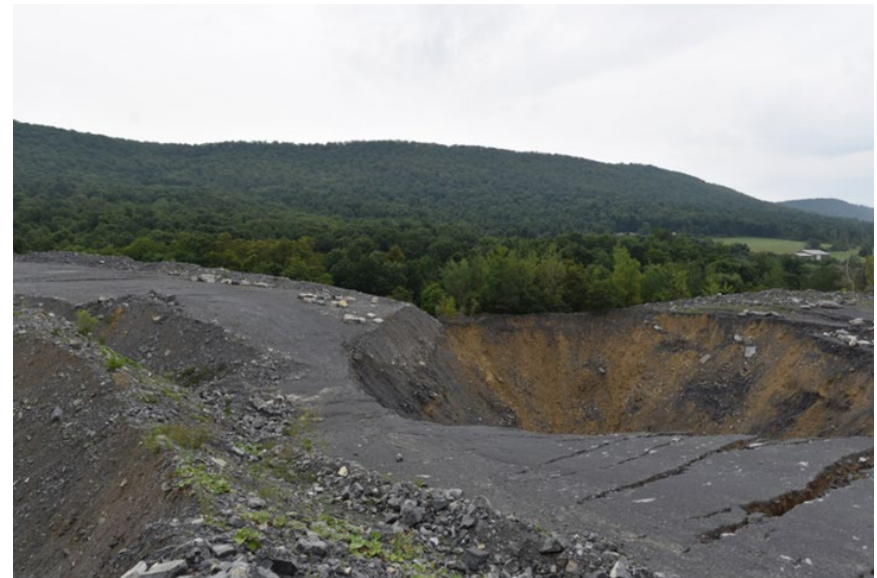
PA Limestone Mine: Legacy Area  
(November 2020, July 2021)

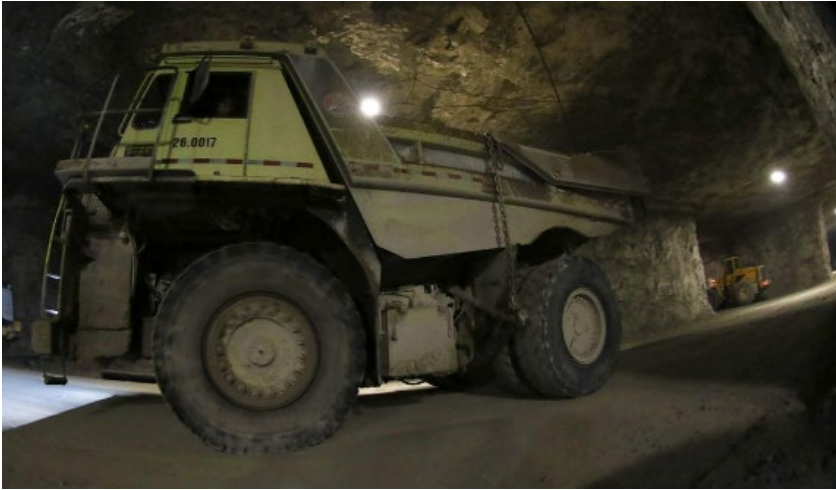
# Airblast Hazards

Miners may be exposed in or near:

Haul roads and travel roads.

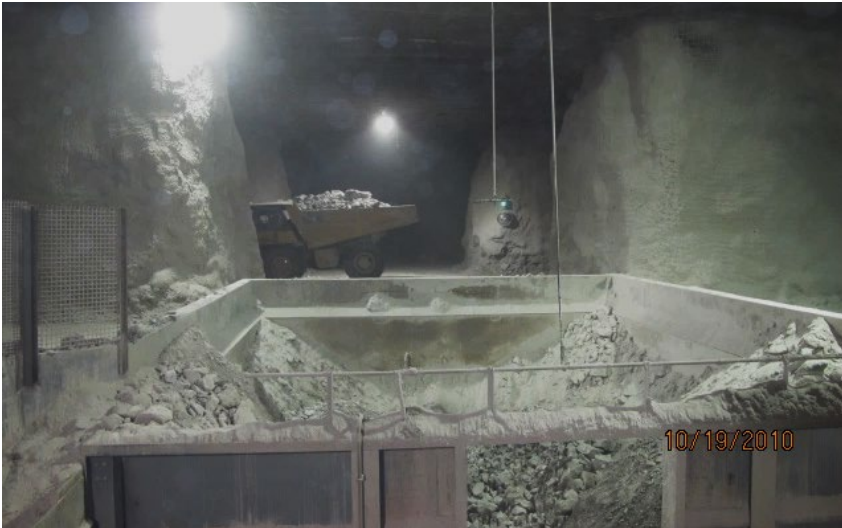
Crushers, shops, explosive magazines, and other underground infrastructure.

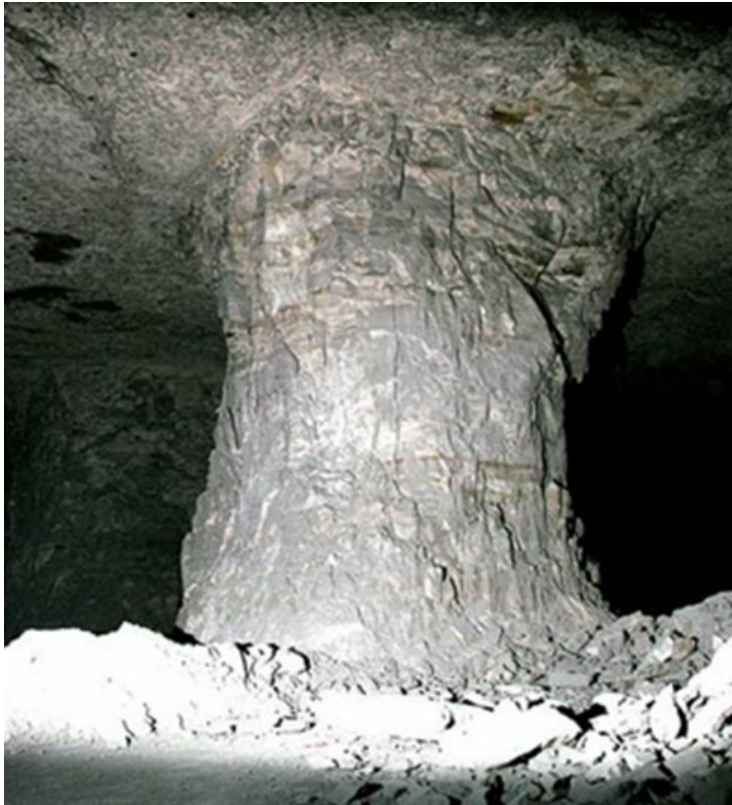
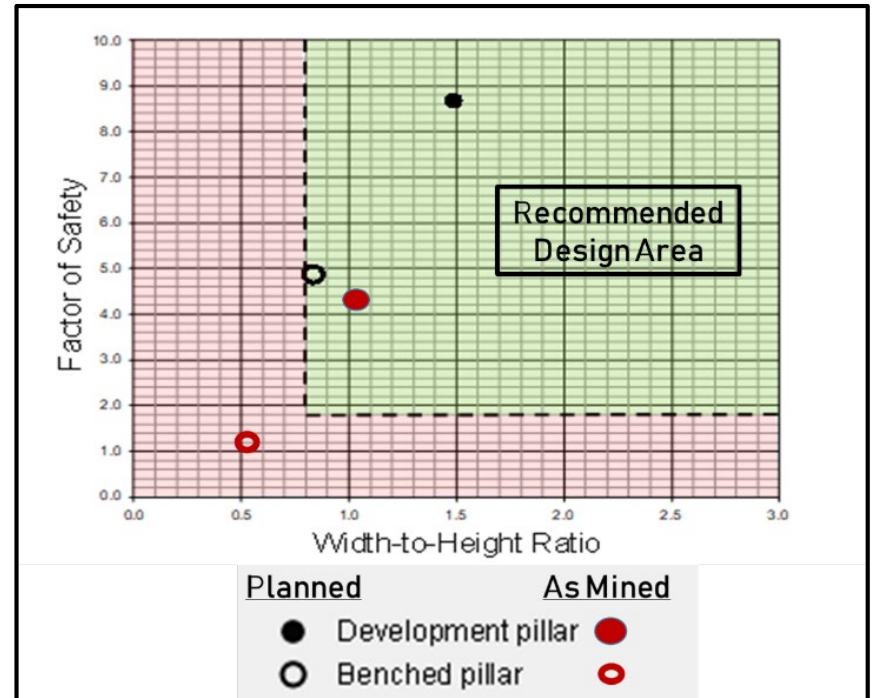
NIOSH S-Pillar Program

Common aspect of all recent collapse events— tall, slender pillars

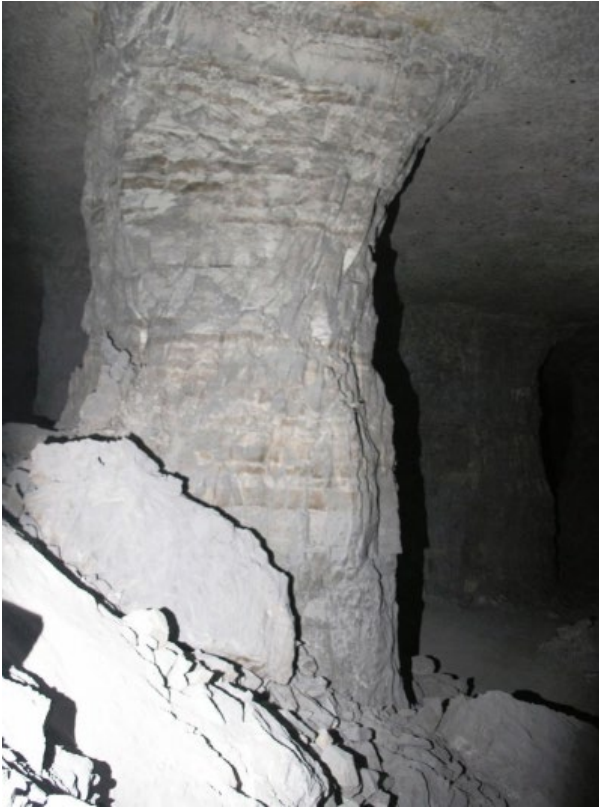
# Assessment of “legacy” areas

- Evaluate the likelihood of collapse
- Evaluate the consequence of a collapse
