A Case Study of the Collapse of Slender Pillars Affected by Through-Going Discontinuities at a Limestone Mine in Pennsylvania

Abstract

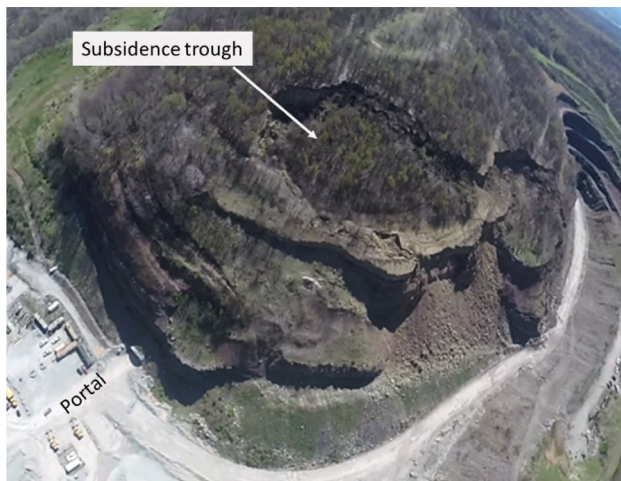
Fig. 1 Aerial view of the mine showing extent of surface subsidence associated with the collapse of the pillars

mountainside overlying the mine workings had occurred. The subsidence area encompassed about 3 Ha. Underground inspections to delineate the collapsed area showed that about 35 pillars had collapsed. A wide-angle, aerial camera view of the mine showing the access portal and the subsidence area is presented in Fig. 1. The mine owners have requested that the name of the mine operation remains anonymous in this publication and will be referred to as ‘the case study mine’.

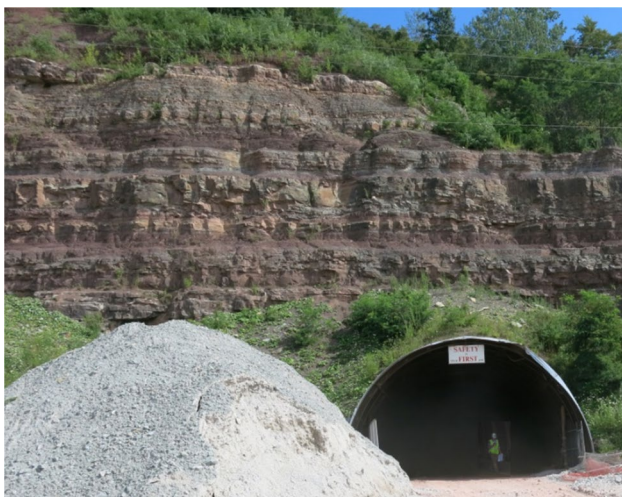
Fig. 3 Access portal entering the mine with Mauch Chunk beds exposed in the highwall

The Loyalhanna limestone extracted at the mine typically occurs at depth in the region, but is mined in numerous locations where folding has brought it nearer to the surface. The folding of the Loyalhanna limestone is gentle and is hardly noticeable at the scale of the collapsed mine workings. In southwestern Pennsylvania, the Loyalhanna is stratigraphically a lower member of the 1000- to 1500-m-thick, Mississippian-age Mauch Chunk Formation. The Loyalhanna limestone has a maximum thickness of 30 m, but is typically 20 m thick in the Chestnut Ridge mines. It is light to greenish gray and compositionally ranges from a calcareous sandstone to a sandy limestone (Edmunds et al. 1979). At the mine, the Loyalhanna limestone bed is overlain by distinctive reddish-brown mudstones, shales, and siltstones of the Mauch Chunk beds, as shown in Fig. 3.

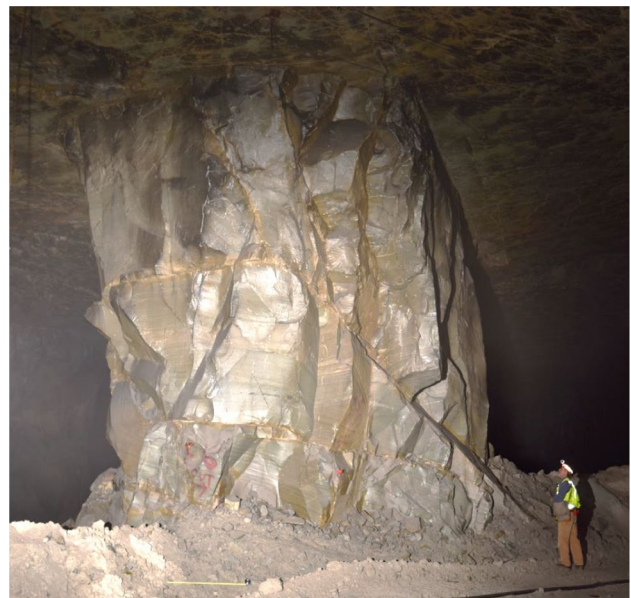
Fig. 4 Prominent N60°W striking joint intersecting a pillar south of the collapsed area

Jointing observed underground showed multiple orientations, although most joints fell generally into a northwest and northeast set with dips ranging from vertical to less than 30°. One particular set of joints stood out in terms of prominence, persistence, and uniformity. This set, with a strike of N60°W, occurred in a well-defined zone 150 m wide that intersected the main portal area and the eastern half of the pillar collapse zone. Joints in the zone were typically spaced 3–5 m apart and dipped 60–80° to the southwest, as shown in Fig. 4. Some joints traces exposed by the within pillars were curvilinear with dips less than 60° in the lower portion of the pillar. Many of the joints near the collapsed area were dilated by groundwater dissolution and some showed apertures up to 15 cm. The joints, which were perpendicular to both the axis of the Chestnut Ridge anticline and the strike of the thrust fault are interpreted as transverse joints associated with anticline formation.

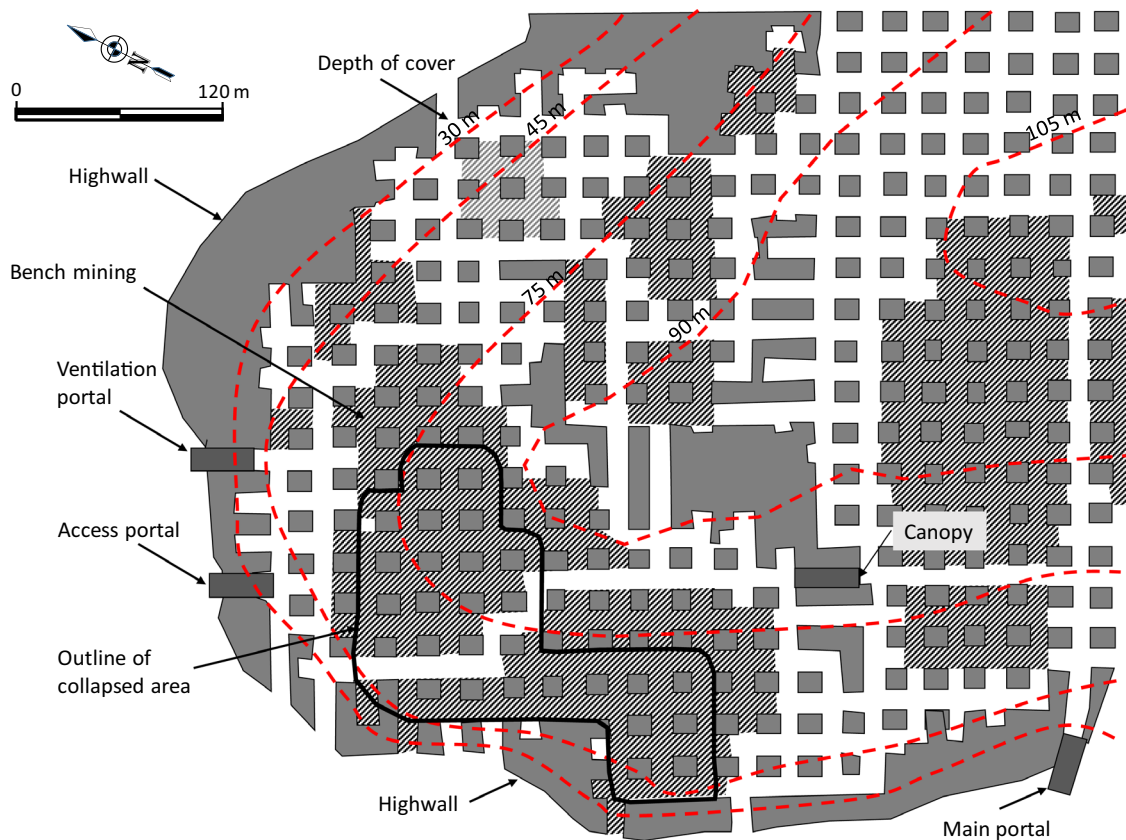
Fig. 5 Plan view of the mine workings showing the room-and-pillar layout, the outline of the collapsed area and depth of cover contours

Figure 5 shows the mining layout and the outline of the area that collapsed. A relatively regular pillar layout was followed starting at the portals, but as the mine progressed, it appears that poor ground conditions were encountered near the low-angle fault exposed in the highwall and underground. As a result, large blocks of ground were left intact

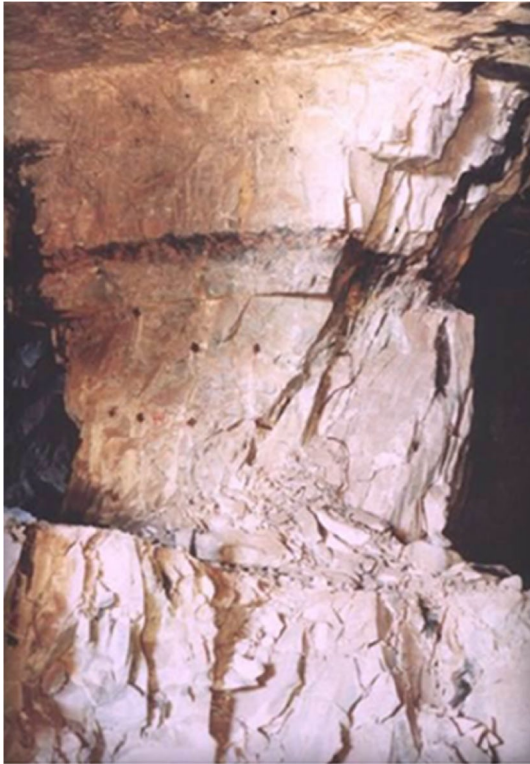
Fig. 6 Pillar impacted by large angular joints along the edge of bench mining showing sections of the pillar that fell away during bench mining (photo by A. T. Iannacchione)

with the objective to resume mining beyond the poor ground. During this time, bench mining was conducted in the area near the portals. Bench mining more than doubled the height of the pillars, exposing continuous angular joints that caused sections of the intended pillars to fall away during the blast. Figure 6 shows such a pillar observed around the year 2001 (Iannacchione personal communication 2016).

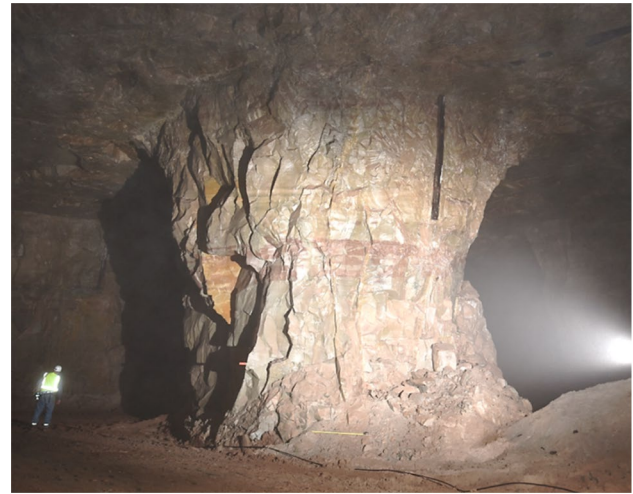
Fig. 7 Pillar affected by angular jointing adjacent to the collapsed area

Figure 7 shows a pillar along the escapeway, which demonstrated the type of roof-to-floor jointing observed in this part of the mine. Note that the walkway was not bench mined and was, therefore, about 10 m above the floor of the benched area.

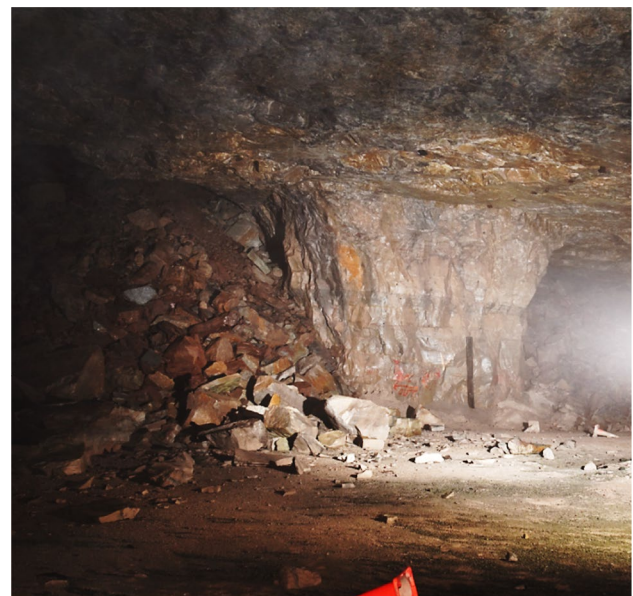
Fig. 8 Rubble from the roof collapse and a stable pillar along the edge of the area that collapsed

Figure 8 shows the roof rubble that flowed between the pillars during the collapse. None of the collapsed pillars were visible, owing to the volume of roof rubble that flowed into the mine voids. This raised the question of whether the event may have simply been a roof collapse. However, the significant depth of subsidence, without signs of pillar humps on the surface, and the abruptness of the collapse rules out that the pillars may still be standing in the collapsed area. A roof collapse would be expected to be more progressive, taking place over an extended period of time.

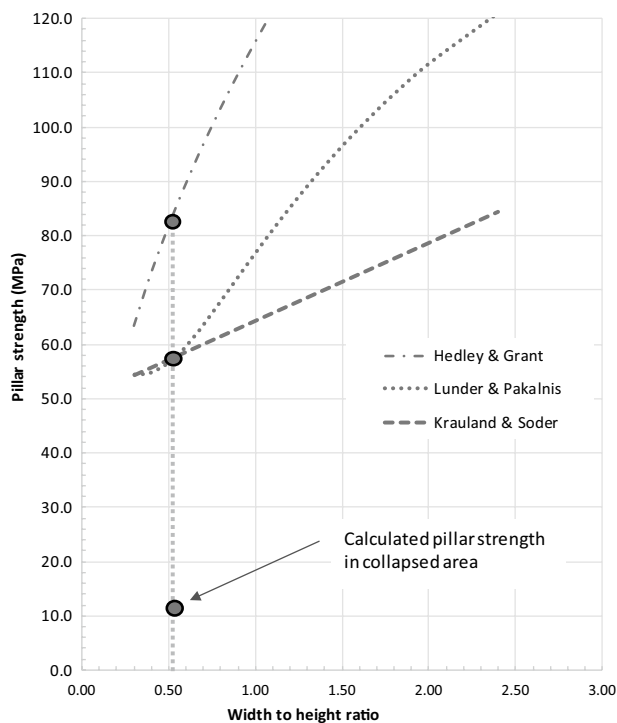
Fig. 10 Calculated pillar strength in the collapsed area compared to predictions using established hard-rock pillar strength equations

In these equations, k is the large-scale rock strength, w is the pillar width, h is the pillar height, σ_c is the uniaxial compressive strength of the intact rock, and κ is a confinement parameter. The pillar strengths for 17.7-m-high pillars of various widths were calculated using each equation and are shown in Fig. 10. For the Hedley and Grant equation, the strength factor relating the large-scale rock strength to the laboratory-scale UCS is 0.58, and for the Krauland and Soder equation the strength factor is 0.354. The calculated 11.0 MPa pillar strength from this case study is also shown in Fig. 10. It is clear that the empirically based strength equations would have grossly overestimated the actual pillar strength and would have predicted stable conditions at the mine.

The reason for the discrepancy between the empirical equations and the actual pillar strength at the case study mine is ascribed to the presence of large angular discontinuities cutting through the slender pillars. It appears that the case studies that were used to develop the empirical equations did not include any cases of such slender pillars with large through-going discontinuities. The impact of large through-going discontinuities is also not explicitly included as an input parameter in the selected pillar strength equations.
