## Backbiter rivet issue

Subject: Miller BackBiter Shock-Absorbing Lanyard Model No. 8798B

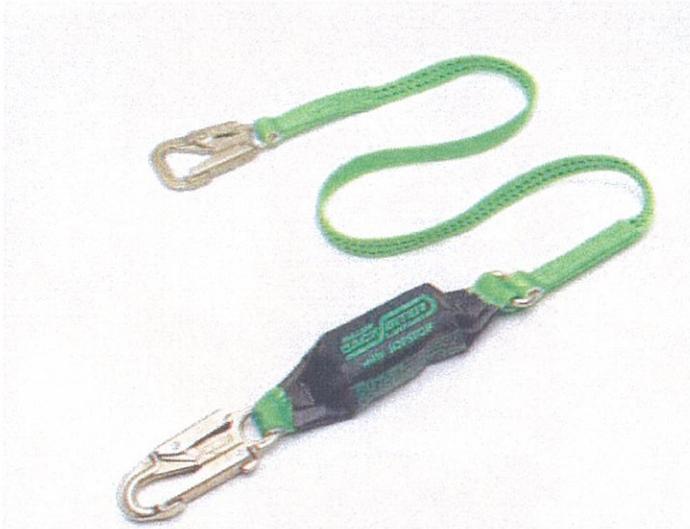
**Background:** We were notified of a backbiter rivet shearing, causing the keeper on the snap hook to detach from the unit. Note: The snap hook and gate were still intact. With the keeper becoming unattached, this resulted in the loss of dual-action functionality of the snap hook. The lanyard and snap hook were drop tested at our facility and passed all applicable ANSI testing. Rivet was analyzed and was to specification metallurgically.

**Corrective action:** A letter was published to our customers explaining the situation. We were not able to duplicate the failure in our test lab. From the analysis we performed, we concluded that the rivet pin, if repeatedly struck, drug across rough surfaces, and abused, could possibly cause the rivet pin to shear. (We had no test data to prove, but we did have two instances in the field). We instructed our customers to carefully inspect the rivet heads for signs of wear prior to use.

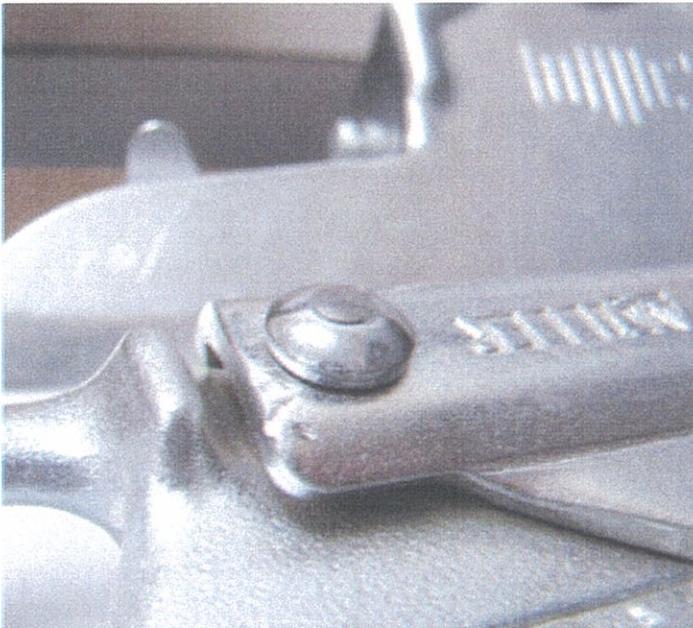
**OLD STYLE**

**Preventative action:** Immediately, we switched to a different design which shielded the rivet pin from damage, Note the countersunk rivet head. This countersunk design protects the pin from accidental blows and wear over time.
