ALERT

Subject: Wheel Loader Product Update – Select L150E Loaders
Fuel line support and electrical cable routing checking/repositioning

WLO01003 - L150E Installing Support Bracket for Fuel Delivery Pipes Attachment 1 - Work Instructions

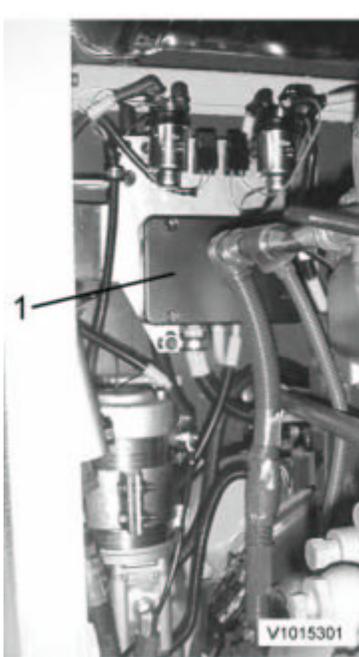
Fig.1 Fuse box

1. Check that the cable harness from the starter motor to the fuse box is not damaged. If required, adjust the position of the cable harness to eliminate the potential of scuffing.
2. Remove the cover from the fuse box. Check that lock washers are installed under the two M10 nuts where connecting tab and cable terminal are positioned. If the lock washers are missing, new lock washers must be installed. Check the tightening torque of all nuts in the fuse box. For tightening torque, please see text in fuse box, Fig. 1, 2 and 3. The tightening torques are the same as the listed torque values below:

4. Re-install the cover on the fuse box, see Fig. 1.

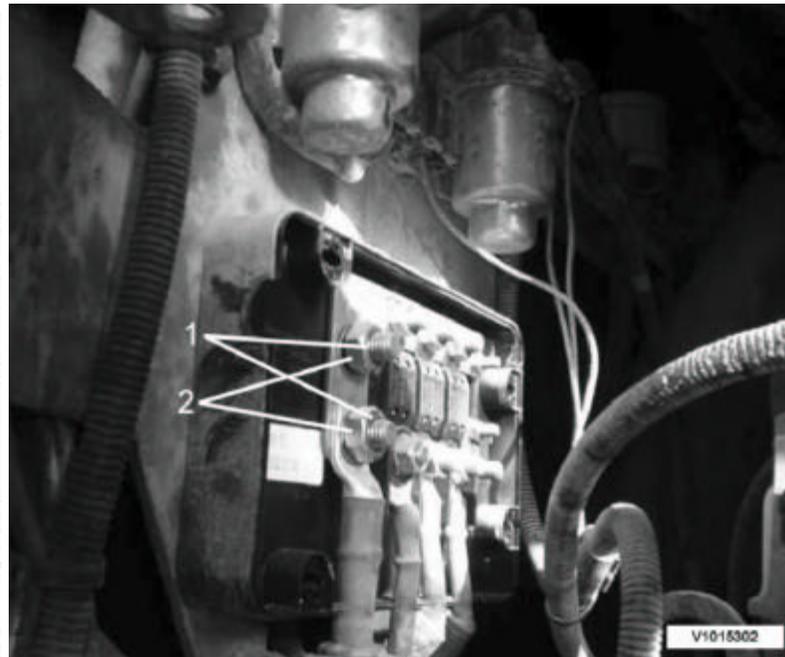
Fig. 2

1. Nut 2. Lockwasher

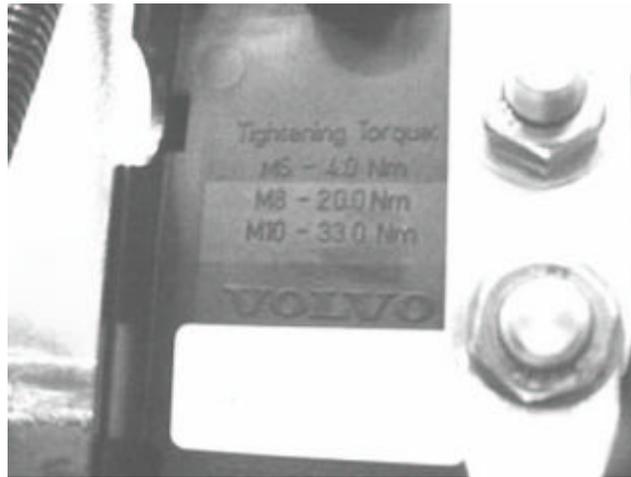
Fig.3 Torque values for tightening on fuse box

M5 4 Nm (3 lbf ft)

M8 20 Nm (15 lbf ft)

M10 33 Nm (24 lbf ft)

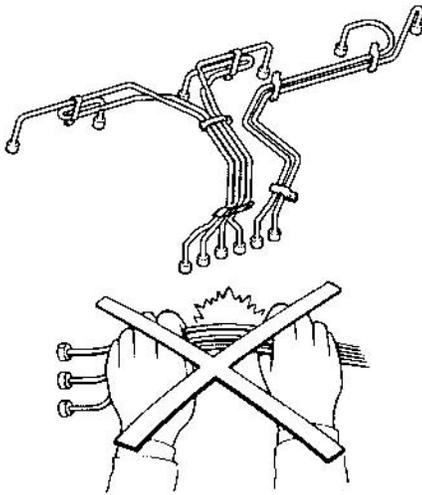
Fig. 4. Fuel delivery pipes

1. Remove and replace the number 4 fuel delivery pipe. Remove all the existing clamps for the injector delivery pipes 4 thru 6. Re-install the clamps. Tighten the nuts to the following torque: 20-25 Nm (15-18 lbf-ft).

The pipes, under any circumstances must not be bent or re-routed

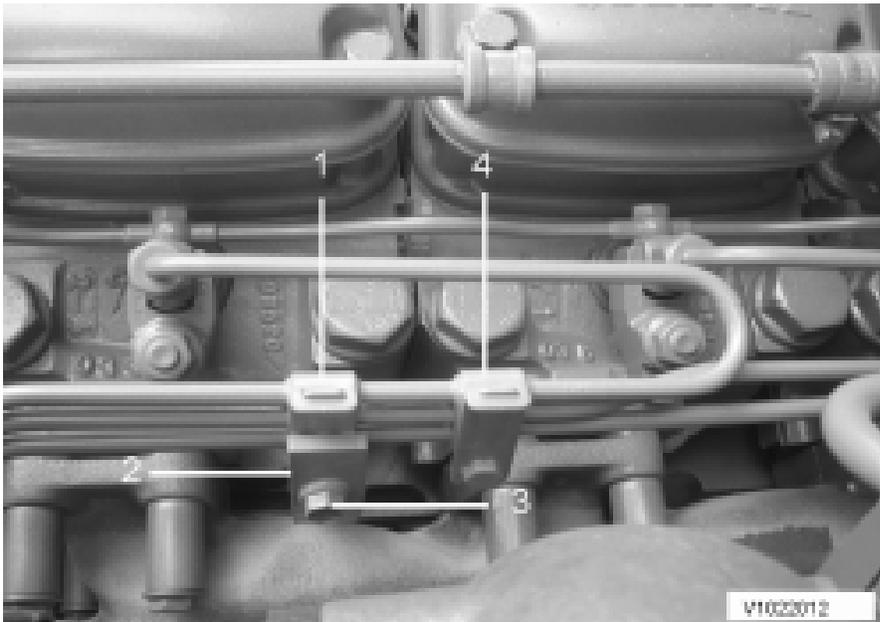
Figure 5.

| 1. Clip | 3. Bolt |
| 2. Support bracket | 4. Existing clip |

2. Secure the new support bracket to the engine. Install the new steel-rubber clip around the delivery pipes and tighten down all the bolts. Adjust the bracket to remove any tension in the delivery pipes. The existing steel-rubber clip is to be positioned approximately 20 mm (0.8 in) from the new clip. See Figures 5 and 6.

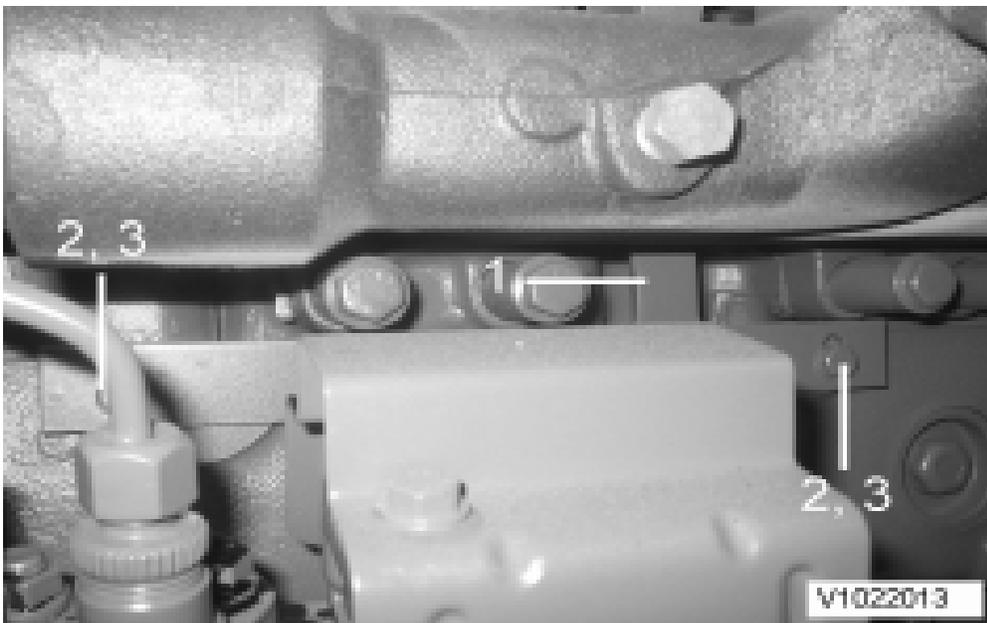
Fig. 6

| 1. Support bracket | 2. Bolt | 3. Washer |
