DISTRICT 2 COAL MINE NEAR MISS

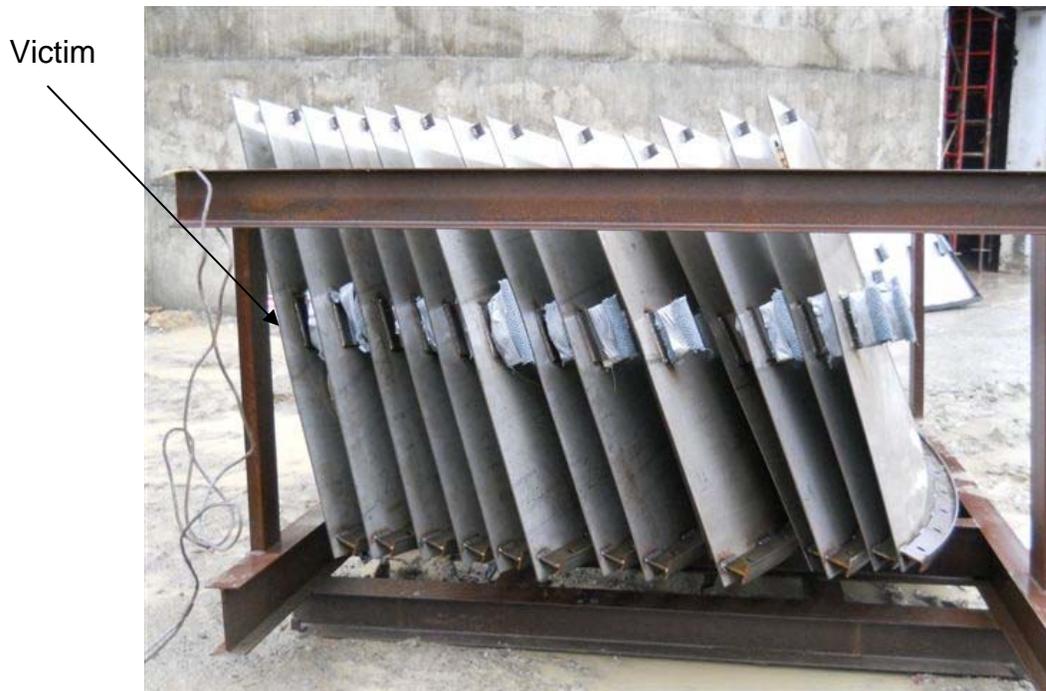
A non-fatal injury occurred on January 26th, 2012 at the Oak Springs Slope project at Enlow Fork Mine (36-07416). A contractor working on the coal silos was attempting to remove a stainless steel sheet (10'X 4'6" X 3/8", 393 pounds) from a storage rack using a wire rope sling. The injured miner reached in between the sheet he was hooking the sling to when the remaining 13 plates on the rack shifted pinning him between them. When other workers were able to remove him from between the sheets he was not breathing and had to be resuscitated before being taken to the hospital. Injuries sustained included a broken clavicle.

- Stay away from pinch points and suspended loads which can lead to injury if the rigging device should fail.
- Inspect devices for signs of wear such as rust, metallic loss, fraying of rope, broken strands in cables, elongation of metal, etc.
- Obtain the weight of the object you are planning to move and do not exceed the rated capacity of your hoisting, towing, or rigging tools.
- Use proper racks to tack tell to minimize falling of materials
