DISTRICT 2 – COAL MINE NEAR MISS

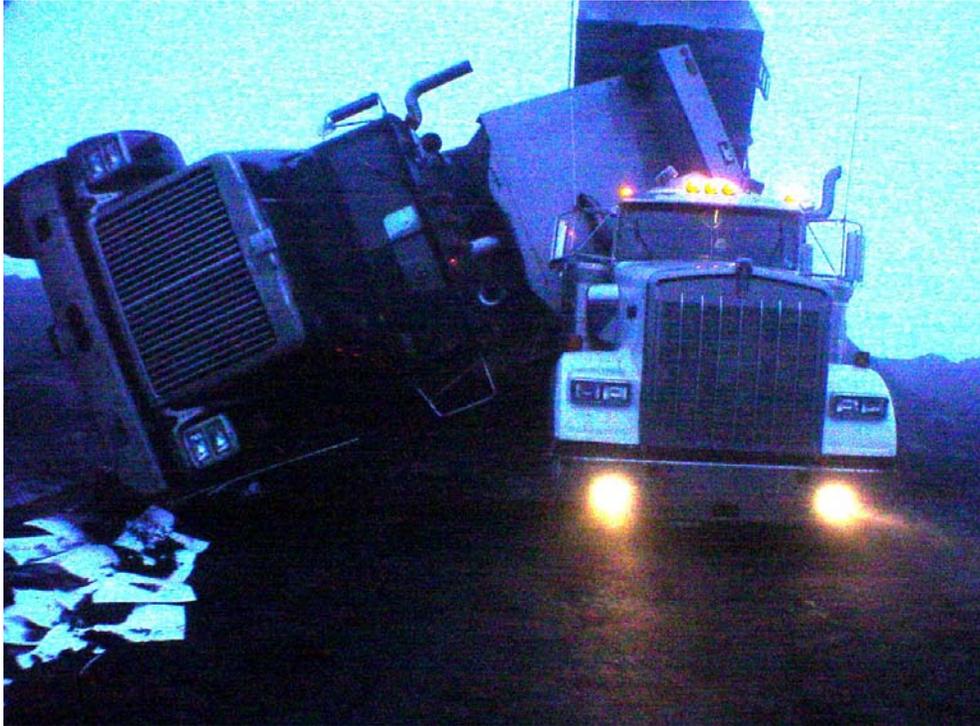
On January 6, 2005 at approximately 7:00 a.m., a 27- year old contract truck driver received minor injuries in a near miss accident at a coal preparation plant. The driver of a Kenworth tri-axle was dumping his load, when the driver of an International tri-axle pulled along side him and started to dump his load. When the driver of the International truck pulled forward to finish dumping, his rear wheels went into a soft spot, causing the truck to roll over on the driver's side. This truck's bed struck and crushed the passenger side of the Kenworth truck's cab. The driver of the Kenworth truck was taken to the hospital. His injuries included a strained neck and back. This was a lost time accident.

- Trucks dumping side by side should stay a distance of at least the height of the bed apart.
- Trucks dumping side by side should be positioned so that drivers can see each other.
- Contract operators should ensure that all drivers follow all safety rules and regulations at the mine.
- Truck drivers should make sure all persons and equipment are clear before moving the truck with the bed in a raised position.
- Ground where trucks dump must be able to support the weight of the trucks
