CLOSE CALL

Electrical Flash/ Burn

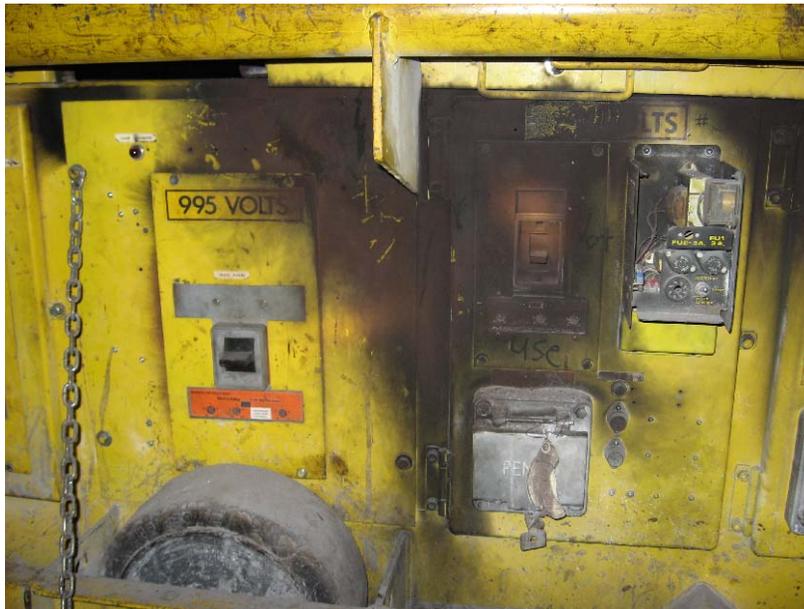
On November 20, 2008, four miners (two supervisors and two hourly workers) received flash burns while working on a section power center. A top cover of the 13800 VAC power center had been removed to facilitate the activities. Miners were attempting to find and correct the reason for nuisance trips on a circuit breaker that protected 995 VAC 3-phase power circuits. During the troubleshooting and repair activities, electrical connections were made that were not design specification. A phase to phase short circuit occurred between two phases of the 995 VAC on the line side of the circuit breaker that resulted in a high current arc flash. The heat and blast of the arc exited the power center enclosure through the opening in the top of the power center.

1. Follow safe trouble shooting and repair procedures.
2. Consult documentation and electrical diagrams for the equipment that requires trouble shooting or repair activities.
3. Maintain electrical safety devices in design specification.
4. Always wear PPE during electrical trouble shooting and repair activities.
