## Coal Mine Fatal Accident 2004-04

Operator:	Spartan Mining Company, Inc. (Massey Energy)
Mine:	Ruby Energy Mine
Accident Date:	February 5, 2004
Classification:	Electrical
Location:	District 4, Mingo County, WV
Mine Type:	Underground
Employment:	37
Production	3,500 tons/day

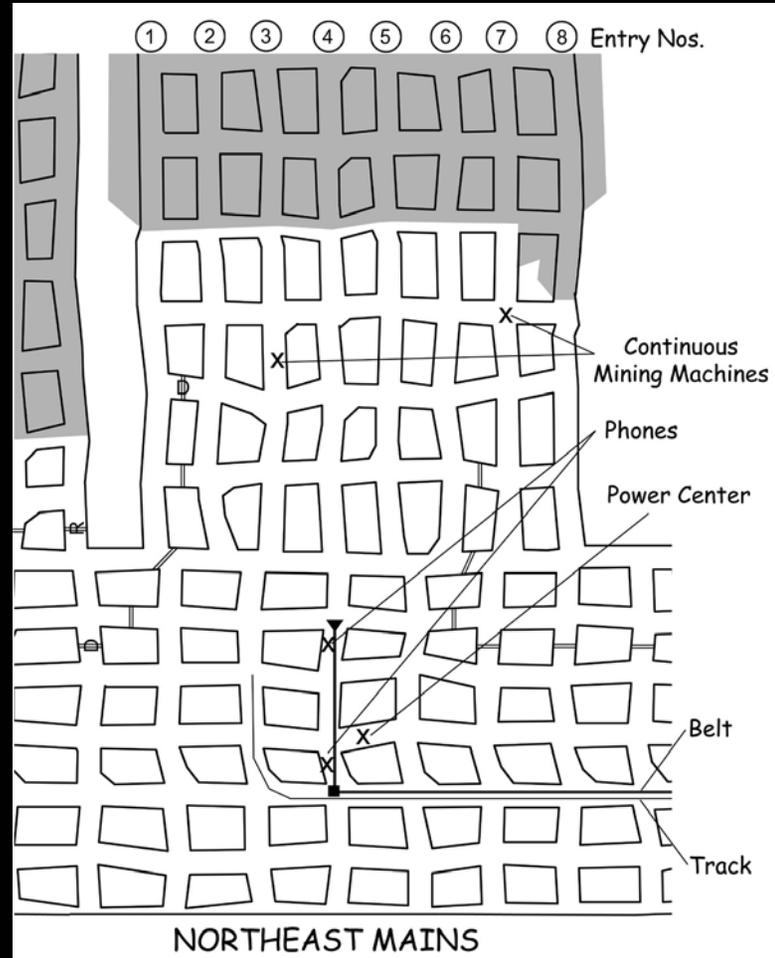
- While moving the left-side CM forward, the operator accidentally let the ripper cutting drum down onto the CM trailing cable.
- A bit lug damaged the cable, bursting the inner voltage insulation, allowing 2 power phases to contact each other.
- The resulting short circuit caused mine power (underground and outside) to deenergize, including power to the mine fan and the preparation plant. The left-side CM circuit breaker also opened.

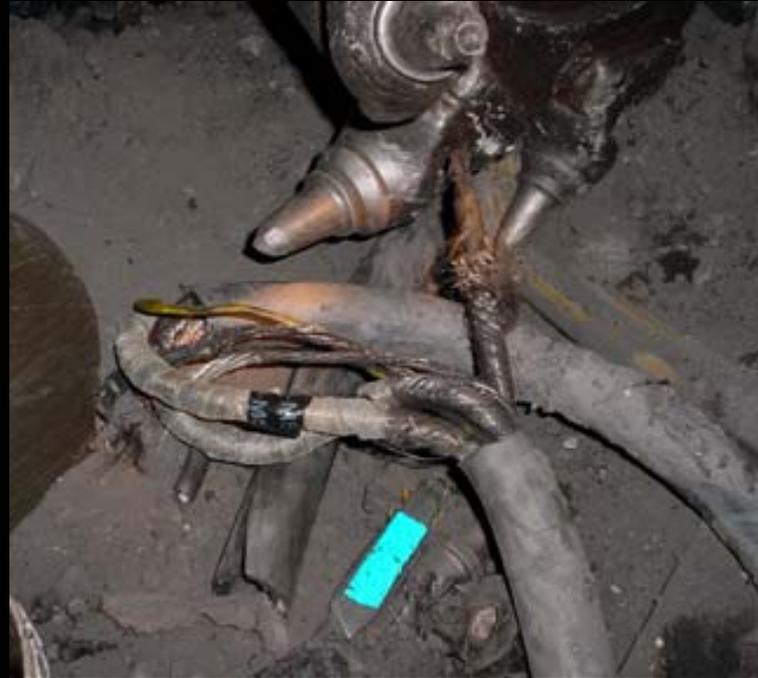
- The scoop operator bumped the scoop against the ripper drum, freeing the trailing cable.
- The electrician arrived at the CM and told the miners that he needed to check the damaged area of the trailing cable. He also informed them that the fan was off and that they only had 15 minutes until they had to leave the section.
- The electrician cut about 14" of the outer jacket, exposing the three power phases, ground, and monitor wires. Two of the power phases were burned and needed to be cut and spliced. The outer jacket on the third power phase was damaged and needed to be reinsulated. The ground and monitor wires were not damaged.

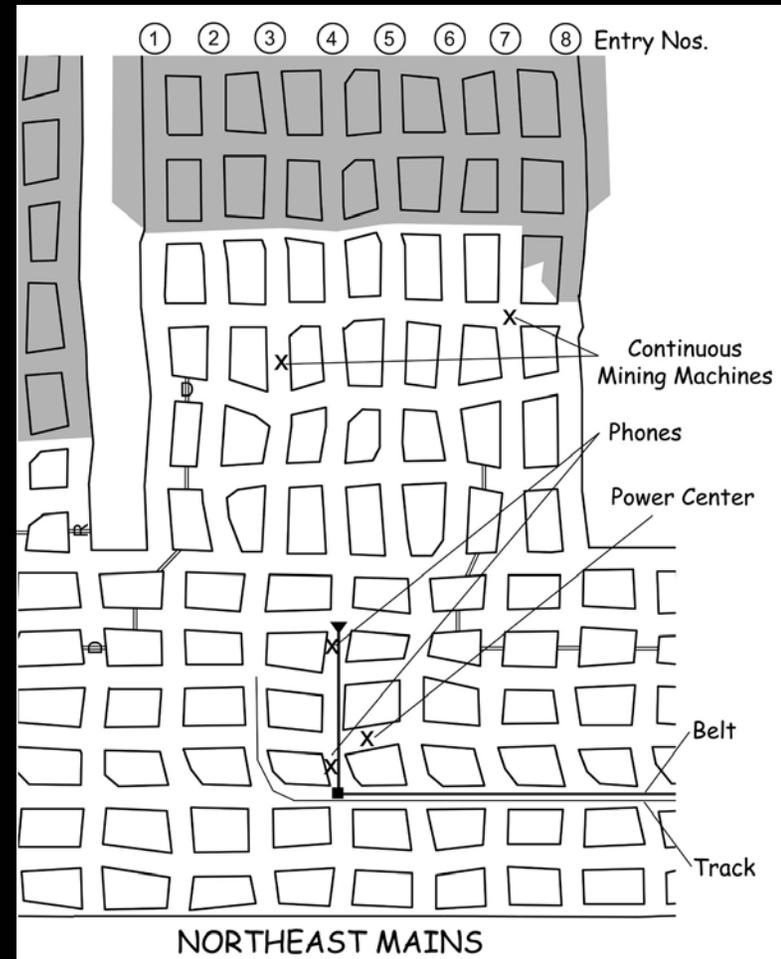
- The CM operator heard a humming noise and felt air movement. He asked the SC operator to go to the section power center to see if the power had come back on.
- After repairing the first two phases, the electrician cut the 3<sup>rd</sup> phase apart and prepared both ends for the connector.
- The section foreman was waiting near the loading point phone, when he noticed air pressure on the back-up check curtains. After a minute or two, he heard the take-up jack on the belt take-up engage.
- The section foreman went to the power center and started closing the circuit breakers for all the face equipment.

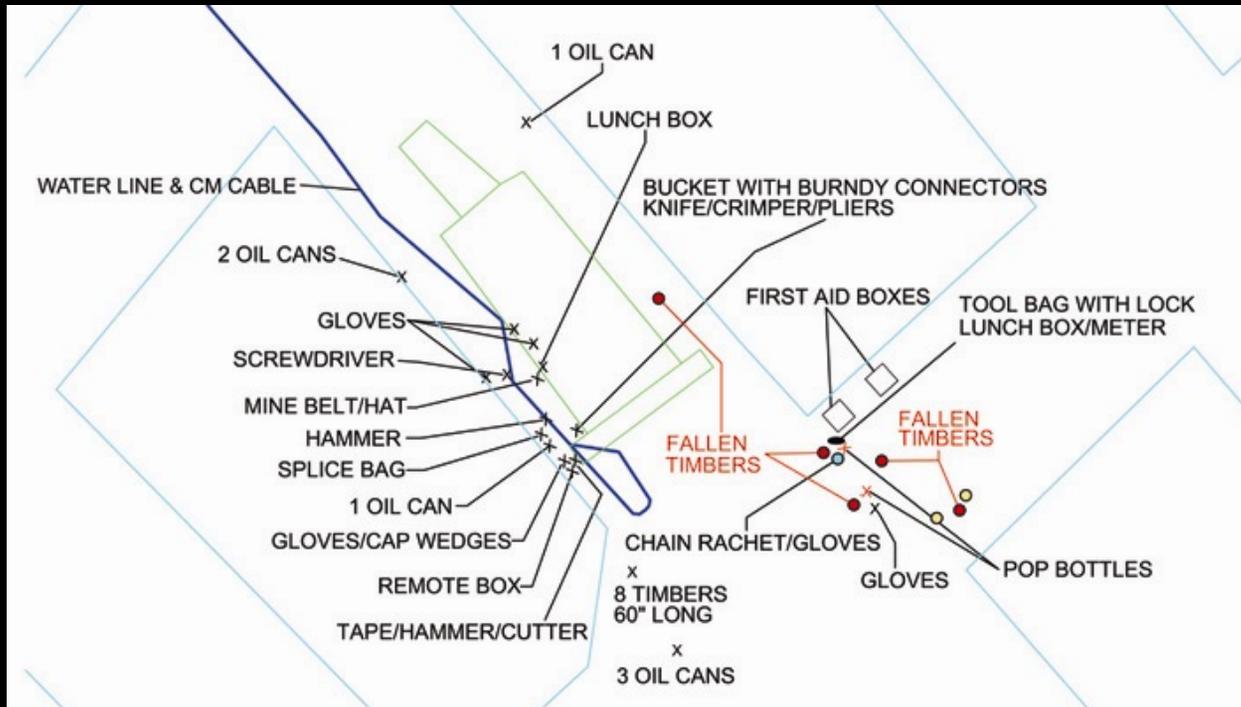
- All cable plugs were still attached to their receptacles on the power center.
- He first closed the circuit breaker for the right-side CM. When he closed the breaker for the left-side CM, it immediately tripped out, and centered.
- The electrician, who was still working on the 3<sup>rd</sup> power phase, received fatal electrical shock.
- The section foreman continued to engage the circuit breakers for the shuttle cars, scoop chargers, and pumps.
