MNMM Fatal 2004-11

- Falling, Sliding Material Accident
- June 19, 2004 (Oregon)
- Sand & Gravel Operation
- Line Maintenance Man
- 33 years old
- 3 years experience

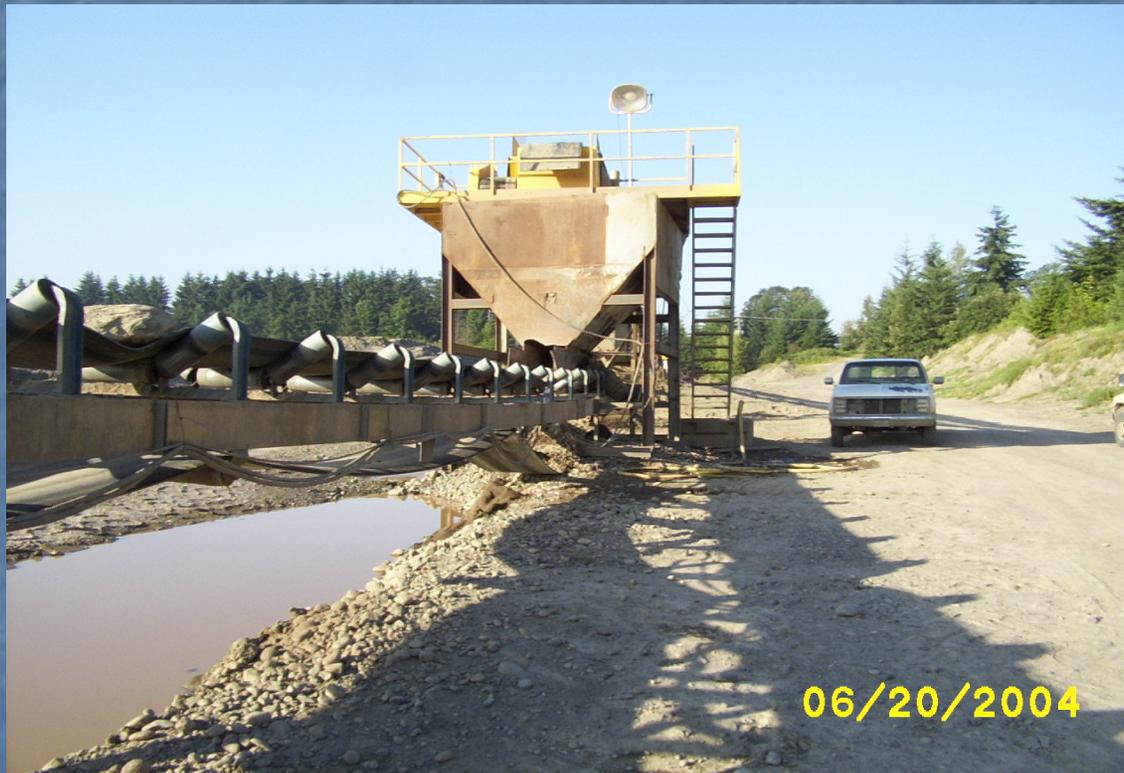
- A three man crew was attempting to unplug material at the discharge chute below a 30-ton hopper. The victim entered the hopper from the top without wearing a secured safety harness and lanyard when the material suddenly gave way and engulfed him.

Transfer hopper where accident occurred

- Management should develop procedures requiring miners to wear a safety harness and lanyard securely attached when working in the transfer hopper.
- The electrical circuit supplying power to the field conveyors was not de-energized, locked out, and tagged out prior to entering the transfer hopper.
- A risk assessment was not conducted with the crew before work began to unplug the transfer hopper.

- Evaluate a task before performing work.
- Establish and follow safe job procedures that mitigate hazards when unplugging discharge chutes.
- Position yourself in a safe location where you are not exposed to hazards.
- Never enter a location where unexpected or unanticipated sliding material could entrap you.
- Close supply and discharge points and wear a safety harness and lanyard, which is securely anchored, prior to entering bins, hoppers, tanks, or silos.

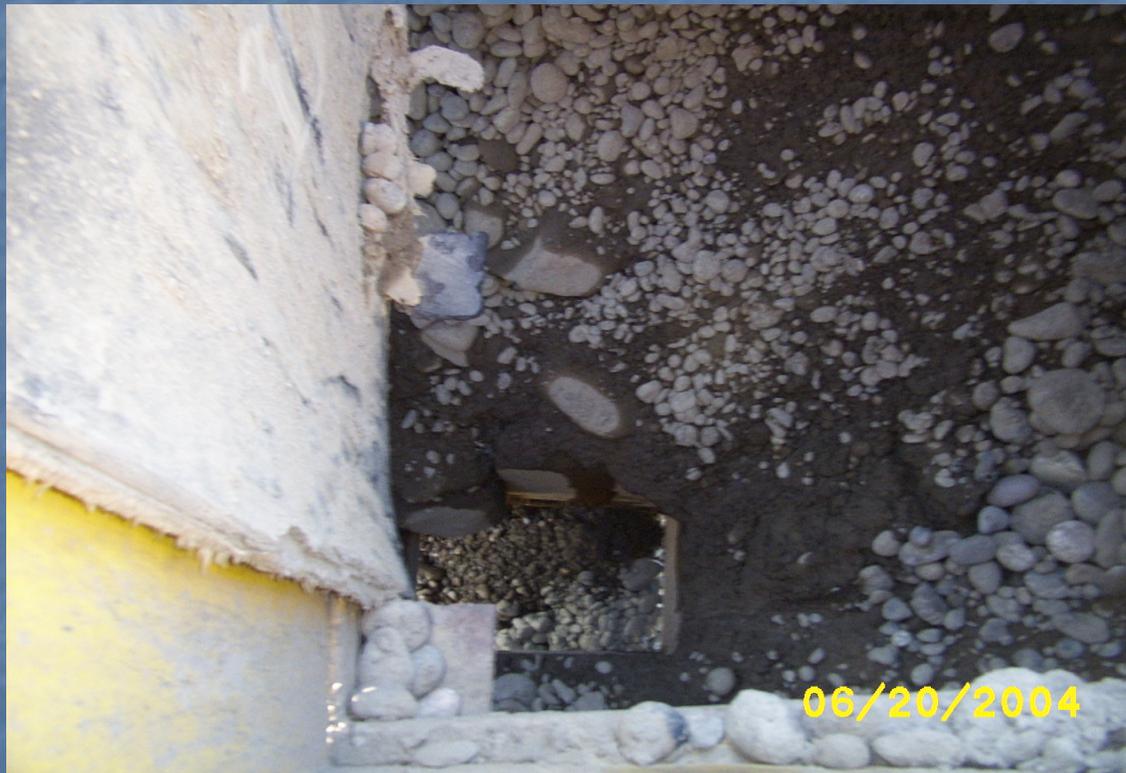
View from the top of hopper where feed dumps in

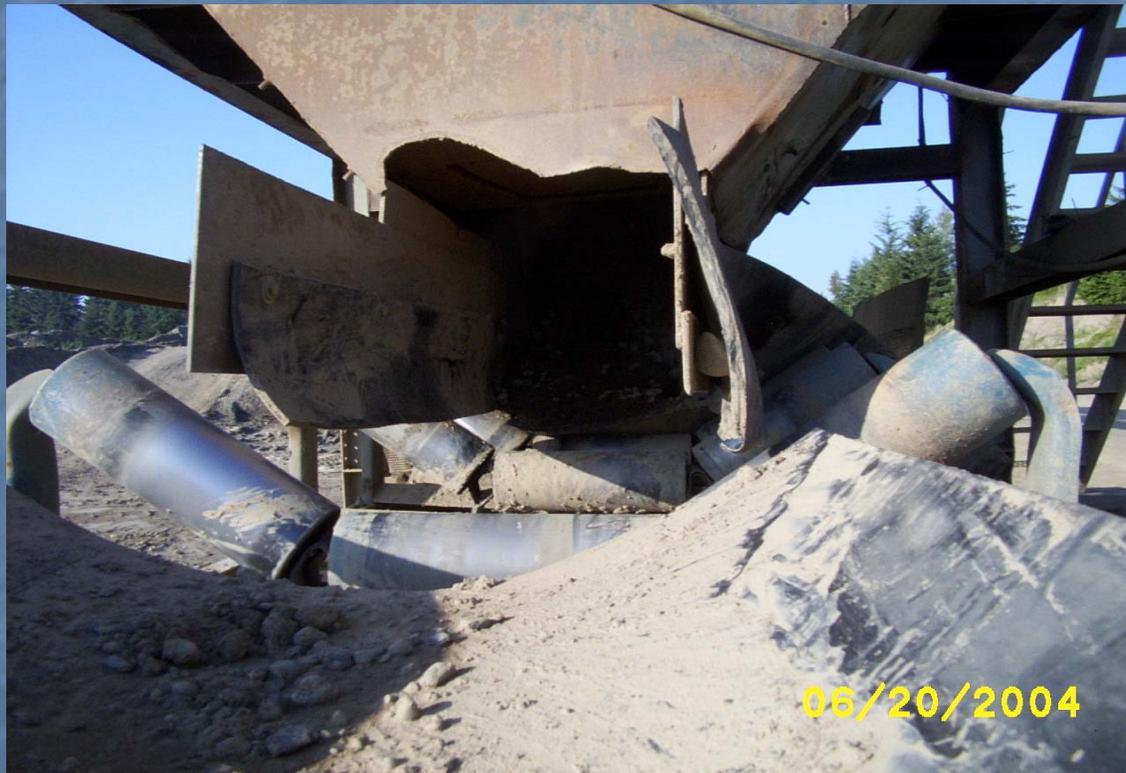
Bin discharge opening to conveyor belt
