Fatality #25 - November 20, 2004
Fall of Face/Rib/Highwall - Bituminous - WV
Endurance Mining Co. - Red Cedar Surface Mine

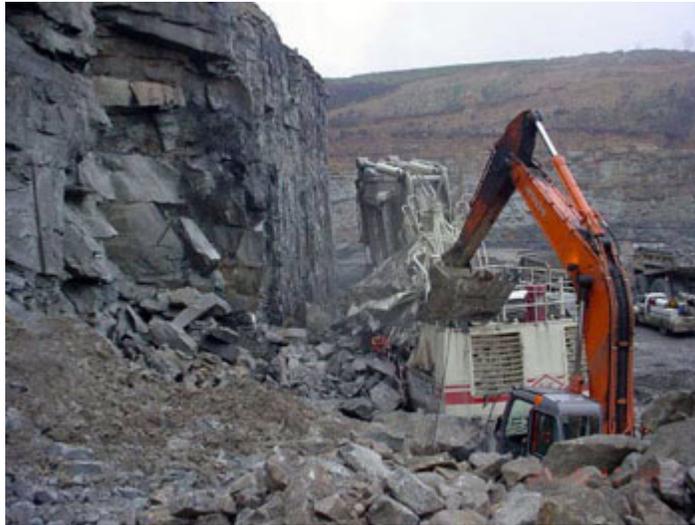
Coal Mine Fatality - On Saturday, November 20, 2004, an equipment operator was fatally injured while operating an excavator close to a highwall. While loading spoil into trucks, with the operator's cab positioned on the highwall side, the highwall collapsed and crushed the cab. The work was being performed near old underground mine works.

- Do not work near dangerous highwalls or banks.
- Operate excavators with the cab positioned away from the highwall side.
- Be aware of changing highwall conditions and develop mining methods that address adverse changes.
- Train examiners to recognize adverse conditions and environmental factors that can decrease stability.
- Involve front line supervisors when developing mining plans.
