Coal Mine Fatal Accident 2006-19

Operator:	Black Castle Mining Co.
Mine:	Black Castle Mining Co.
Accident Date:	February 1, 2006
Classification:	Ignition of Gas
Location:	Dist. 4, Boone County, West Virginia
Mine Type:	Surface Coal Mine
Employment:	234
Production:	11,700 Tons/Day

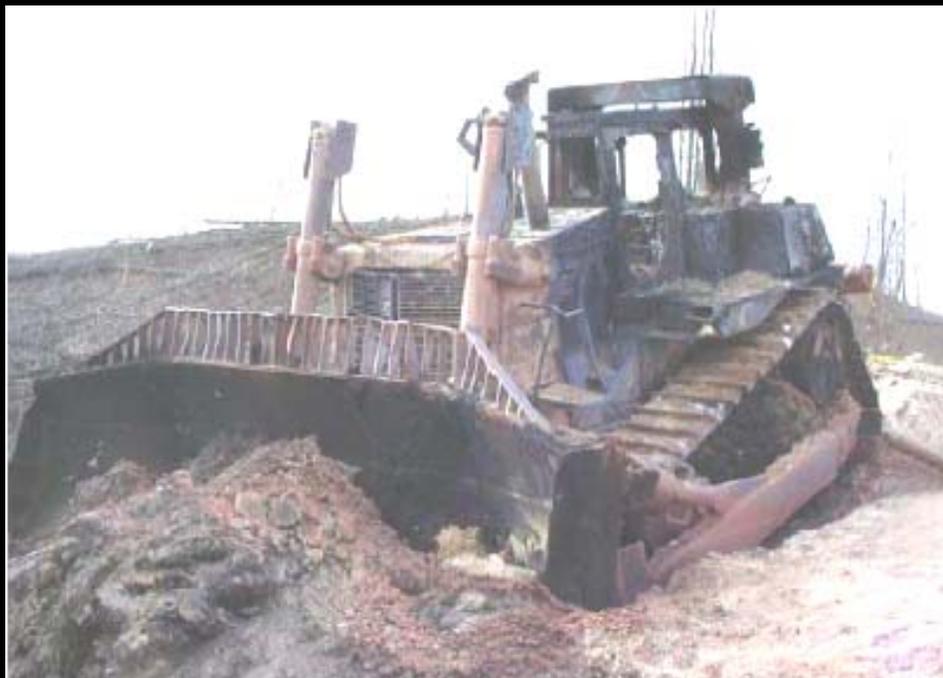
At approximately 2:10 p.m. on Wednesday, February 1, 2006, a 58-year old bulldozer operator with 15 years experience was fatally injured due to an ignition of natural gas. As the bulldozer operator was developing a drill bench, the blade of the machine contacted and ruptured a 16-inch low-pressure, high-volume natural gas line which immediately burst into flames.

Causal Factor: Mine management directed the bulldozer to work in close proximity to a known but unlocated active gas line. Although aware of the gas line and potential hazard, mine management did not accurately locate and mark the gas line before directing the bulldozer to operate in the area. This exposed the bulldozer operator to a hazardous condition. There were no policies or procedures in place to address hazards associated with working near active gas lines.

Corrective Action: The Ground Control Plan was revised to establish safety precautions to be taken when gas lines are in close proximity to active work areas. The Ground Control Plan has been received and acknowledged by the District Manager, District 4, Mine Safety and Health Administration.
