Fatality #30 - November 12, 2007
Machinery - Underground - New Mexico
San Juan Coal Company - San Juan Mine 1

COAL MINE FATALITY - On Monday, November 12, 2007, at approximately 4:39 p.m., a miner with over six years experience was fatally injured in a machinery accident. The accident occurred in the belt entry when a feeder breaker was being positioned over the belt tailpiece while the 72-inch wide belt conveyor was running. The anchored tailpiece broke free and was pulled down the entry, striking the victim in the back. The victim succumbed to injuries on December 4, 2007.

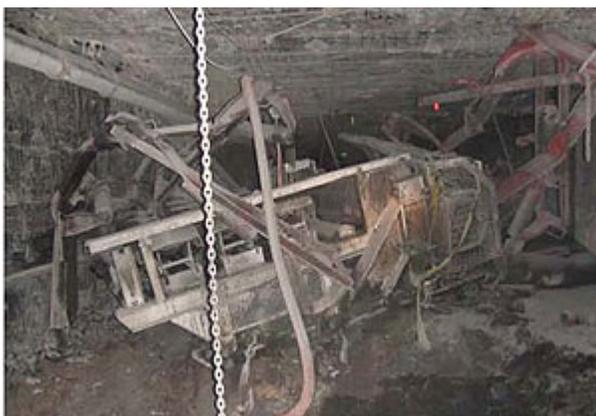
TAILPIECE OUTBY ENTRY AFTER ACCIDENT

- De-energize, lock out and tag the electrical power on the conveyor belt and take-up prior to setting or adjusting the feeder breaker over the tailpiece.
- Release the belt take-up to remove stored energy in the belt when setting the feeder breaker.
- Prior to setting the feeder breaker, examine the tailpiece anchors to determine that the anchors are not damaged or corroded.
- Examine tailpiece mounts for damage such as evidence of failing welds or bent mounts.

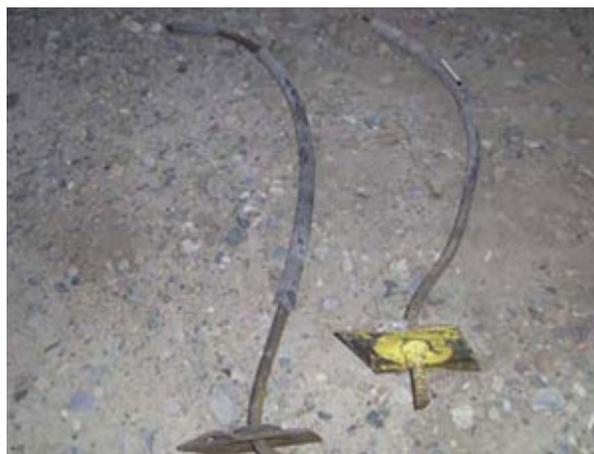
TWO BOLTS PULLED OUT OF MINE FLOOR
