Fatality #8 - April 22, 2008
Fall of Roof or Back - Underground - Virginia
Osaka Mining Corporation - Mine No. 1

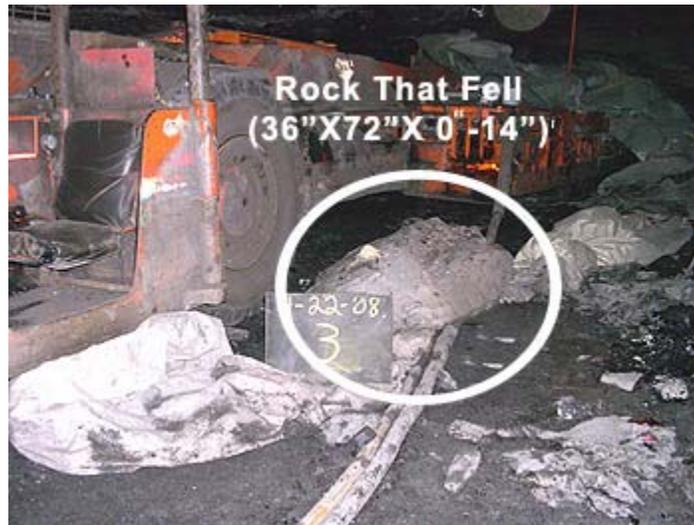
COAL MINE FATALITY - On Tuesday, April 22, 2008, a 61-year old roof bolting machine operator with 30 years of mining experience was fatally injured while observing a continuous mining machine producing coal at the working face. A rock approximately 36" x 72" x (0"-14") fell from the roof, striking the victim and the continuous mining machine operator. The victim was fatally injured by the roof fall and the continuous mining machine operator received nonfatal injuries.

- Conduct a thorough visual examination of the roof, face, and ribs immediately before any work is performed and thereafter as conditions warrant.
- Be alert to any change of roof conditions.
- Identify and remove loose roof material from a safe position.
- Mine personnel not essential to the specific activity should remain outside the work zone.
