**UNITED STATES DEPARTMENT OF LABOR
Mine Safety and Health Administration**

**Report on Issues Related To High Temperature Disposable
Diesel Particulate Filters Including Laboratory Results on
Kindling Temperatures**

October 2004

**Approval and Certification Center
Mechanical and Engineering Safety Division**

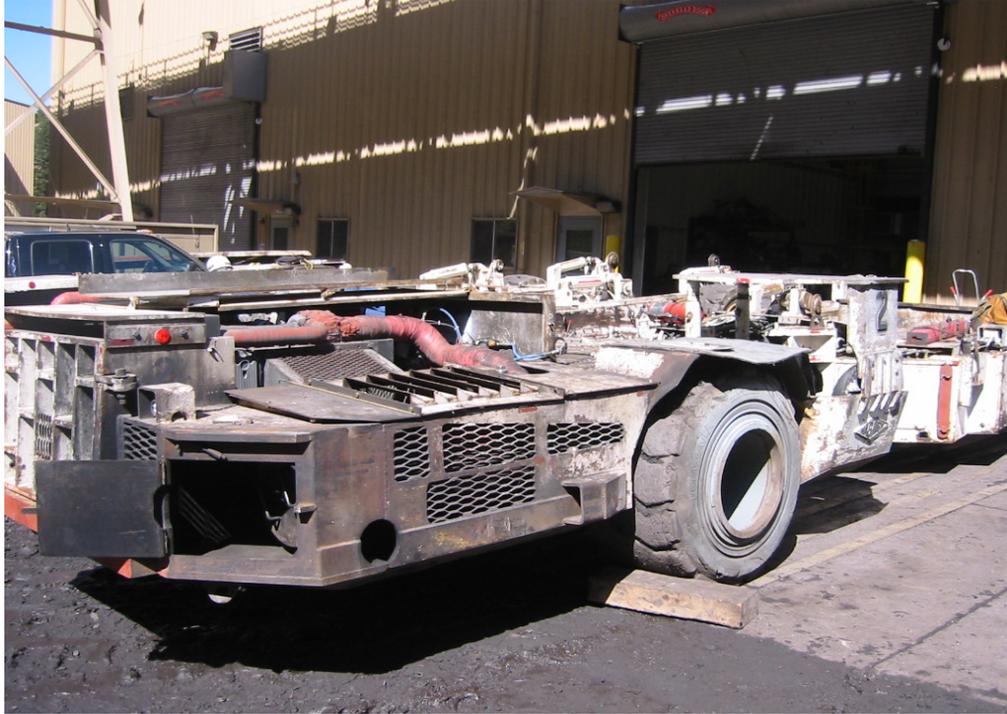
FIGURE THREE: No. 2 WAGNER 20X SHIELD HAULER EQUIPPED WITH WATER INJECTION SYSTEM

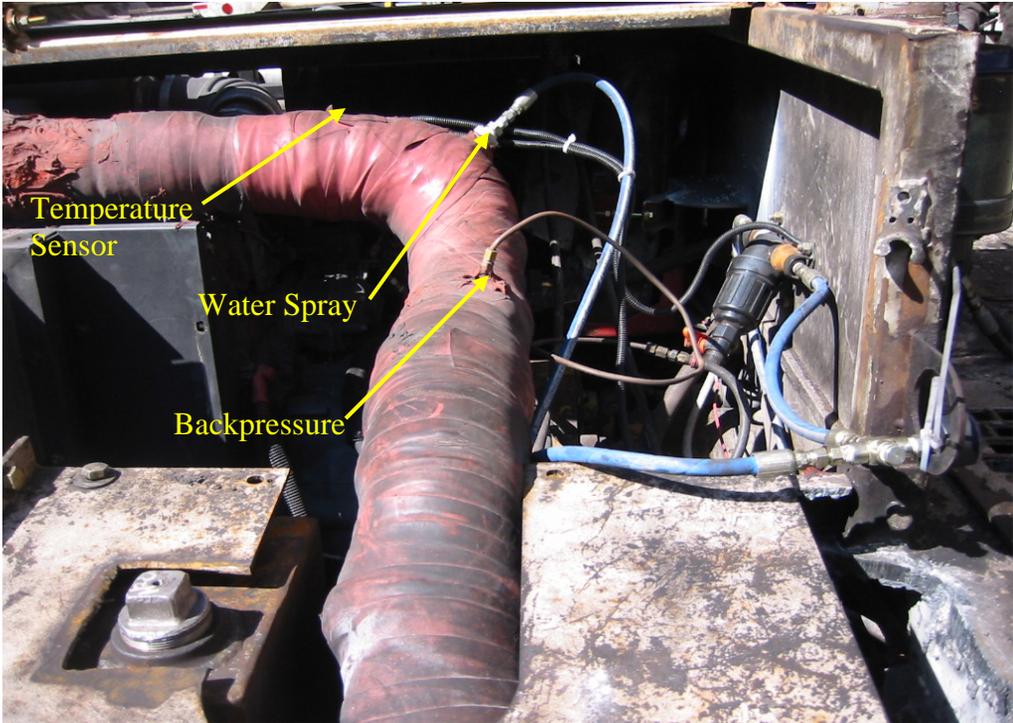
FIGURE FOUR: WATER INJECTION SYSTEM

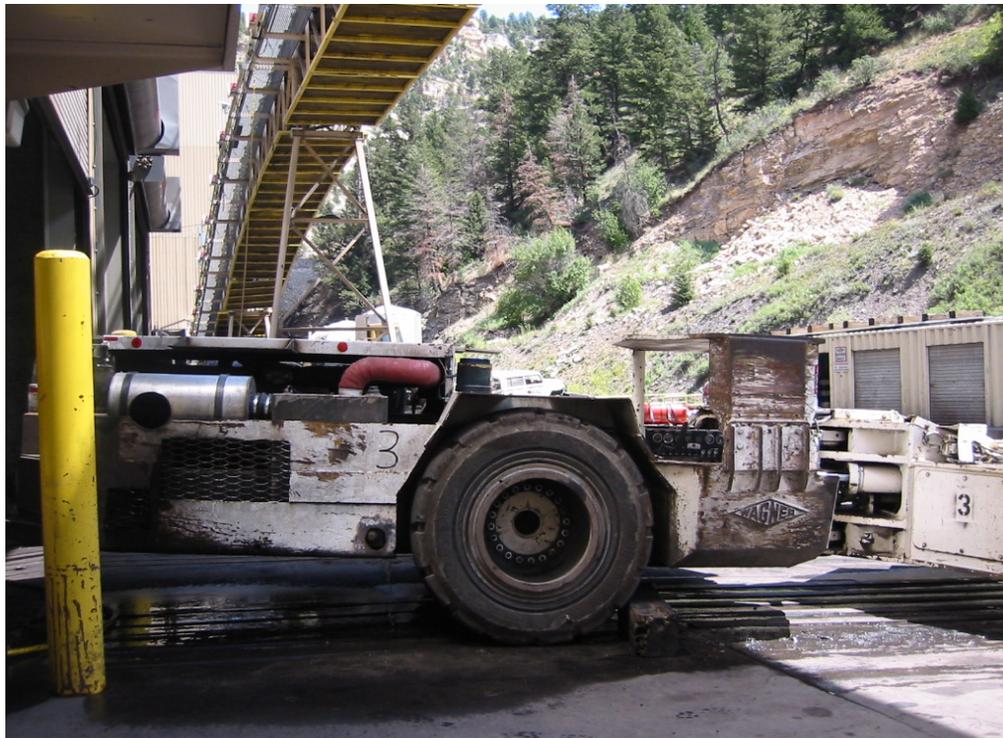
FIGURE FIVE: No. 3 WAGNER 20X SHIELD HAULER EQUIPPED WITH WATER SCURBBER SYSTEM

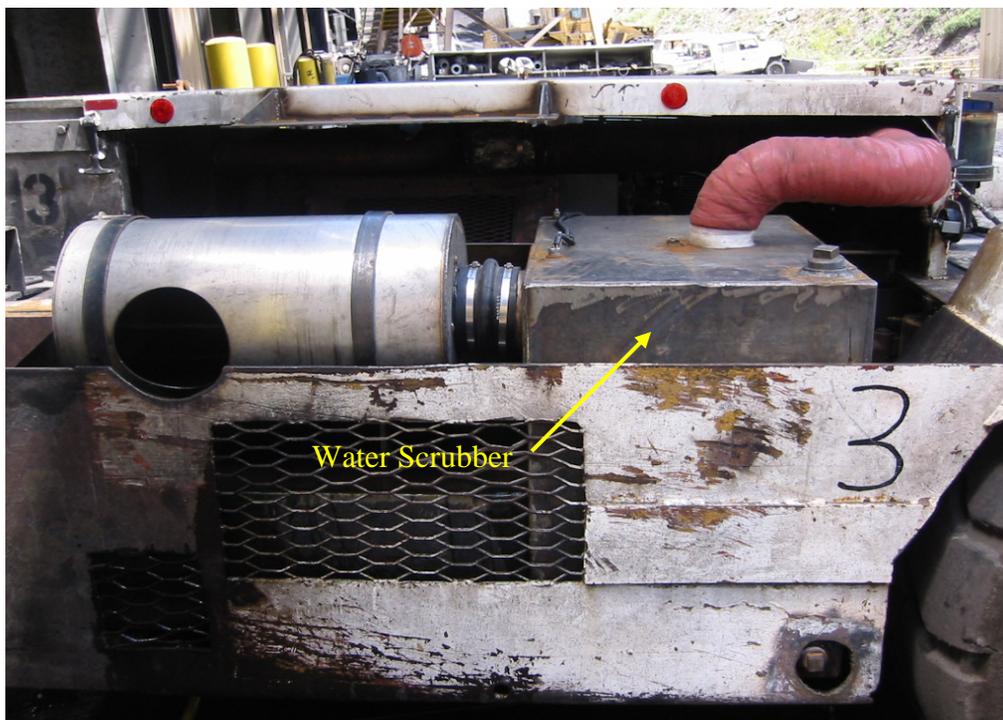
FIGURE SIX: WATER SCRUBBER SYSTEM

The scrubber system displayed the most cooling ability in the limited tests performed at the mine. In terms of fire hazards of high temperature filters being exposed to high exhaust gas temperatures, the scrubber system would be the most affective option of the three systems evaluated. After receiving and reviewing the temperature logging data, the scrubber system seemed to cool the exhaust gases most effectively.

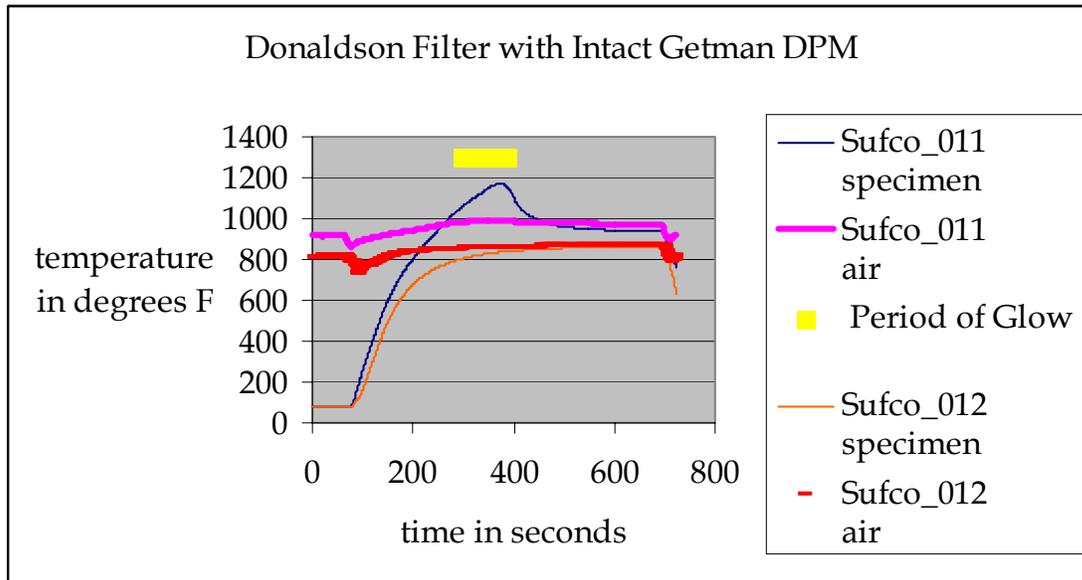
Graph 2. The Sufco_011 sample began to glow at an air temperature of 982°F. The sample temperature had started to rise prior to ignition.

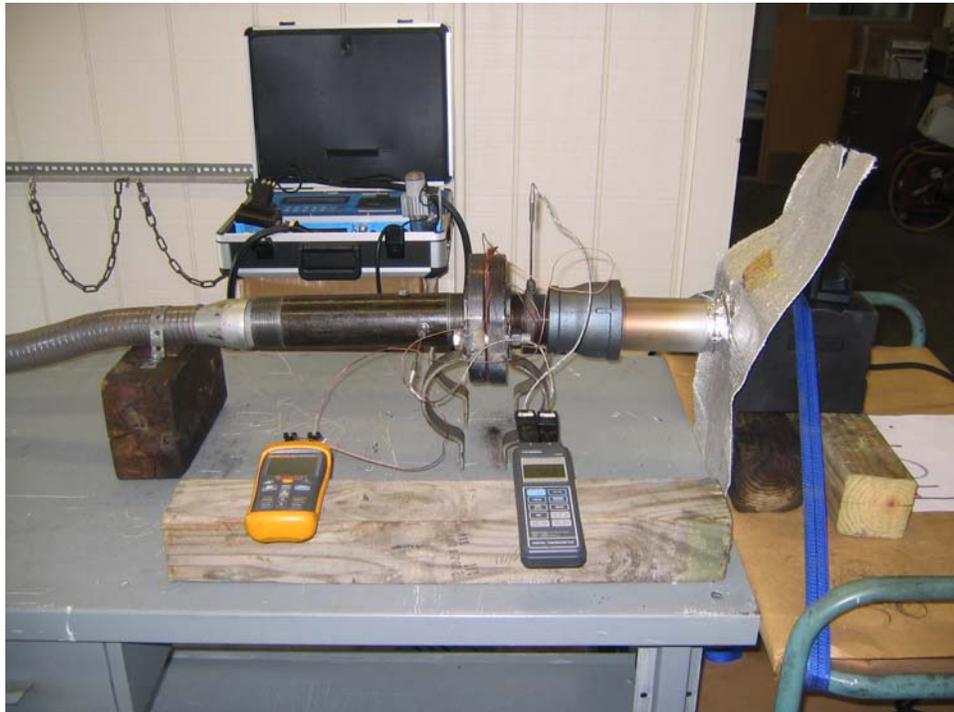
Figure 1: Original Heat Gun Test Setup.

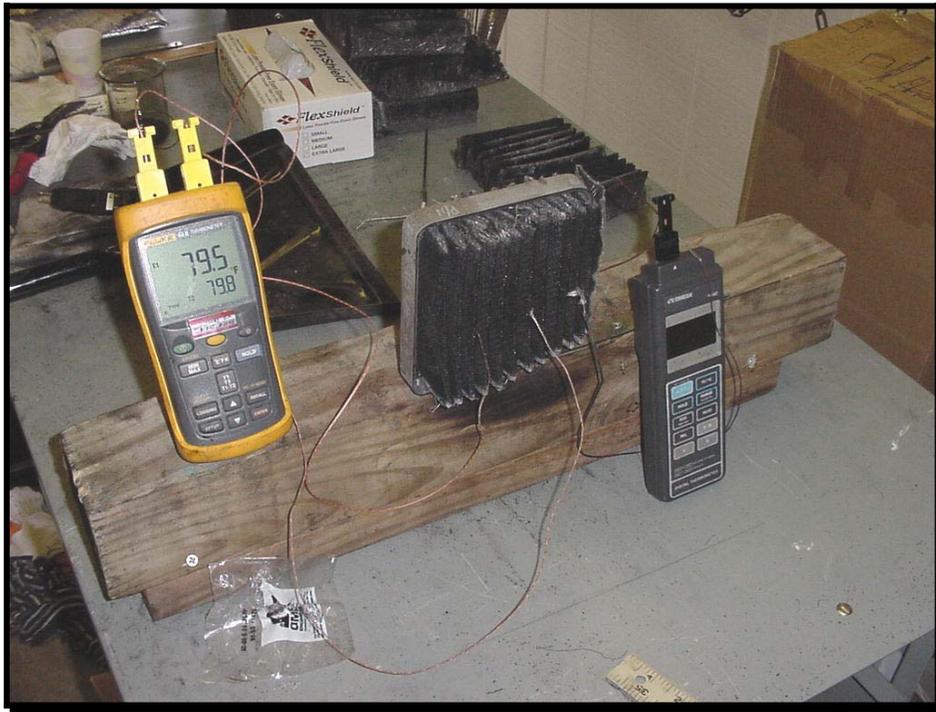
Figure 1: Filter Sample placed on rack for testing, with thermocouples applied.

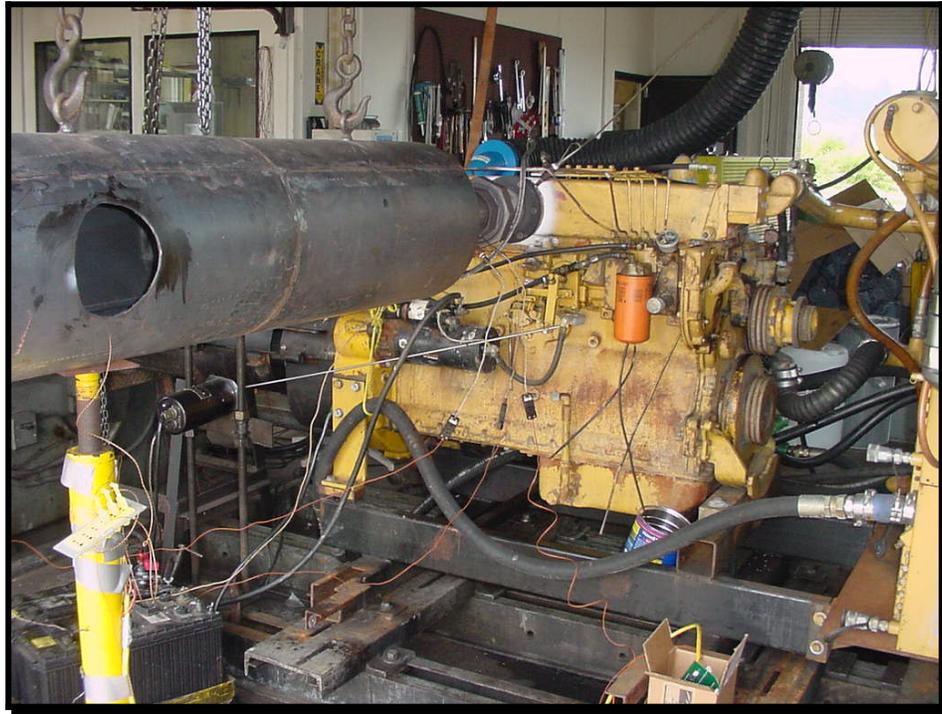
Figure 1. Filter ignition test setup.

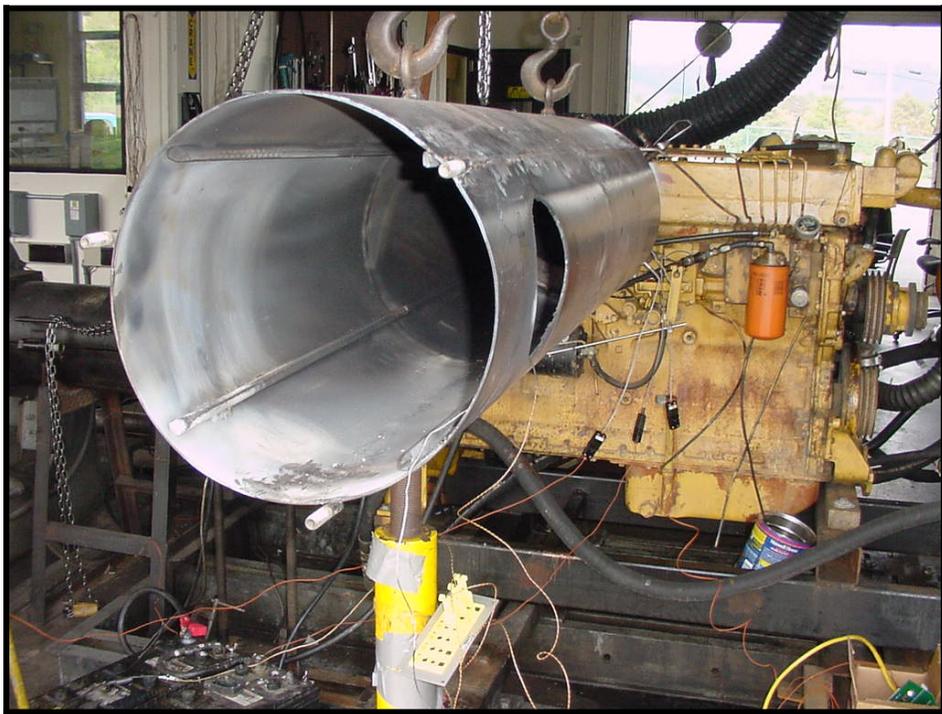
Figure 2. Filter Ignition Test Setup showing inside of filter canister.

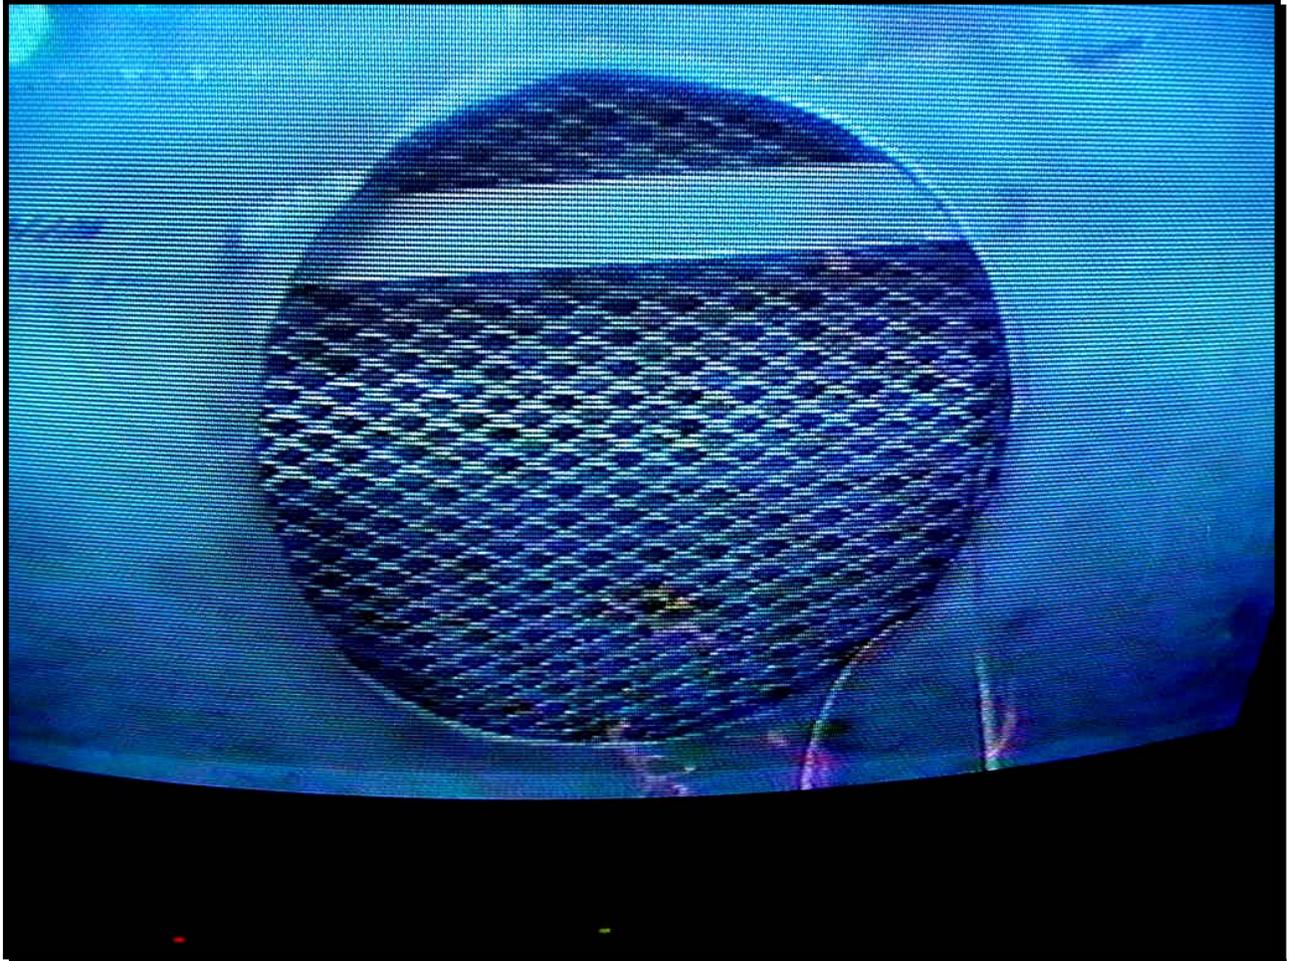
Figure 5. Example of filters emitting Sparks.

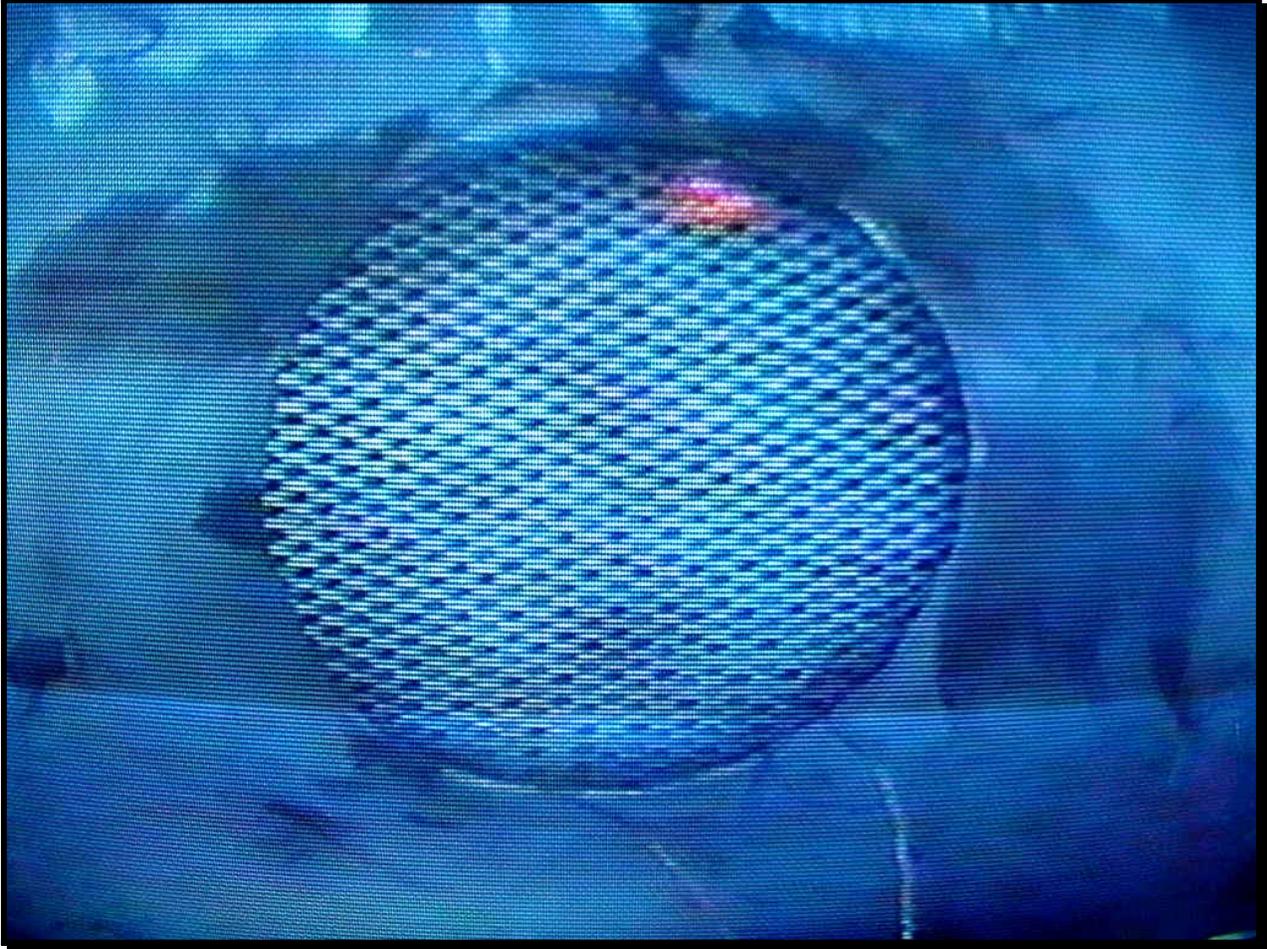
Figure 6. Example of filter Glowing.

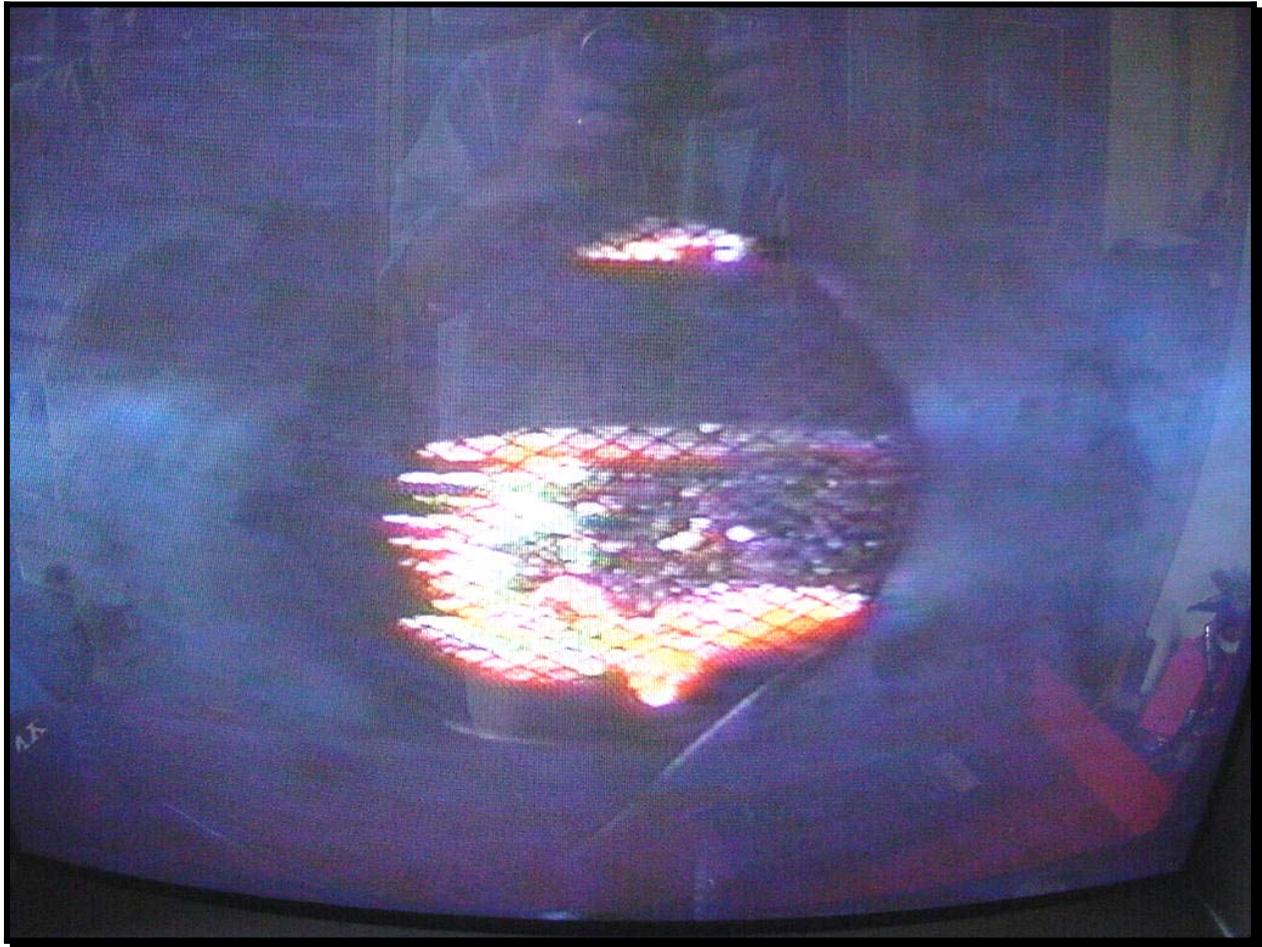
Figure 7. Example of filter Burning.

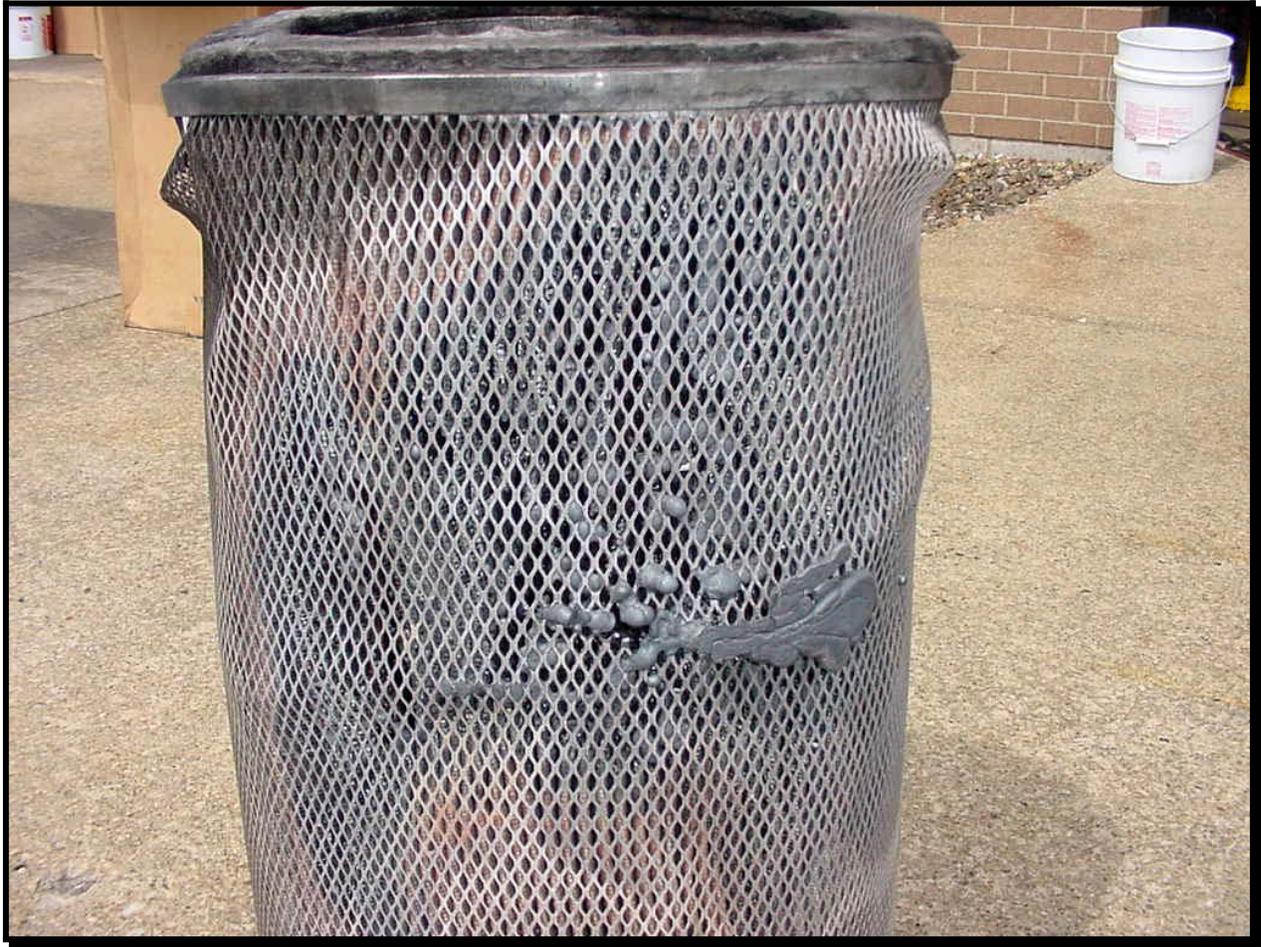
Figure 8. Typical result of a filter ignition. Globules adhering to filter are melted glass media and steel screen.

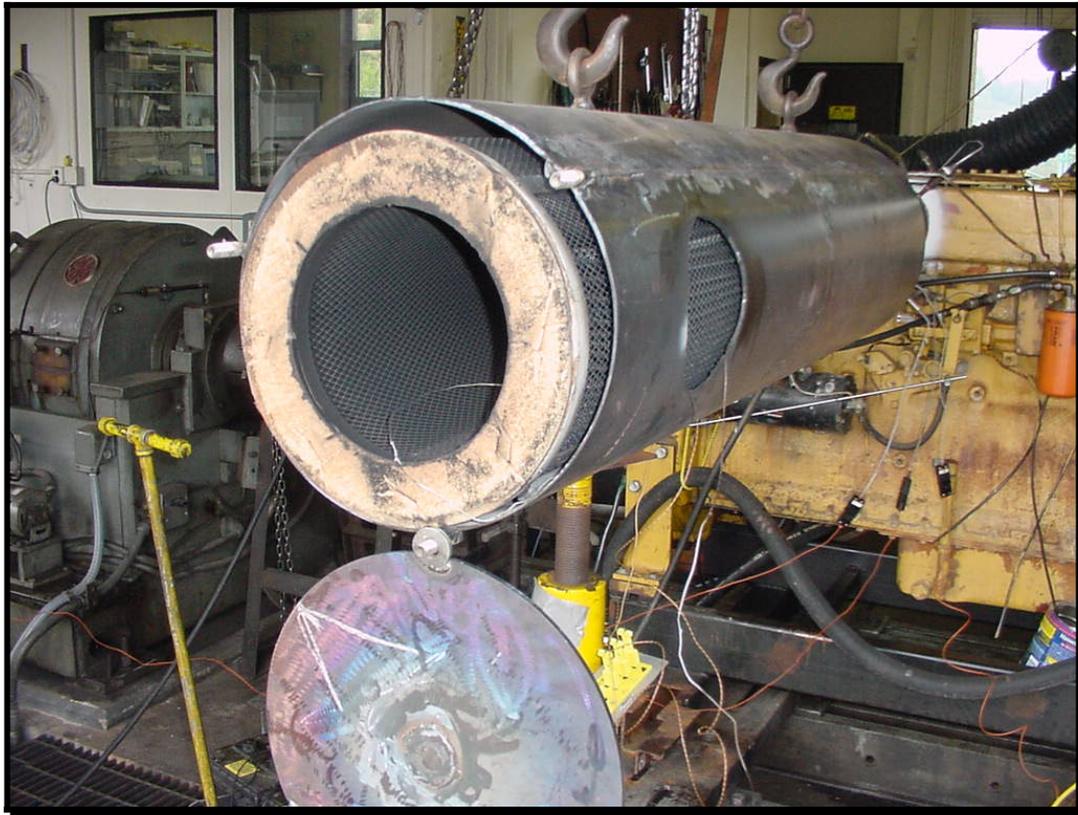
Figure B. 3. Installation of a set of test filters.

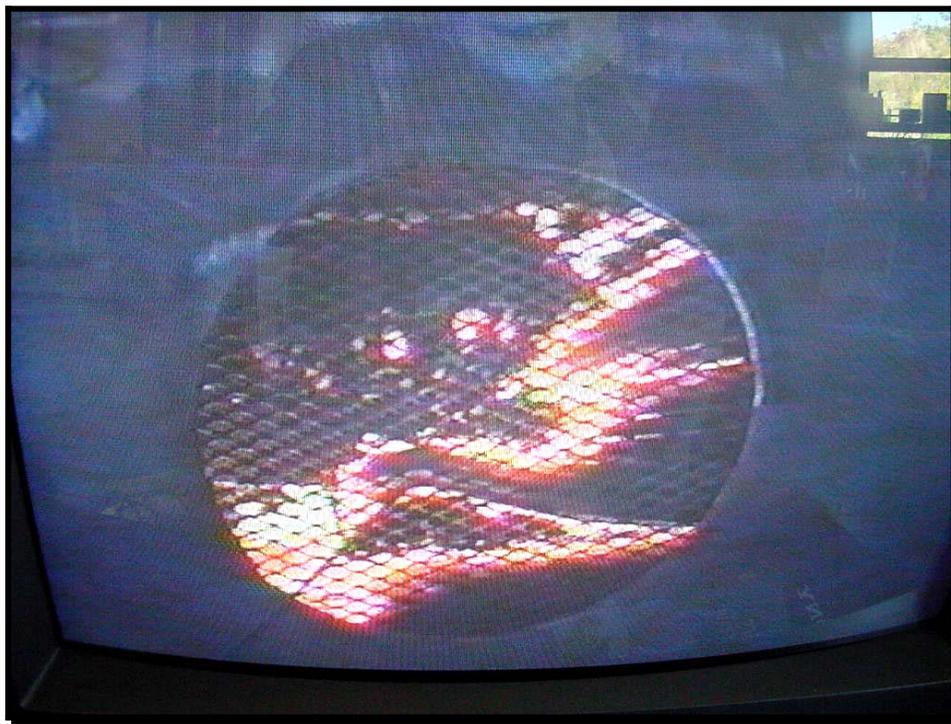
Figure B. 5. Test #5, Video view of filter burning.

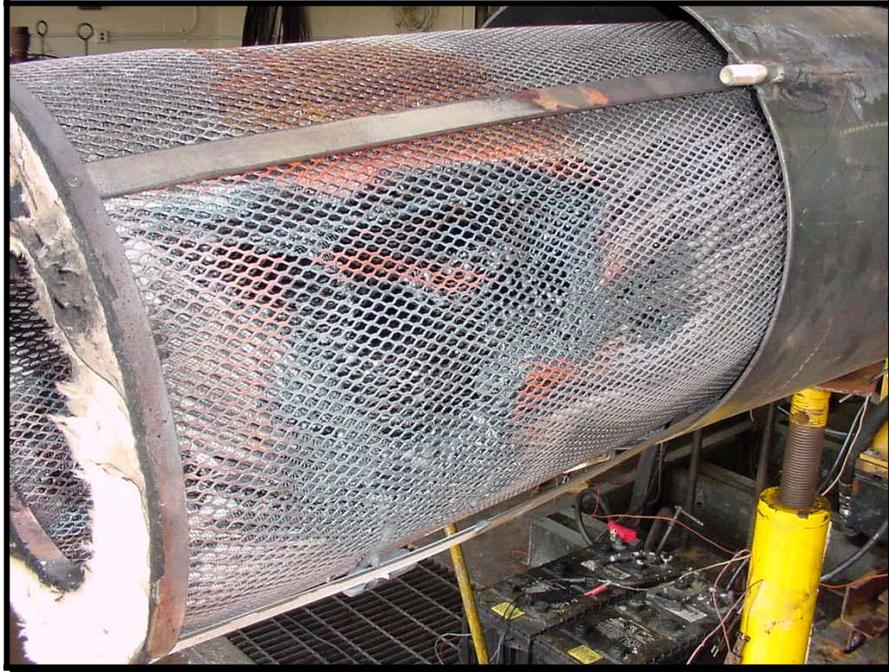
Figure B. 6. Test #5; Burn Damage to Filter #2 aligned with filter canister hole.

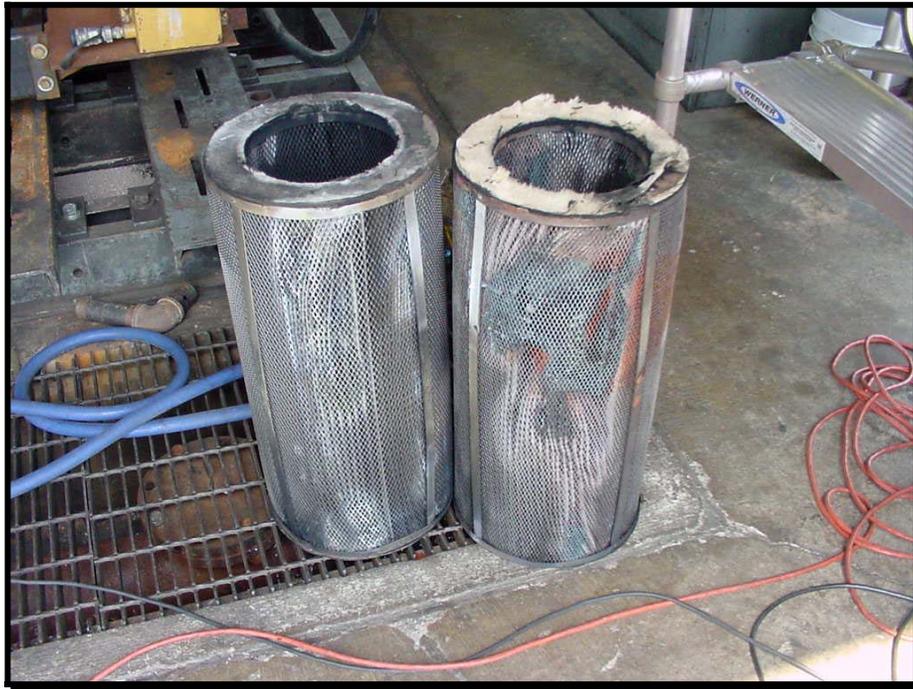
Figure B. 8. Test #5; Burn damage to both filters, Filter #1 on left.

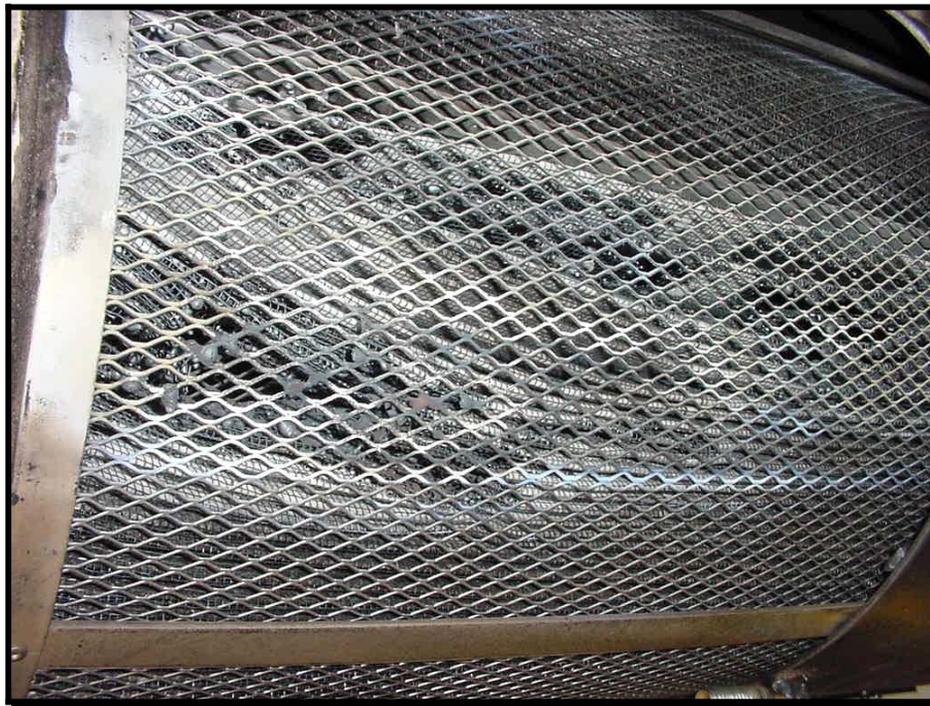
Figure B. 9. Test #5; Burn damage to Filter #1.

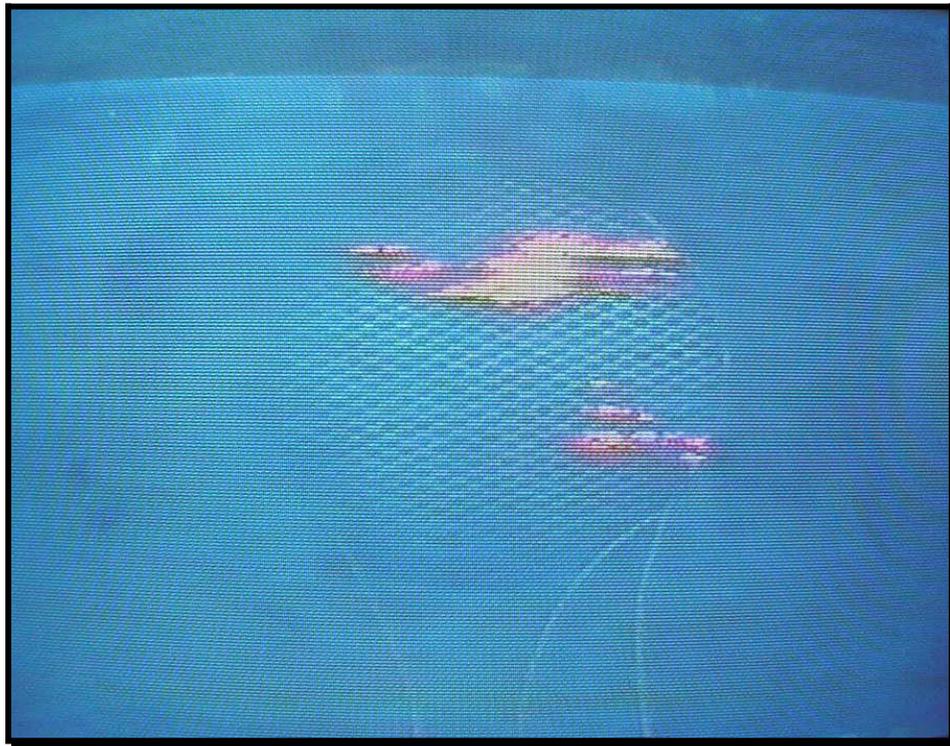
Figure B. 22. Test #16. Filter #2 continuing to burn (haze due to smoke).

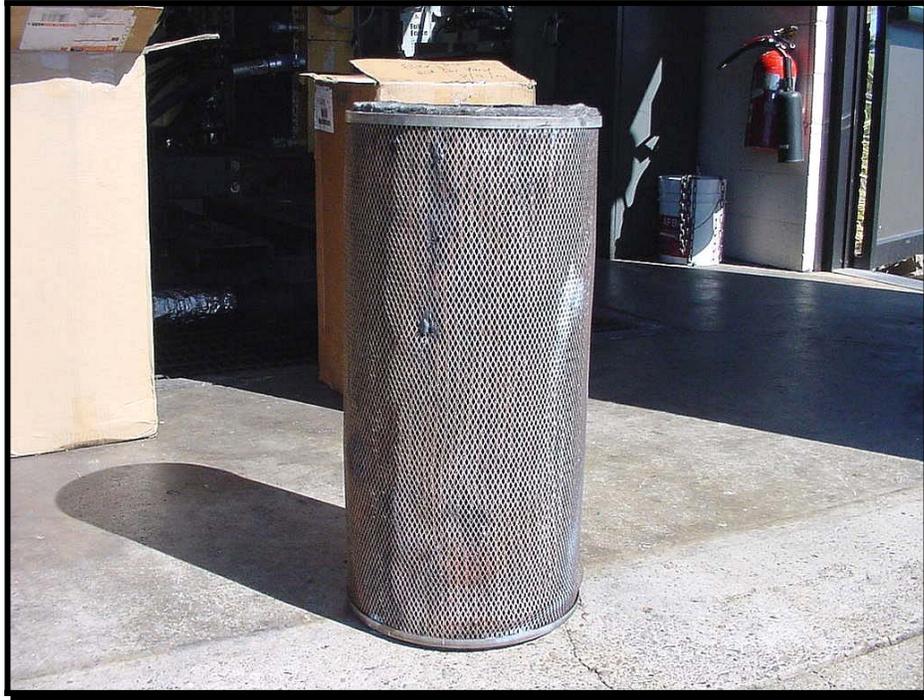
Figure B. 23. Test #16; Damage to filter #2 from ignition.

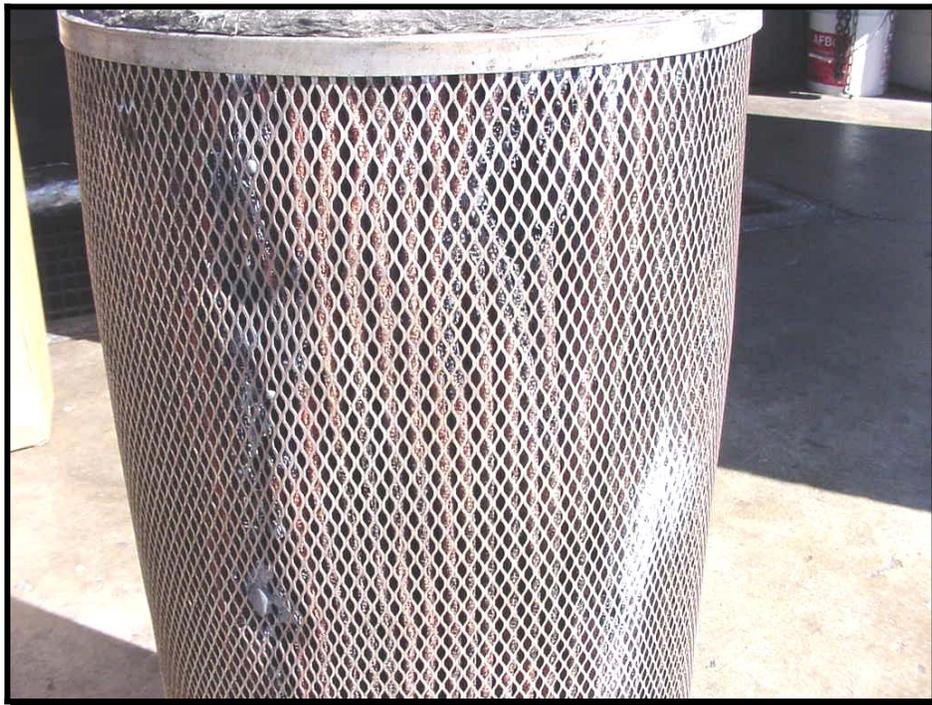
Figure B. 24. Test #16; Damage to #2 filter.

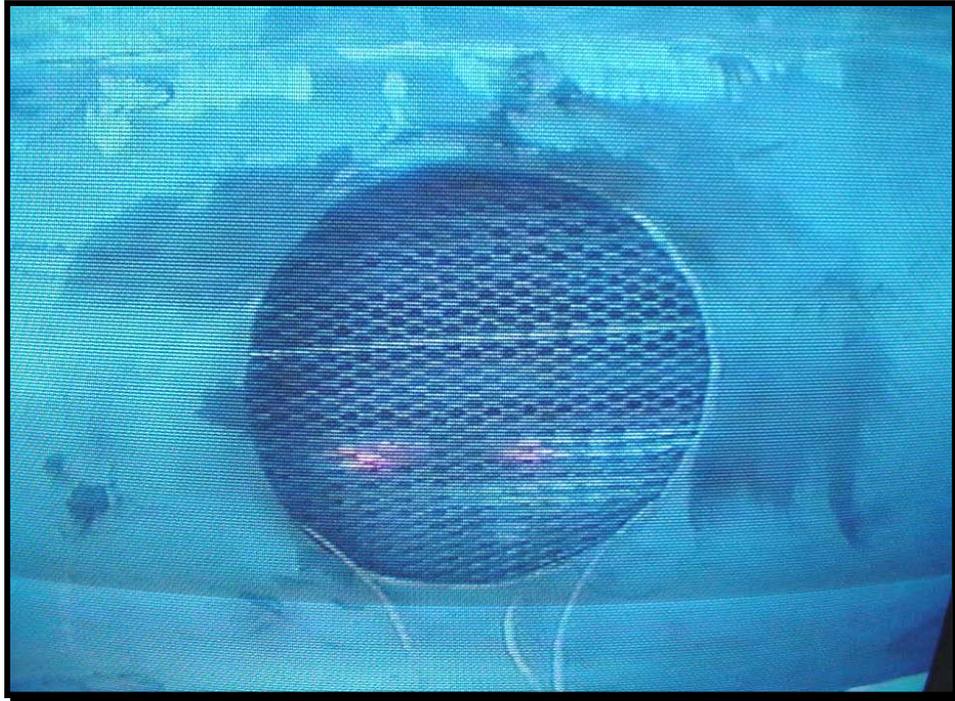
Figure B. 25. Test #17; Glowing ignition on Filter #2 at 850F.

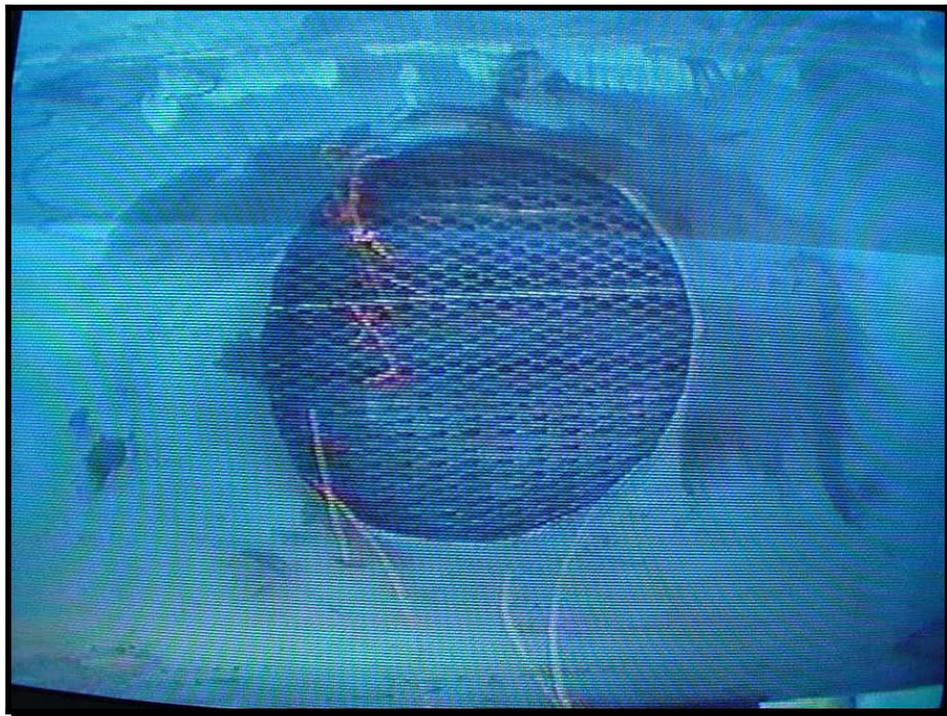
Figure B. 26. Test #17; Sparks from top of #2 filter at 1000F.

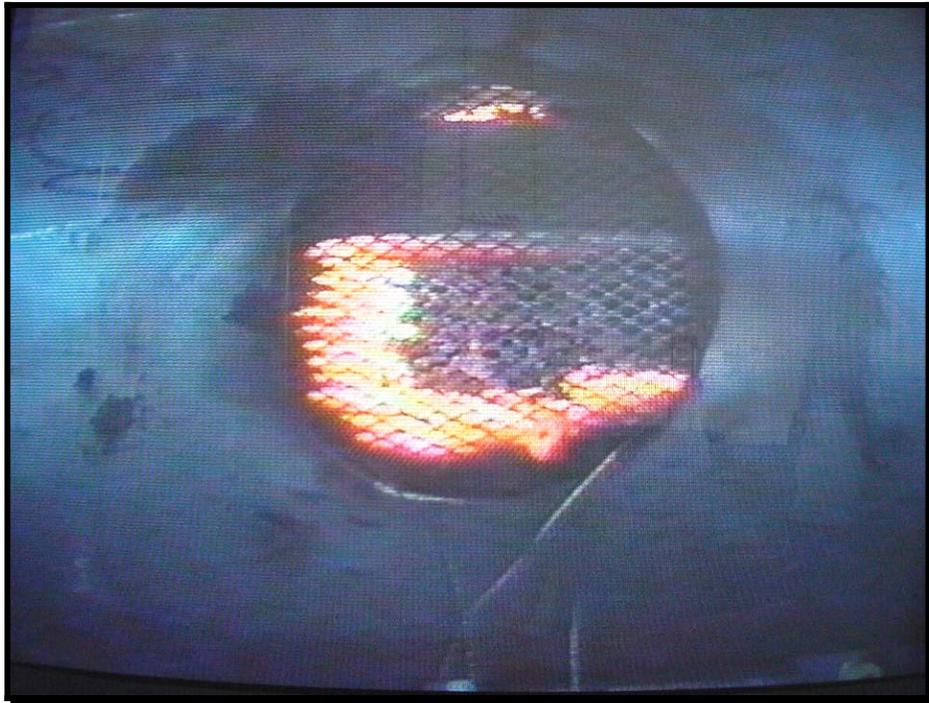
Figure B. 29. Test #18; Filter #2 burning, with hole apparent in center of burn.

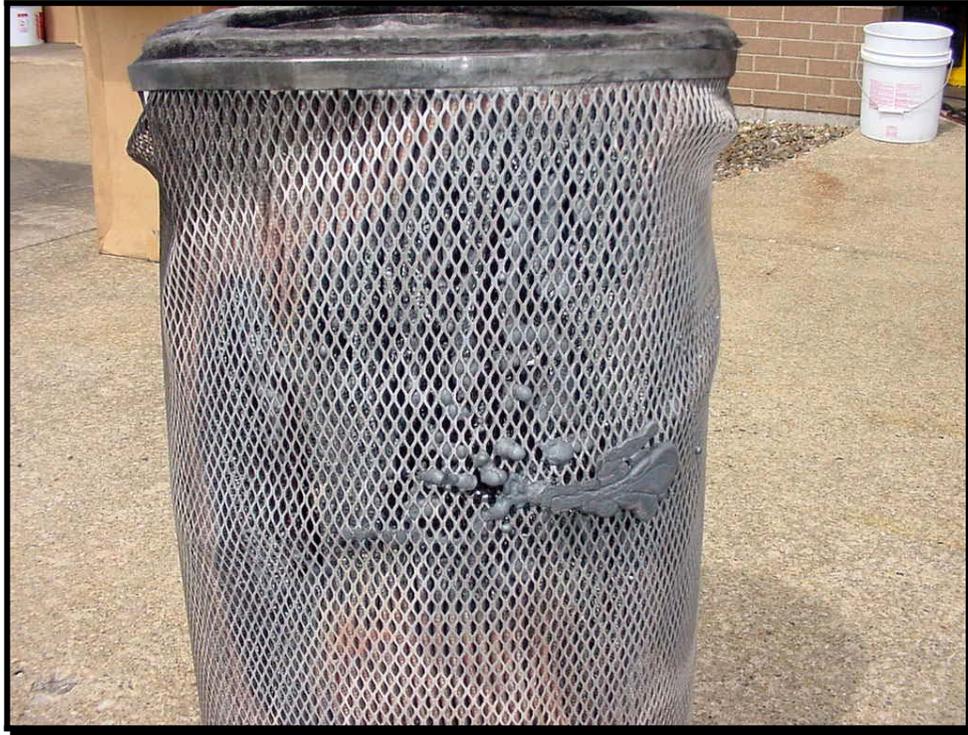
Figure B. 34. Test #23; damage to filter #2 along bottom of filter.

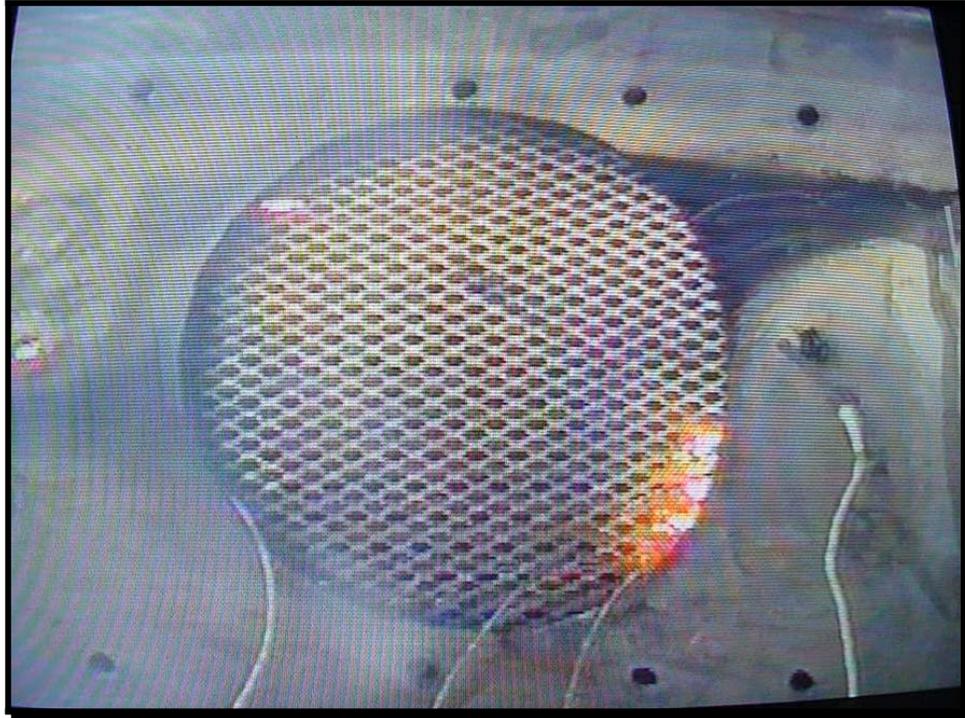
Figure B. 36. Test #24; initial #2 filter ignition.

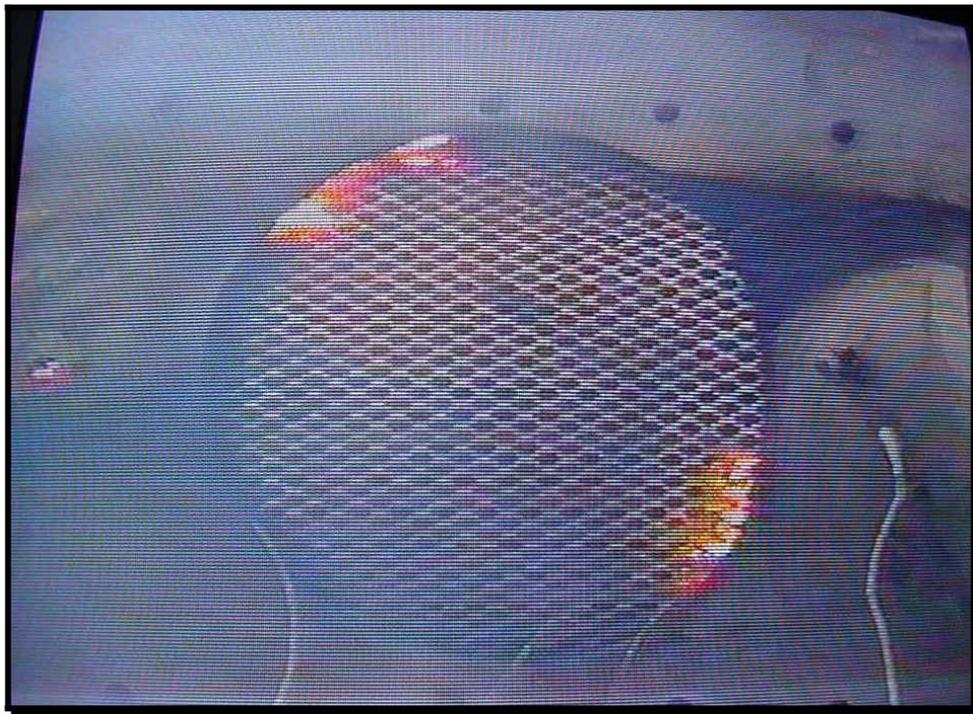
Figure B. 37. Test #24; second ignition on #2 filter.

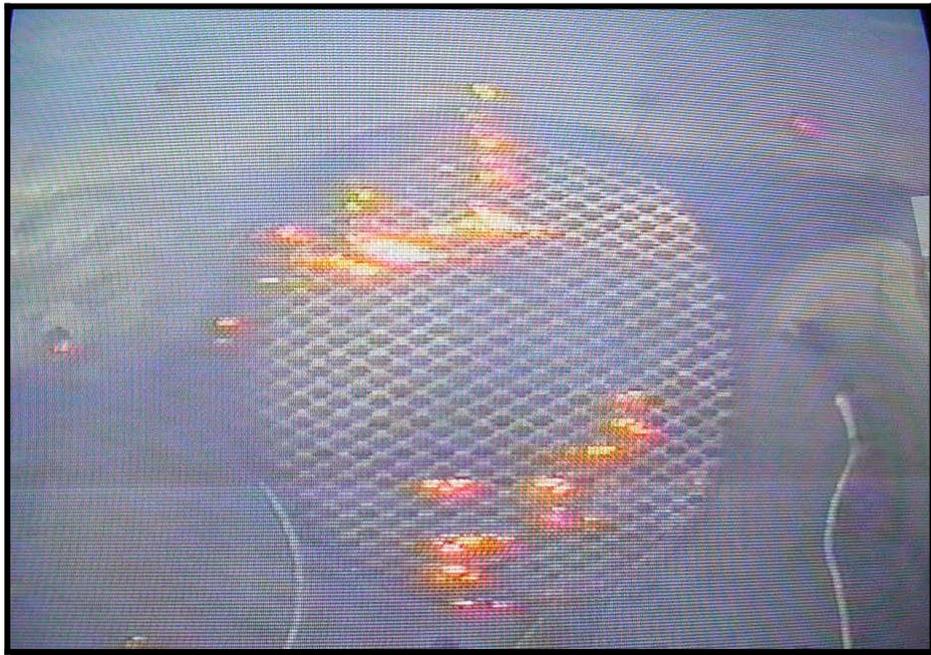
Figure B. 39. Test #24; filter #2 burning over large area of exposed surface.
