# **Equipment Alert -- January 25, 2011**

## **Catastrophic Failure Of An Oxygen Cylinder Fitting In A Refuge Alternative**

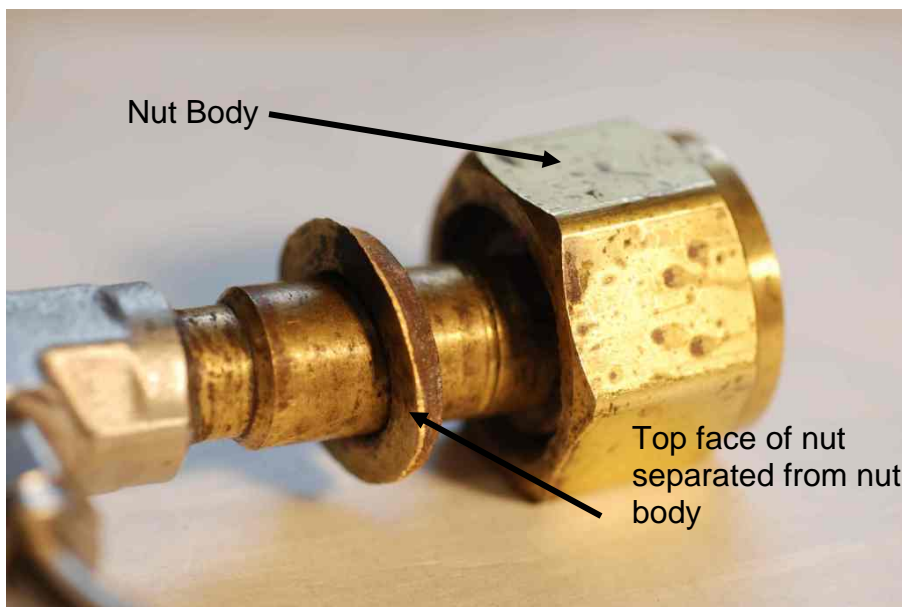
The refuge alternative manufacturer, state inspectors, and MSHA examined the refuge alternative to determine the cause of the incident. The preliminary findings indicate there was a catastrophic failure of a brass high pressure fitting connected to an oxygen cylinder valve. Photograph 1 (below) shows the separation of the top face of the nut from the nut body.

This catastrophic failure allowed a rapid release of oxygen, which pressurized the interior of the steel structure. The initial determination is that the pressure build-up inside the container forced open both the tent deployment door and the air-lock access door, ejecting a supply container and three 5-gallon water containers from the access door area onto a nearby rib.

1. All refuge alternatives should be physically examined to ensure correct fittings are installed on compressed gas systems. Operators should contact the refuge alternative manufacturer to assist in the examinations. The operator should ensure that the refuge alternative manufacturer performs all necessary repairs to the refuge alternative. The examination should include removing access doors, if necessary, to measure and examine each fitting to verify compliance with the applicable CGA standard. The examination may require removal of fittings to take necessary measurements.

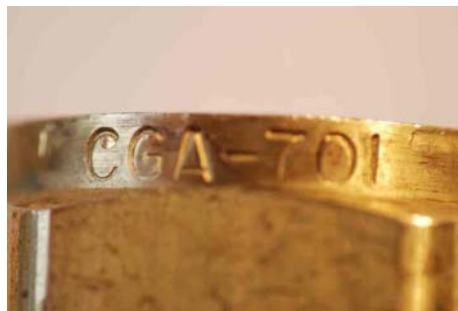
Photograph 2

Further examination of the high pressure oxygen fittings revealed that some of the fittings used in the refuge alternative did not meet the applicable Compressed Gas Association (CGA) standard. Although the fittings had markings that indicated “CGA 701” (photograph 2), the examination revealed that the hexagon nut wall thicknesses did not meet CGA specifications, as the nut walls were approximately 40% thinner (.097 inches) than the required .250-inch minimum wall thickness (photograph 3 & 4). Also, the hexagon nuts were approximately 8% shorter (.091 inches) than the CGA-required 1.125-inch minimum length (shown upright in photograph 5).

CGA designation on high pressure fitting (nut)

A fitting identified with a CGA standard number does not guarantee that the fitting complies with the CGA standard. The fittings should be physically examined to verify compliance.

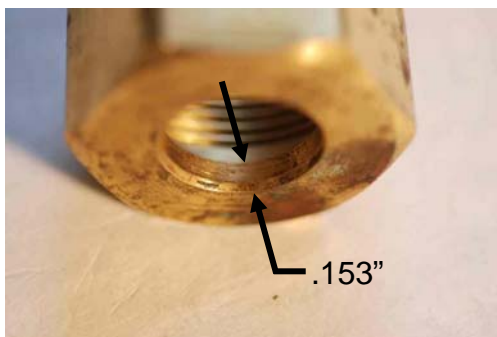
Photograph 3

Measured wall thickness on non-compliant high pressure fitting (nut)

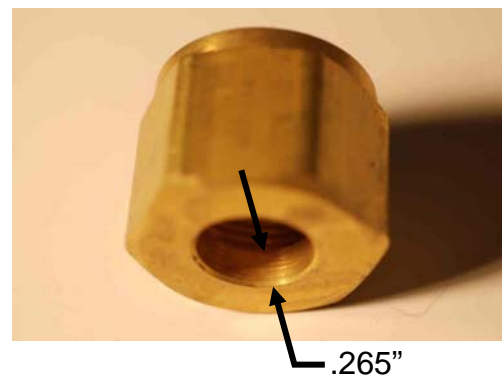
Photograph 4

Measured wall thickness on CGA compliant high pressure fitting (nut)

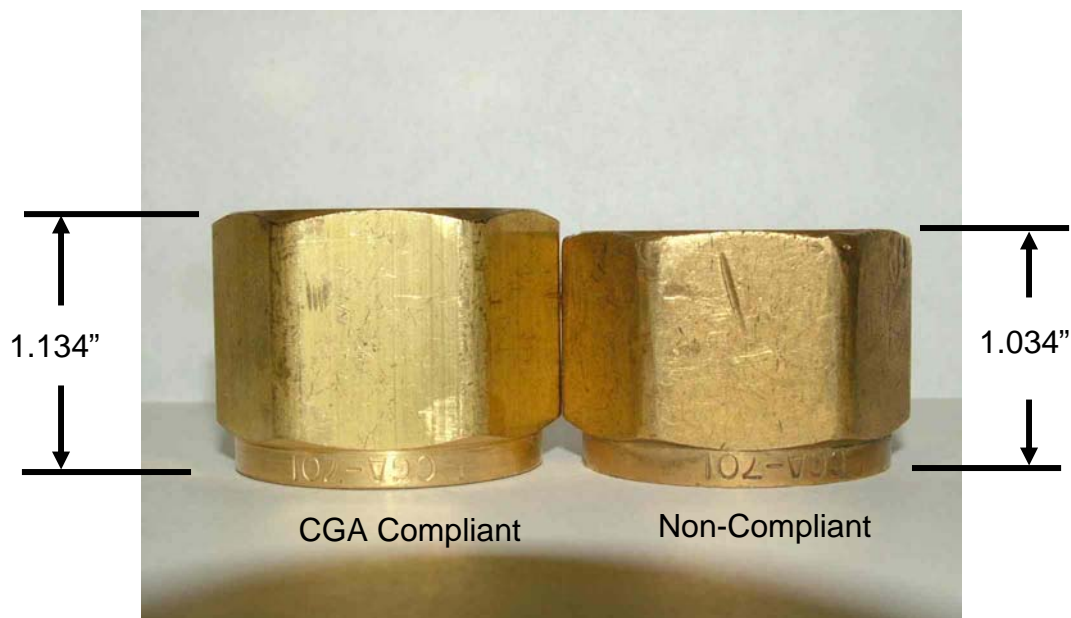
Photograph 5

Measured length (shown upright) on non-compliant and CGA compliant high pressure fitting (nut)
