Quarterly Stakeholder Call

August 10, 2018

U.S. Department of Labor
Mine Safety and Health Administration

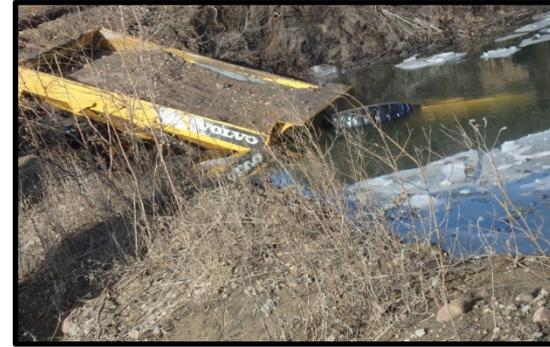
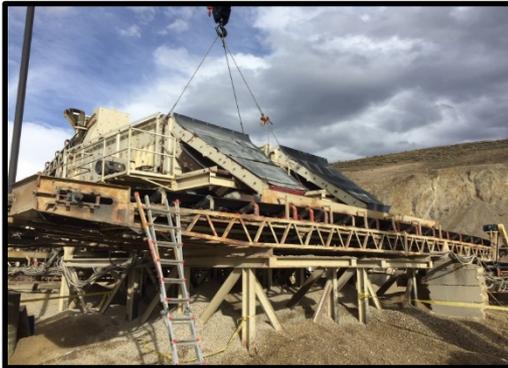
January 25, 2018: Equipment operator killed when his articulated haul truck travelled through a berm and into an ice covered pond, submerging the truck's cab.

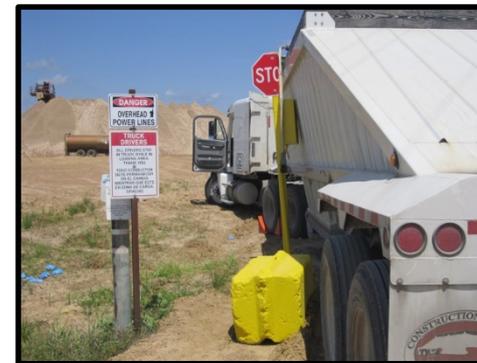
April 12, 2018: Truck driver killed when he fell from, and was run over by, his truck while scanning into the operator's check-in system. The victim was found underneath the belly dump of the semi-trailer, and the truck was still in gear.

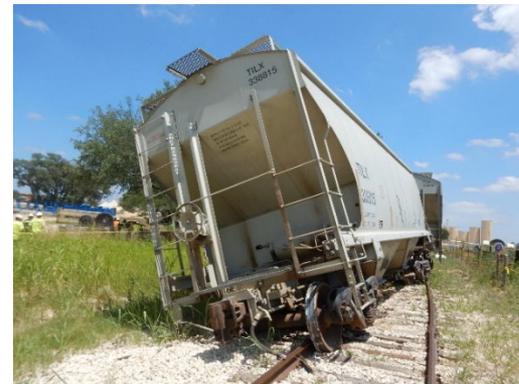
June 23, 2018: Miner fatally injured trying to stop two loaded run away railcars at a load out facility in Texas.

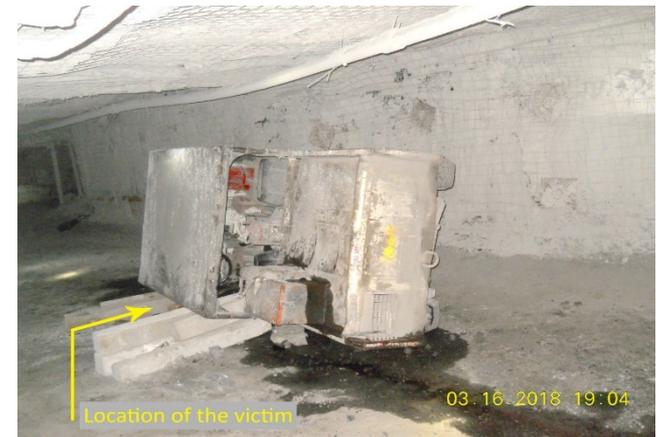
March 16, 2018: Mechanic was fatally injured while operating a diesel personnel carrier on the mine haulage road. The vehicle hit the right rib and rolled onto its left side. The victim was partially ejected from the mantrip and the canopy of the mantrip came to rest on his chest.

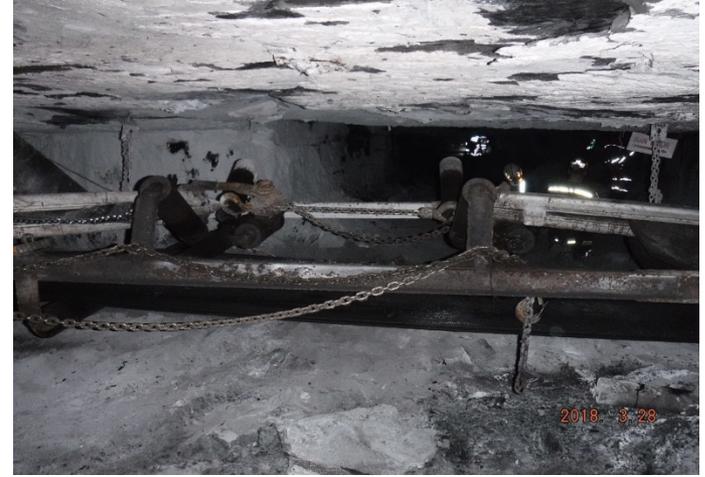
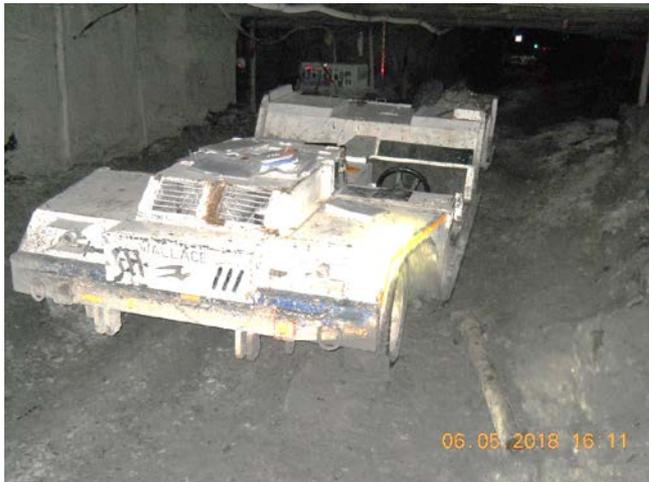
March 28, 2018: Belt foreman was fatally injured while he and a co-worker were in the process of splicing an underground conveyor belt when the conveyor belt inadvertently started.

- Fatality No. 4 - March 28, 2018 - Foreman performing maintenance on conveyor belt that was not locked and tagged out
 - Kentucky

- Before splicing conveyor belts, perform the following steps:
 - Open the circuit breaker that supplies electrical power to the conveyor belt drive.
 - Open the visual disconnect for the cable that supplies electrical power to the conveyor belt drive.

- Lock-out and tag-out the visual disconnect yourself and NEVER rely on someone to do this for you.
 - Release the tension in the conveyor belt take-up/storage unit.

- Block the conveyor belt against motion.
- Keep the key to the lock at all times while repairs and/or maintenance are performed.
- Ensure that you are the only person who removes the lock after repairs and/or maintenance are completed.

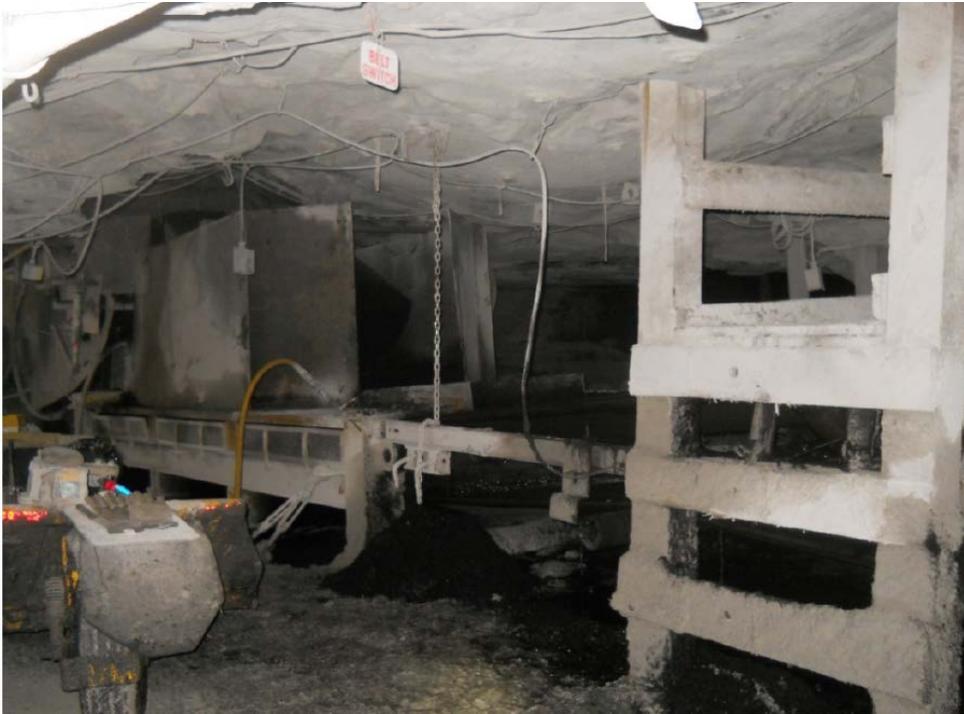
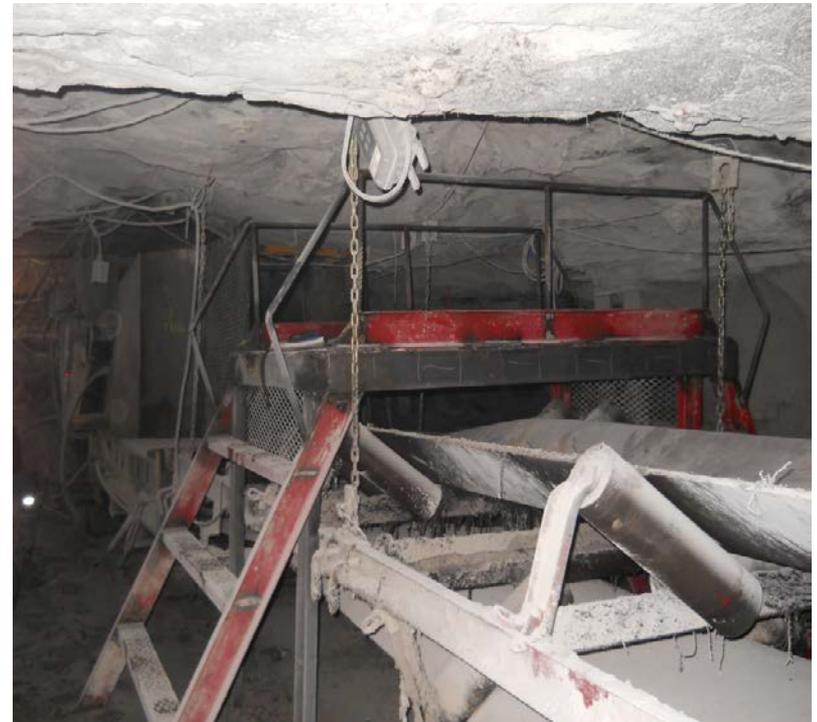
Install practical belt crossing facilities at strategic locations, including near controls, when height allows.

- Never attempt to cross a moving conveyor belt except at suitable crossing facilities.
- Train all employees thoroughly on the dangers of working on or traveling around moving conveyor belts.
- Provide conveyor belt stop and start controls at areas where miners must access both sides of the belt.
- Install pull cords and switches that control power to the belt along the wide side of the length of the conveyor belt to stop the belt in emergencies.

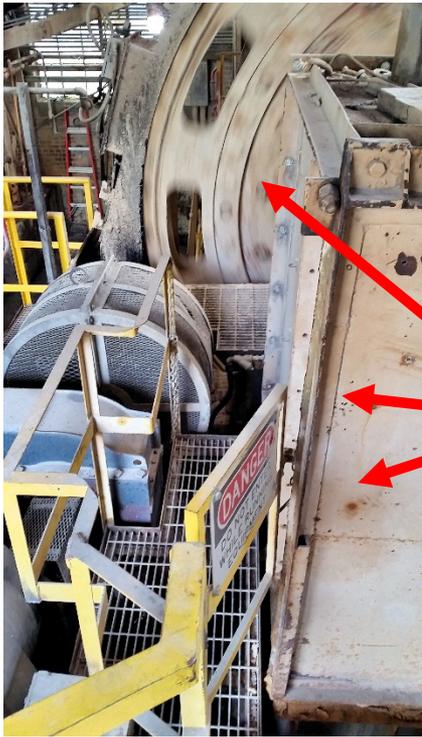
NO. This gate and sign are easily bypassed. The walkway has missing grating and leads to an unguarded rotating mill.

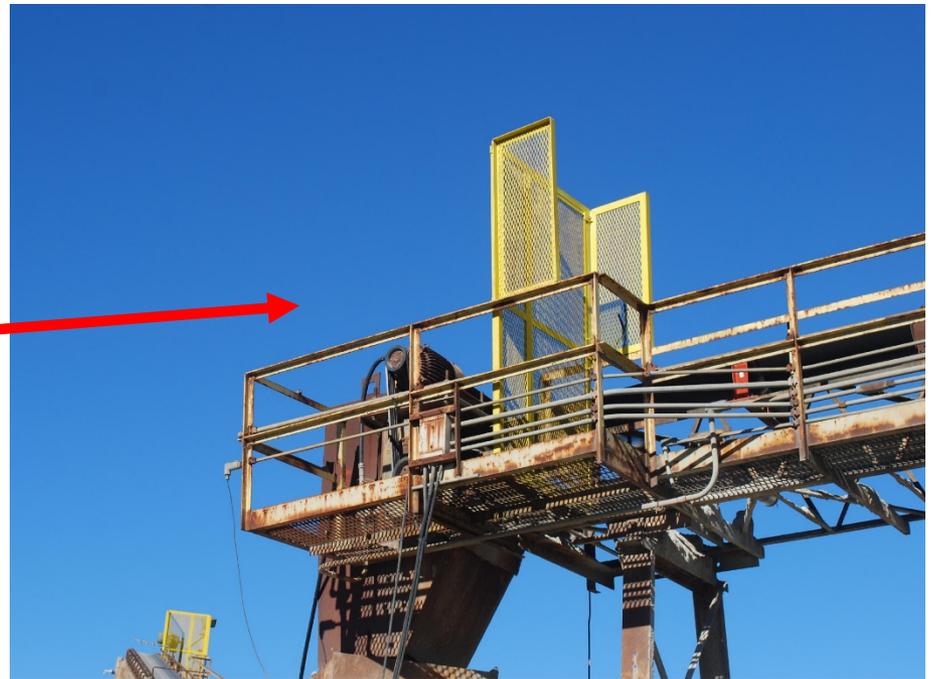
This guard is close to the head pulley and drive components. It is bolted or locked closed and cannot be easily bypassed. There is sufficient room to perform maintenance on the equipment. The door is hinged and opens easily; there are no large or heavy guards to handle.

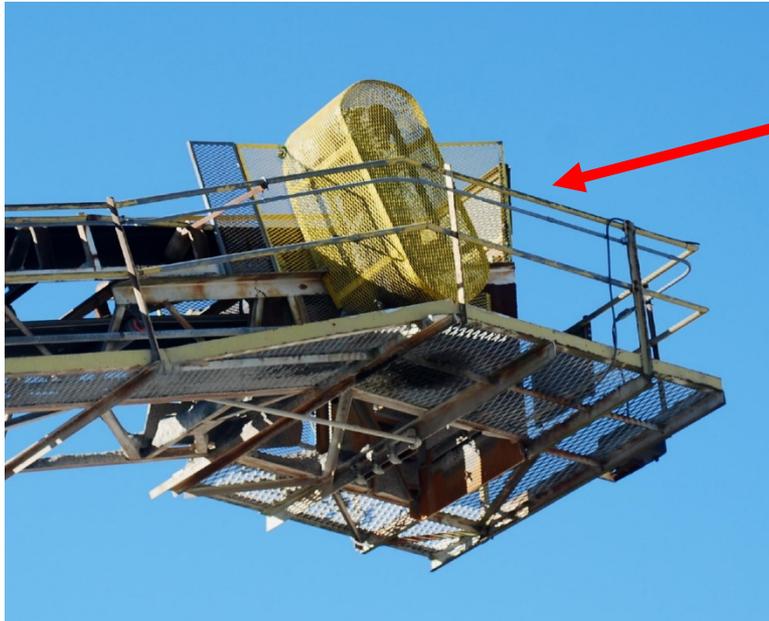
This conveyor has two compliant guards; one is very large and heavy, Neither one has handles. Handling them manually at the end of this elevated conveyor risks strains, sprains and fractures. Once it is removed, there is no place to store it and work safely on the equipment.

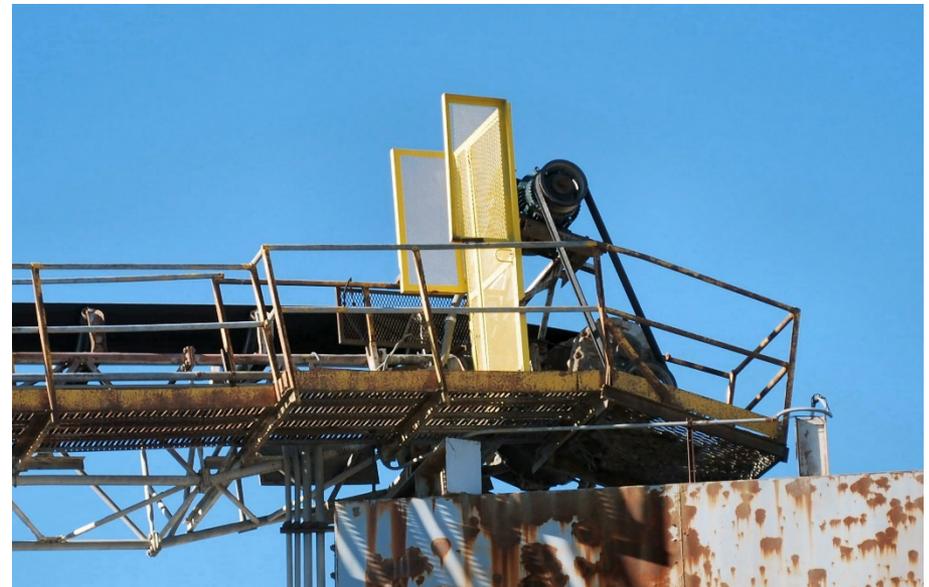
This guard has a hinged door that is securely closed but can be opened for maintenance access. There are no heavy parts to handle or drop on someone.

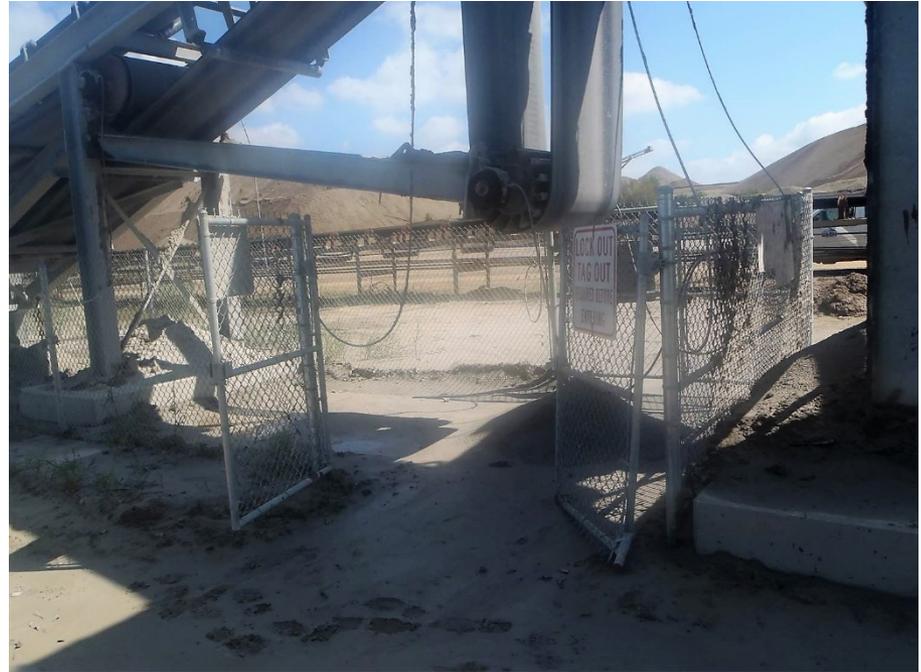
The guard is compliant in its concept, but it is in violation as it stands. The gate was found open with its hinges broken and the conveyor operating.

Miners regularly entered the hazardous area during operation.

Management at this mine did not maintain the guard, install meaningful signage, properly train the workforce or enforce “No Entry” rules.

Similar guards at this mine were observed to have considerable spillage collected inside. Cleaning other than right in front of the gate required hand shoveling into wheelbarrows.

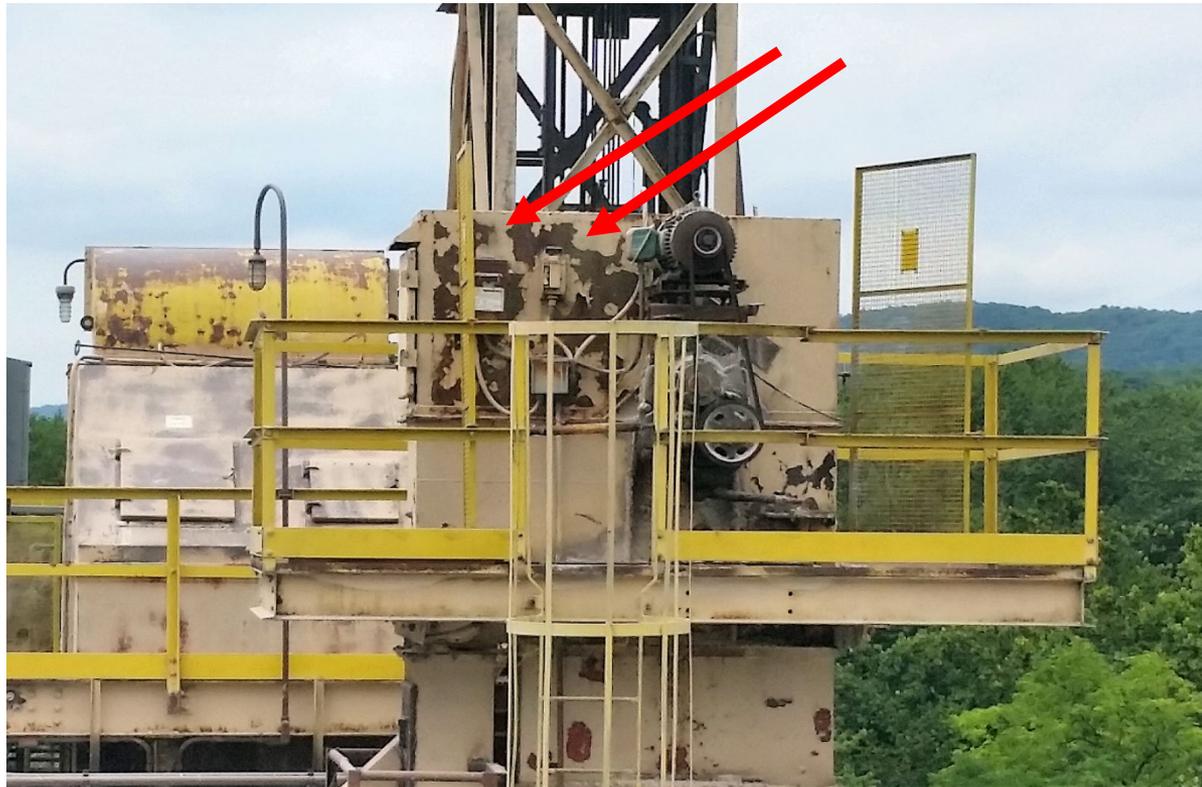
Yes. Like other guards, they have to be substantial, durable, not easily bypassed and maintained in place when operating. This configuration was noncompliant because the start-stop and disconnect/lockout switches (red arrows) were inside the guarded area. Also, the guards could be bypassed by climbing up the ladder from the level below.

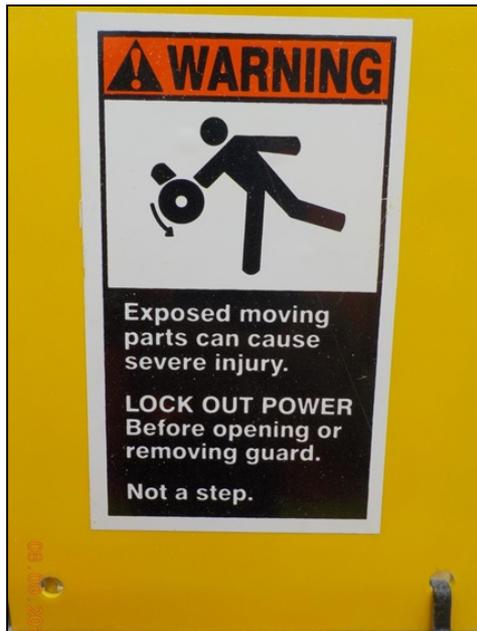
Very small and
unspecific

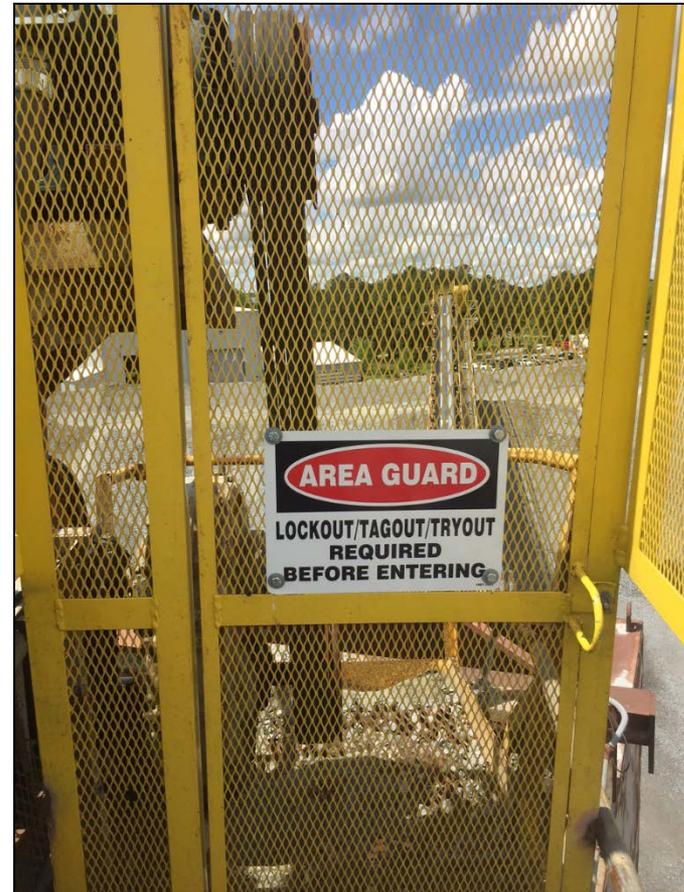
Large, easily read and
specific
