Fatality #1 – January 27, 2011 Powered Haulage - Underground - West Virginia Baylor Mining Inc. - Jims Branch No 3B

COAL MINE FATALITY - - On Thursday, January 27, 2011, a 19 year old underground miner with fifteen weeks of mining experience was killed when he became caught between the "V" shaped coal discharge guides adjacent to the discharge roller of the section conveyor belt. Both belt conveyors were operating at the time of the accident.

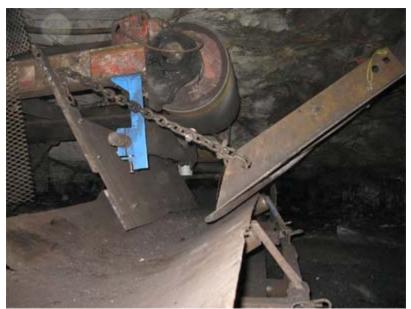
Photo of Reconstructed Accident Scene - Discharge Roller Guarding Removed for Picture

- Train all employees thoroughly on the dangers of working or traveling around moving conveyor belts.
- Never attempt to cross a moving belt conveyor, except at suitable cross-overs or cross-unders.
- Install proper belt cross-overs and/or cross-unders at strategic locations, when height allows.
- Be aware of locations where new miners are working or intend to travel.
- Provide belt conveyor stop and start controls at areas where miners must access both sides of the conveyor. These areas should be provided with adequate crossing facilities (e.g. cross-overs or cross-unders).
- Install adequate guarding at all conveyor belt pinch point locations.
