Fatality #4 - March 25, 2011
Machinery - Underground - Kentucky
Matrix Energy LLC - No. 1

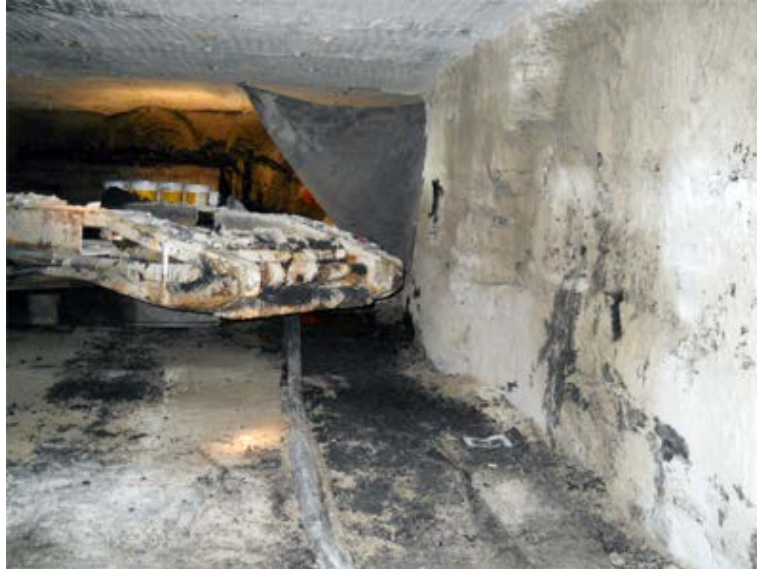
COAL MINE FATALITY - - On Friday, March 25, 2011, a 54-year old continuous mining machine operator with 35 years of experience was killed when he was caught between the coal rib and the conveyor boom of the remote controlled continuous mining machine he was operating.

AVOID "RED ZONES"!!! Prior to tramming the continuous mining machine to a new place, ensure the machine operator is positioned outside the turning radius of the machine.

Prior to tramming the continuous mining machine to a new place, ensure the tip of the conveyor boom is positioned on the side of the mining machine opposite to the side where the machine operator is located.

Install MSHA approved Proximity Detection Systems on continuous mining machines.

Assign another miner to assist the continuous mining machine operator. Train all persons in the programs, policies, and procedures for operating or working near remote controlled continuous mining machines. Additional information on preventing these types of accidents can be found at: [MSHA's Safety Targets Program Hit By Underground Equipment](#).
