Fatality #16 – October 7, 2011

Falling, Rolling, or Sliding Rock or Material - Underground - Kentucky

Owlco Energy LLC - Mine No. 1

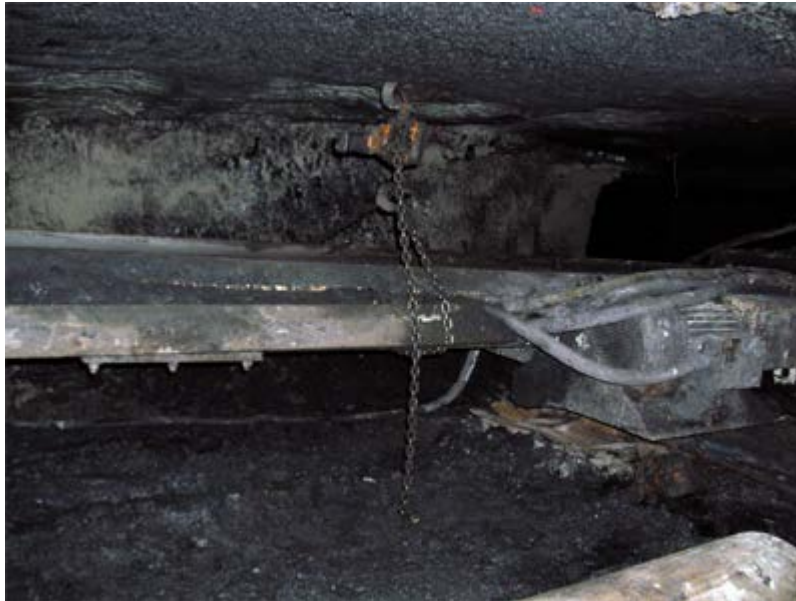
COAL MINE FATALITY - On Friday, October 7, 2011, a 23-year-old section repairman with five years of mining experience was killed when a continuous haulage conveyor fell on him. A rock had been used to block up the continuous haulage conveyor. The victim was working beneath the continuous haulage conveyor attempting to repair the bridge conveyor chain.

- Do not work under raised equipment unless it is securely blocked.
- Use proper blocking material that is properly placed and stable.
- Conduct thorough examinations of all areas where work is scheduled and have adequate oversight to ensure all tasks are performed in a safe manner.
- Provide additional training for all work procedures emphasizing best practices for each specific task.
- Evaluate hazard potential before working in tight spaces. Click on the following link for more information: [MSHA - SLAM Risks the Smart Way - Safety and Health Outreach Program Home Page.](#)
