**Fatality #23 - December 7, 2011**  
**Fall of Highwall - Surface Mine - Virginia**  
**Fairbanks Coal Company Inc - Fairbanks No 4**

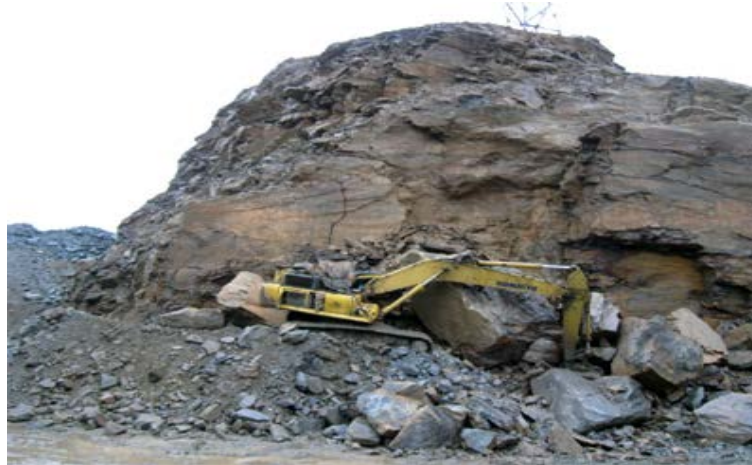
**COAL MINE FATALITY** - On Wednesday, December 7, 2011, at approximately 7:30 a.m., a 49-year-old excavator operator, with 20 years of mining experience, was fatally injured when a highwall he was working near collapsed. The excavator was being used to load rock trucks. The operator's cab was positioned on the highwall side when the accident occurred.

- Operate excavators with the cab perpendicular to, and away from, the highwall.
- Design benches to safely accommodate the type of equipment used and include this in the Ground Control Plan.

- Examine highwalls from as many perspectives as possible (bottom, sides, and top/crest) while maintaining the safety of the examiner(s). Look for signs of cracking or other geologic discontinuities.

- Use auxiliary lighting during non-daylight hours to conduct highwall examinations and to illuminate active work areas.
- Perform supplemental examinations of highwalls, banks, benches, and sloping terrain in the working area during inclement weather.

- Immediately remove all personnel exposed to hazardous ground conditions, barricade, and/or post signs to prevent entry, and promptly correct the unsafe conditions.

- Brief foremen and miners coming to work on any uncorrected hazardous conditions, and ensure the hazardous conditions are noted in the on-shift examination record book.
