Fatality #10 - June 25, 2012
Fall of Face/Rib/Highwall - Underground - Kentucky
McCoy Elkhorn Coal Corp. - Mine #23

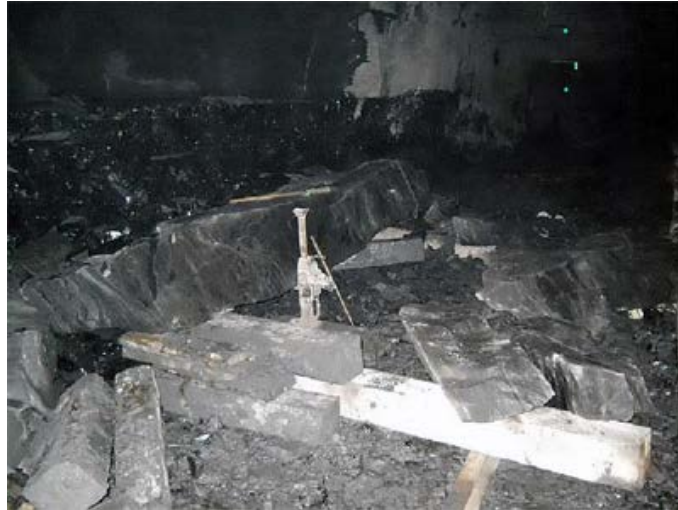
COAL MINE FATALITY - On Monday, June 25, 2012, at approximately 11:45 AM, a 33-year-old outby foreman with 7 years of experience was killed while installing additional rib/roof support in the No. 5 belt/track entry. The victim was wedging a timber against the mine roof to support the rib, when a section of the left hand rib rolled on top of him. The rock was approximately 14 feet long, 4 feet high, and 17 inches thick.

- Conduct thorough pre-shift and on-shift examinations of the roof, face, and ribs. A thorough exam must be conducted before any work or travel is started in an area and thereafter as conditions warrant.

- Support any loose roof or rib material adequately or scale loose material from a safe location before working or traveling in an area.
- Danger-off areas that have hazardous roof or rib conditions until they are made safe.

- Take additional safety precautions when mining heights increase because rib fall injury rates increase substantially as the mining height increases.
- Use rib bolting to control unstable ribs. Rib bolts provide the best protection against rib falls and are most effective when installed on cycle and in a consistent pattern.

- Be alert to changing geologic conditions which may affect roof/rib conditions.
- Ensure that the Approved Roof Control Plan is followed and is suitable for the geologic conditions encountered.

- Revise the Approved Roof Control Plan as needed when adverse conditions are encountered.
