REPORT OF INVESTIGATION

Impoundment for Inactive Surface Coal Cleaning Facility  
Fatal Machinery Accident  
July 3, 2013

Maple Creek Preparation Plant  
Maple Creek Mining Incorporated  
New Eagle, Washington County, Pennsylvania  
MSHA ID 36-00968

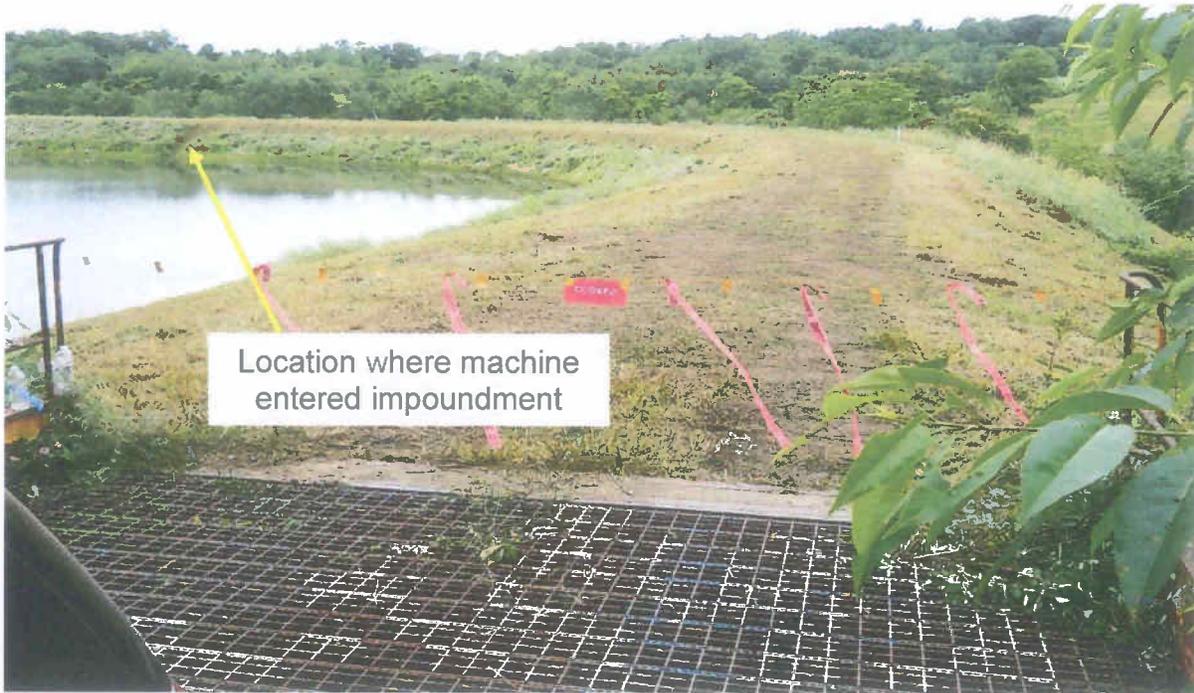
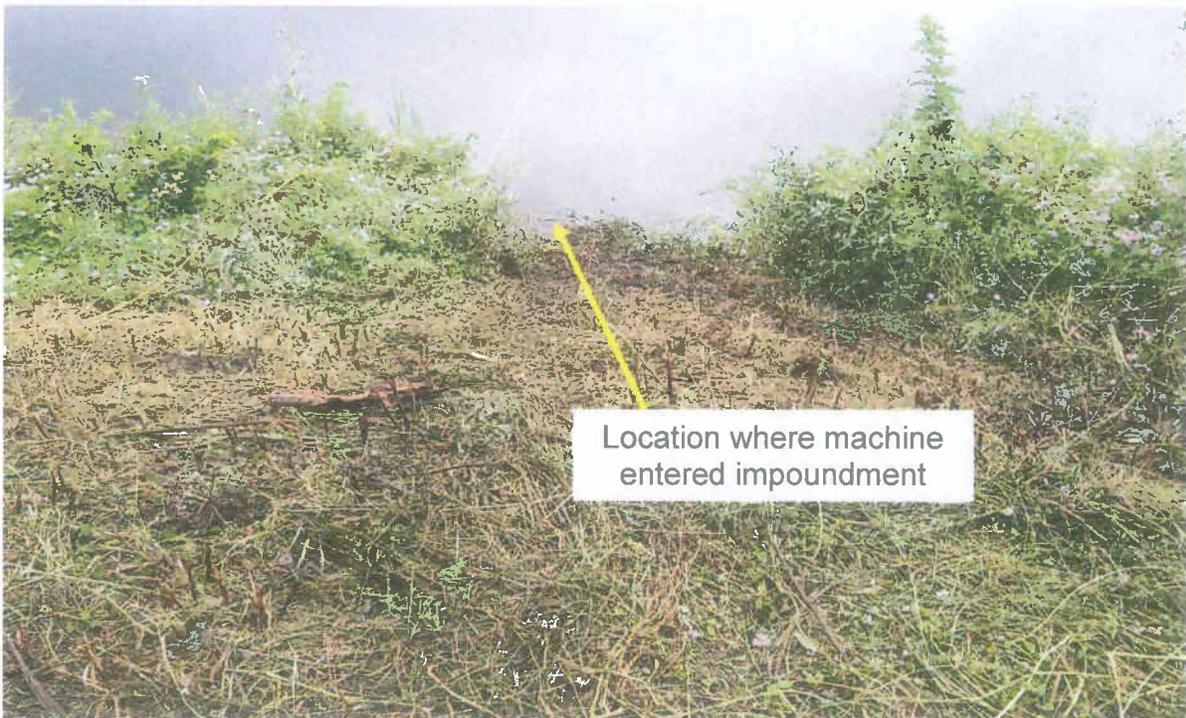
## Appendix B - Accident Site Photographs

MSHA Investigator, Walter Young, documented the accident scene by taking photographs (Appendix B) and making measurements. The affected area was secured from further damage to preserve the scene of the accident. Interviews were conducted with employees of the security company that patrols the less-remote portions of the mine property, Mine Officials, and V.W.S. Inc. personnel.

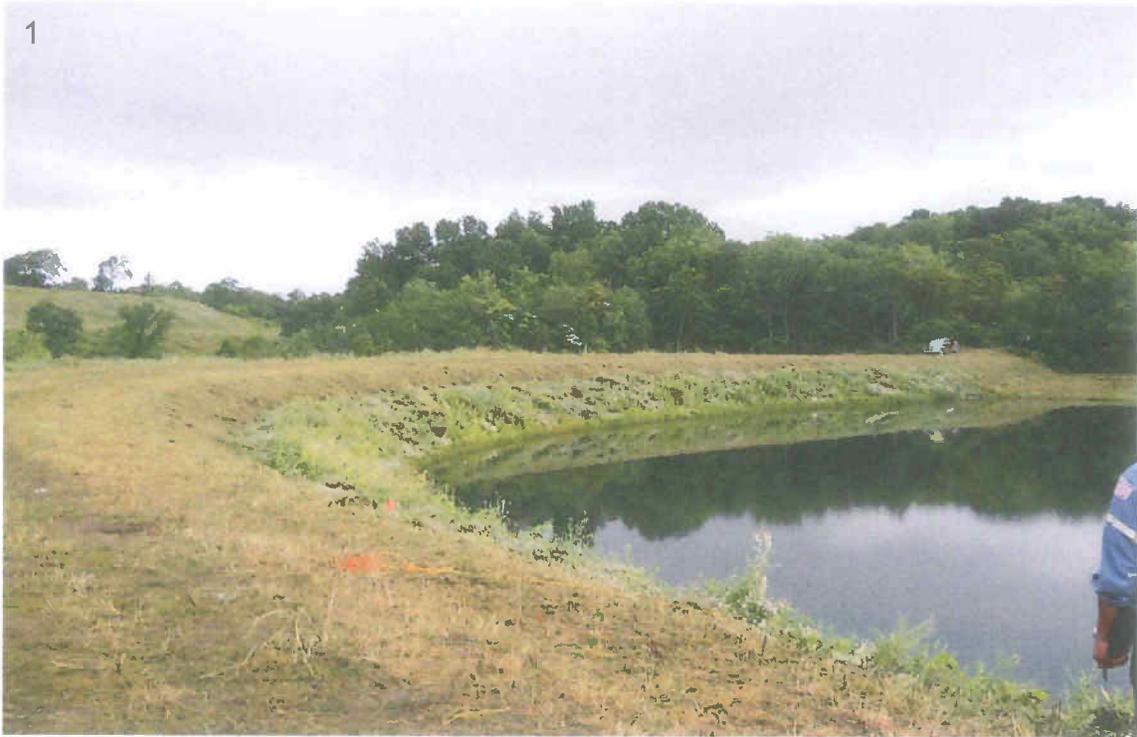
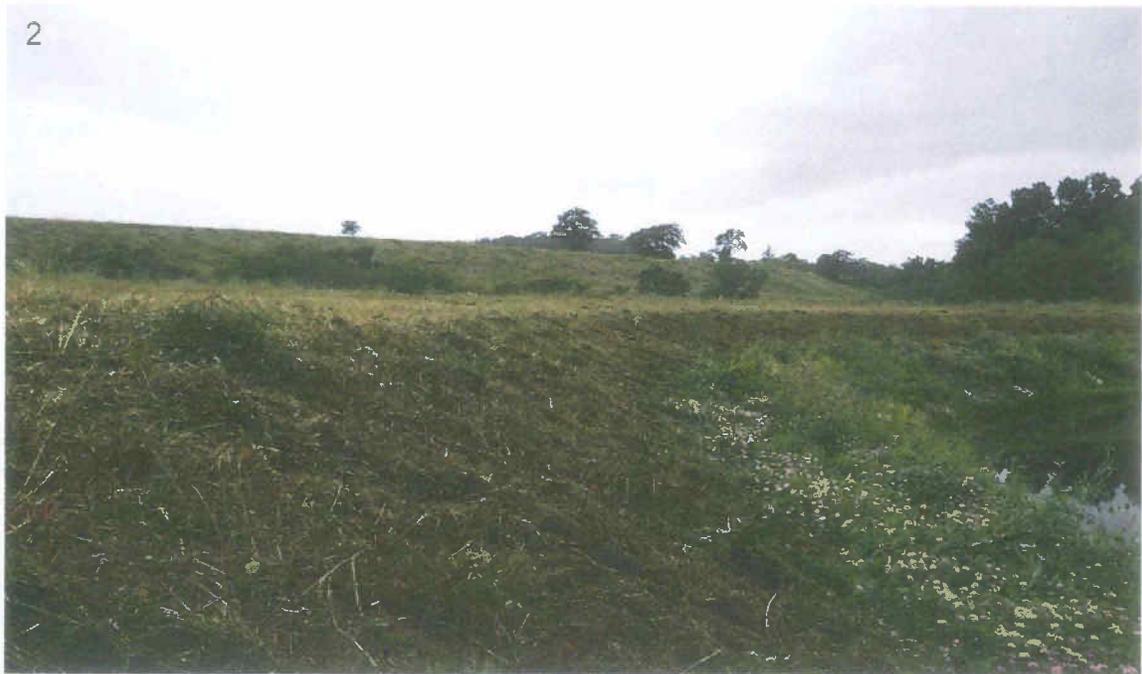
## Appendix C Photographs

impoundment. The machine should have remained stable, since the victim mowed approximately 540 feet along the edge of the impoundment without incident (Appendix C, photographs 1 and 2). There was no abrupt change in the condition or angle of the impoundment embankment at the accident scene. The accident investigators were unable to determine the cause of the accident.

The Bobcat T300 compact track loader is track-mounted on rubber cat pads, which may have had limited traction on the wet embankment. The contractor had mowed this impoundment five times in prior years in the same manner without incident. The Federal Emergency Management Agency's (FEMA) "Technical Manual for Dam Owners" recommends mowing of impoundments twice yearly to aid in inspecting and prevent tree growth. Photograph 3 in Appendix C shows where Dieteman had mowed the downstream side of the impoundment crest with obvious signs of cat pads slipping and spinning. There were no indications of this type of slippage where the victim had been mowing on the upstream side of the impoundment crest (Appendix C, photographs 1 and 2).

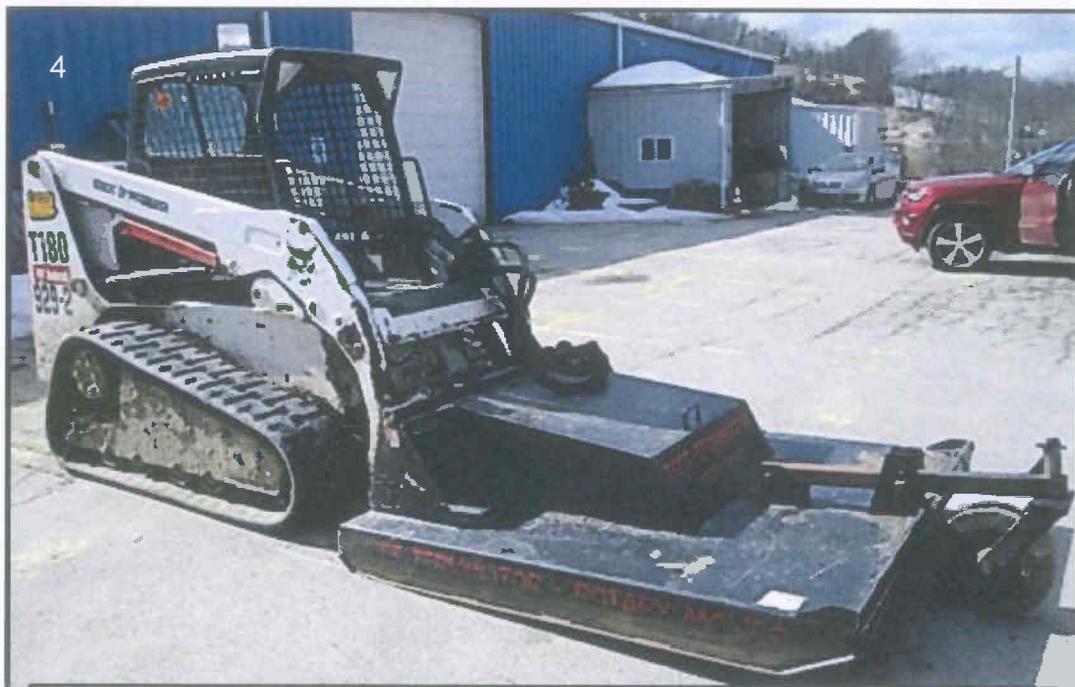
Photograph of a track-mounted T180 Bobcat with front mower attached. This is similar to the T300 Bobcat involved in the fatality.
