Fatality #1 - January 16, 2014
Powered Haulage - Underground - West Virginia
Mettiki Coal WV, LLC - Mountain View Mine

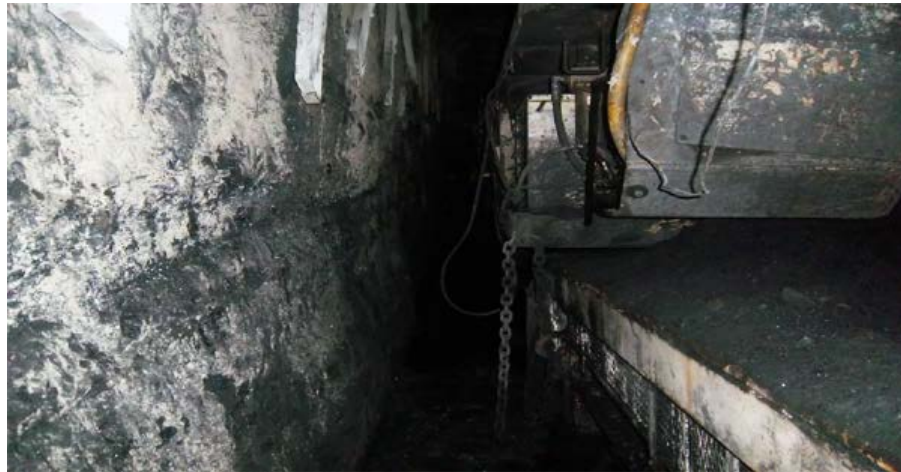
COAL MINE FATALITY - - On Friday, January 16, 2014, a 20-year-old general inside laborer with 2 years of mining experience was killed when he was struck by a feeder. The victim was standing between the coal rib and the feeder when the securing post dislodged, allowing the tailpiece unit to shift and pin him between the rib and the frame of the feeder. The victim had just finished connecting a chain between the feeder and the tailpiece when the accident occurred.

- De-energize and lock out the conveyor belt before repositioning the tailpiece.
- Establish and discuss safe work procedures before beginning work. Identify and control all hazards associated with the work to be performed and the methods to properly protect persons.
- Use equipment or material capable of supporting the tailpiece.
- Ensure any bracing, such as a post, is hitched into the rib properly.
- Ensure the tailpiece is anchored securely before re-energizing the conveyor.
- Operate the belt before allowing miners around the repositioned tailpiece. Keep miners at a safe distance and avoid pinch points until it is determined that the tailpiece is secure.
