Fatalgram

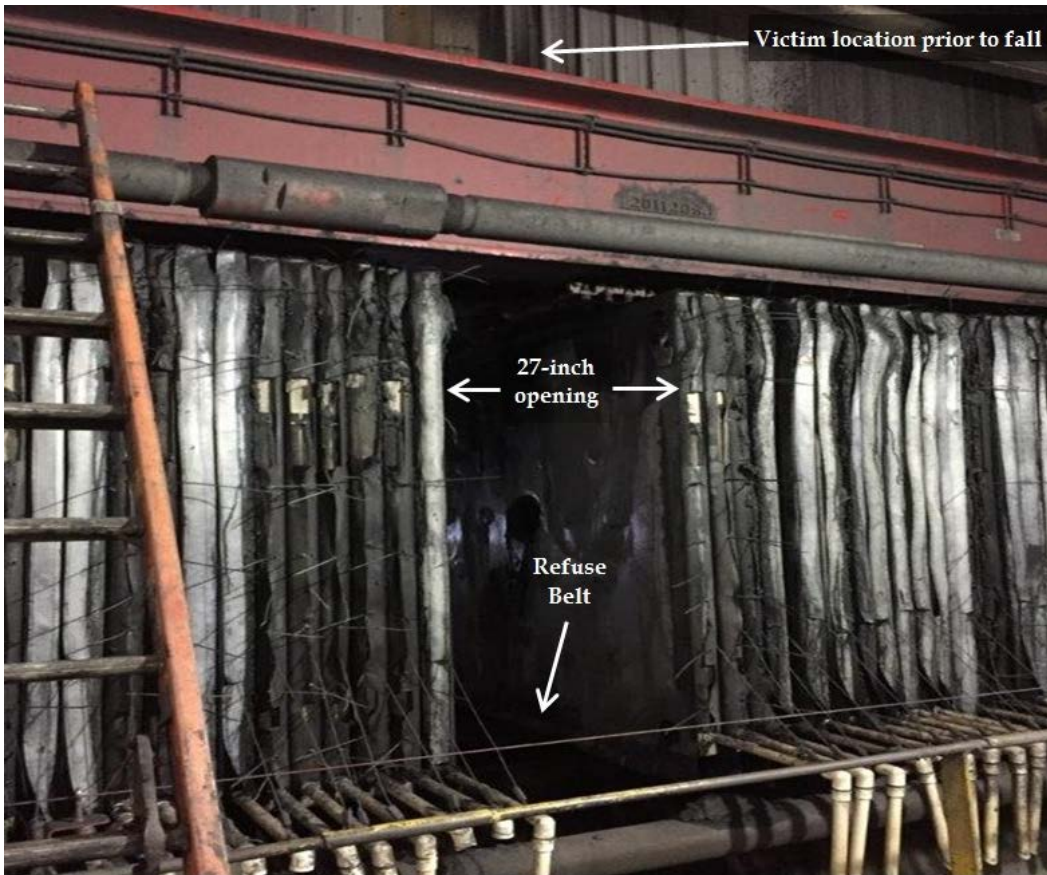
COAL MINE FATALITY – On February 27, 2017, a 43-year-old plant attendant, with approximately 13 years of experience, was fatally injured when he fell through a 27-inch opening in a plate press. The victim had climbed a ladder to repair a damaged plate when he fell about 19 feet onto a moving refuse belt. The victim was found in a transfer chute, approximately 55 feet down the belt from where he had fallen.

- Provide and maintain safe access to all work areas. Train miners on how to safely access all work areas.
- Protect and guard all openings through which persons may fall. Use fall protection, maintaining 100 % tie off, when fall hazards exist. See <https://www.msha.gov/news-media/alerts-hazards/filter>
- Establish specific policies and procedures for the use of fall protection.

- Ensure workers are trained in the use of fall protection. Monitor work practices to ensure fall protection is being properly used.
- Conduct a risk assessment of the work area prior to beginning any task and identify all possible hazards. Use the SLAM: Stop, Look, Analyze, and Manage approach for work place safety.
