APPENDIX AL

SUMMARY OF EXAMINATION OF THREE REFUGE ALTERNATIVES

Summary of Examination of Three Refuge Alternatives
Located at Performance Coal Company's Upper Big
Branch Mine-South

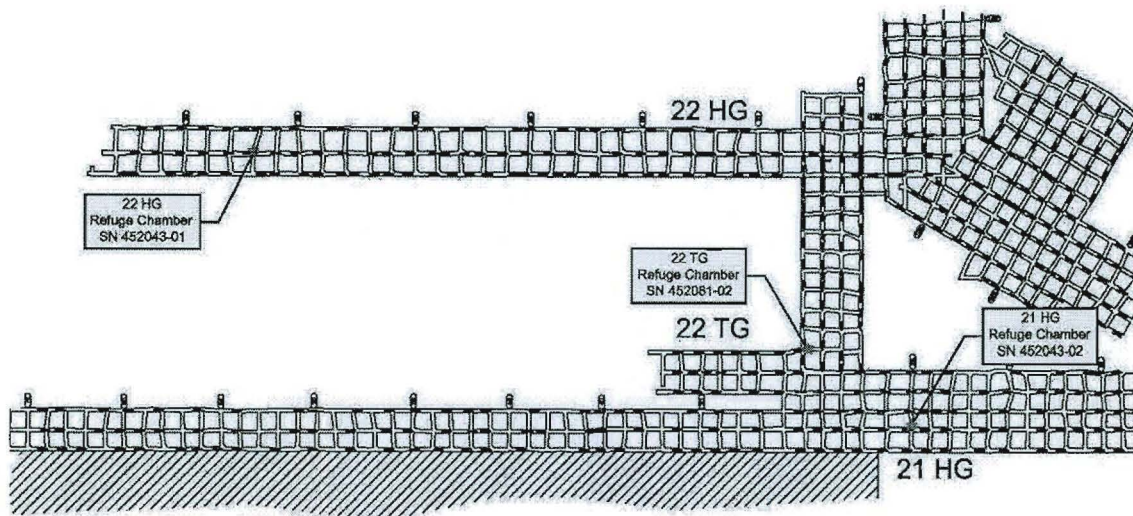
A team of 16 individuals from Strata Safety Products, MSHA, the State of West Virginia, the UMWA, and Massey travelled to each of the three refuge chamber locations to examine and deploy the chambers. The intent was to check the functionality of the chambers following the event of April 5, 2010. The units examined by the team were located in Headgate 21, Headgate 22, and Tailgate 22 sections.
