REPORT OF INVESTIGATION

Fatal Confined Space Accident
October 7, 2022

Portable 11
J R Vinagro Corporation
Tiverton, Newport County, Rhode Island
ID No. 37-00243

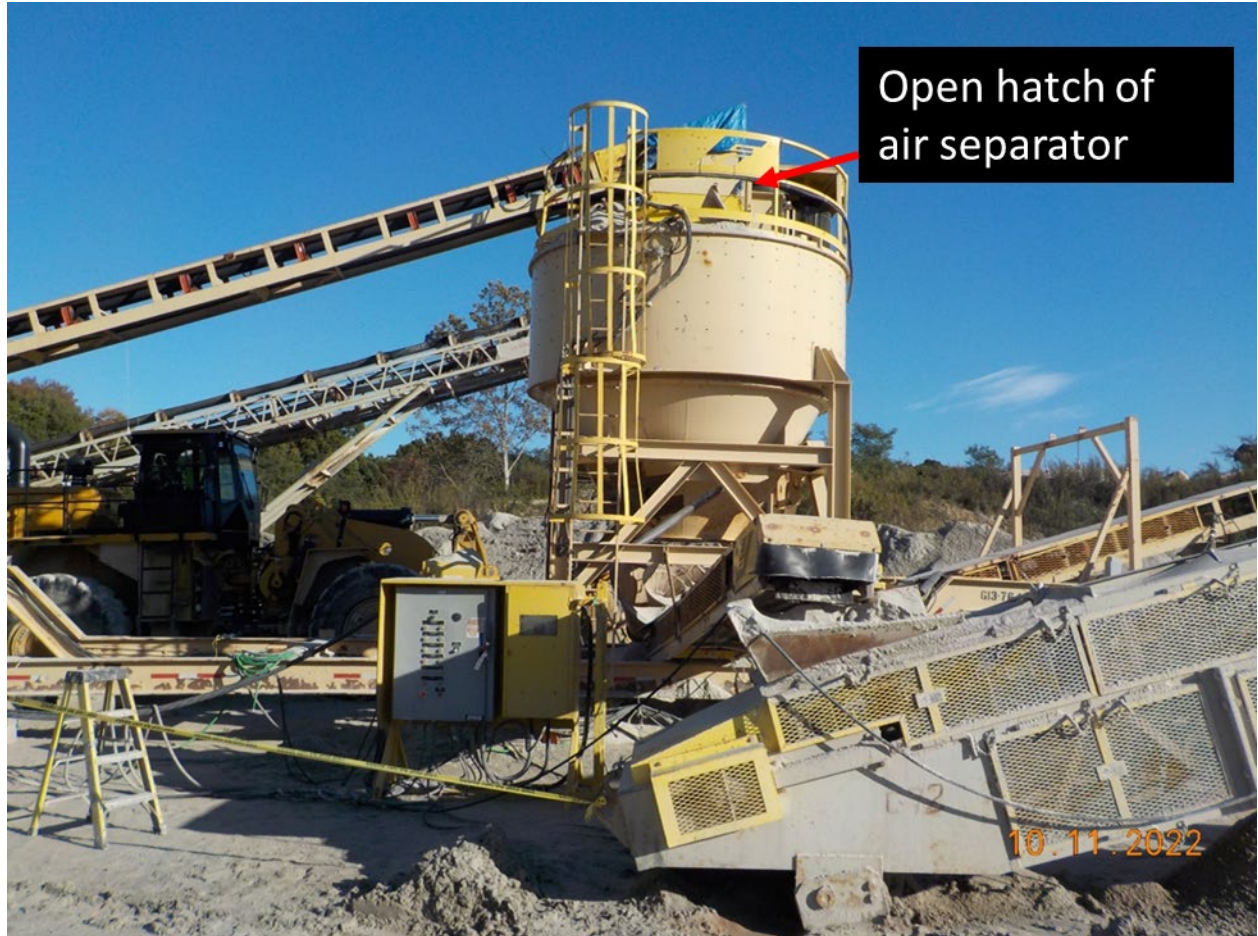
APPENDIX C – Air Separator

The air separator involved in the accident is a Fisher Industries Model 13FT Portable Air Separator and separates coarse material from fine material (see Appendices C and D). Material from the plant is conveyed on a belt to the top of the air separator where the coarse material drops out through an inner cone. A fan inside the air separator creates an updraft that carries the fine material to the outer cone. The air separator has been operating at the Tiverton Materials mine for the past four years.

Investigators found the access hatch on top of the air separator tied in the open position. Based on interviews, investigators concluded that Ovando-Gamez entered the air separator through the access hatch to clear the blockage. Investigators also found the emergency stop button mounted to the handrail around the top of the air separator pushed in and the disconnect switch shut off. Neither the air separator nor the supply and discharge controls were locked out prior to the accident. After the accident occurred, Kent Waterman, Electrician for J R Vinagro, locked and tagged out the disconnect at the main switchgear trailer.

According to interviews, the air separator became blocked with material at least two to three times per week. Miners entered the air separator to clear the blockage about once per shift. At other times, miners were able to clear the blockage by striking the exterior of the cone at the bottom of the separator with hammers. The air separator was equipped with an electromechanical vibrator to prevent material from becoming blocked. The factory installed vibrator motor was not functional due to an electrical malfunction. Investigators determined these defects existed prior to the accident. Investigators found areas where the mine operator previously installed two additional vibrators on the air separator, but the vibrators had been removed prior to the accident. According to interviews, the additional vibrators were removed because they did not function as intended.

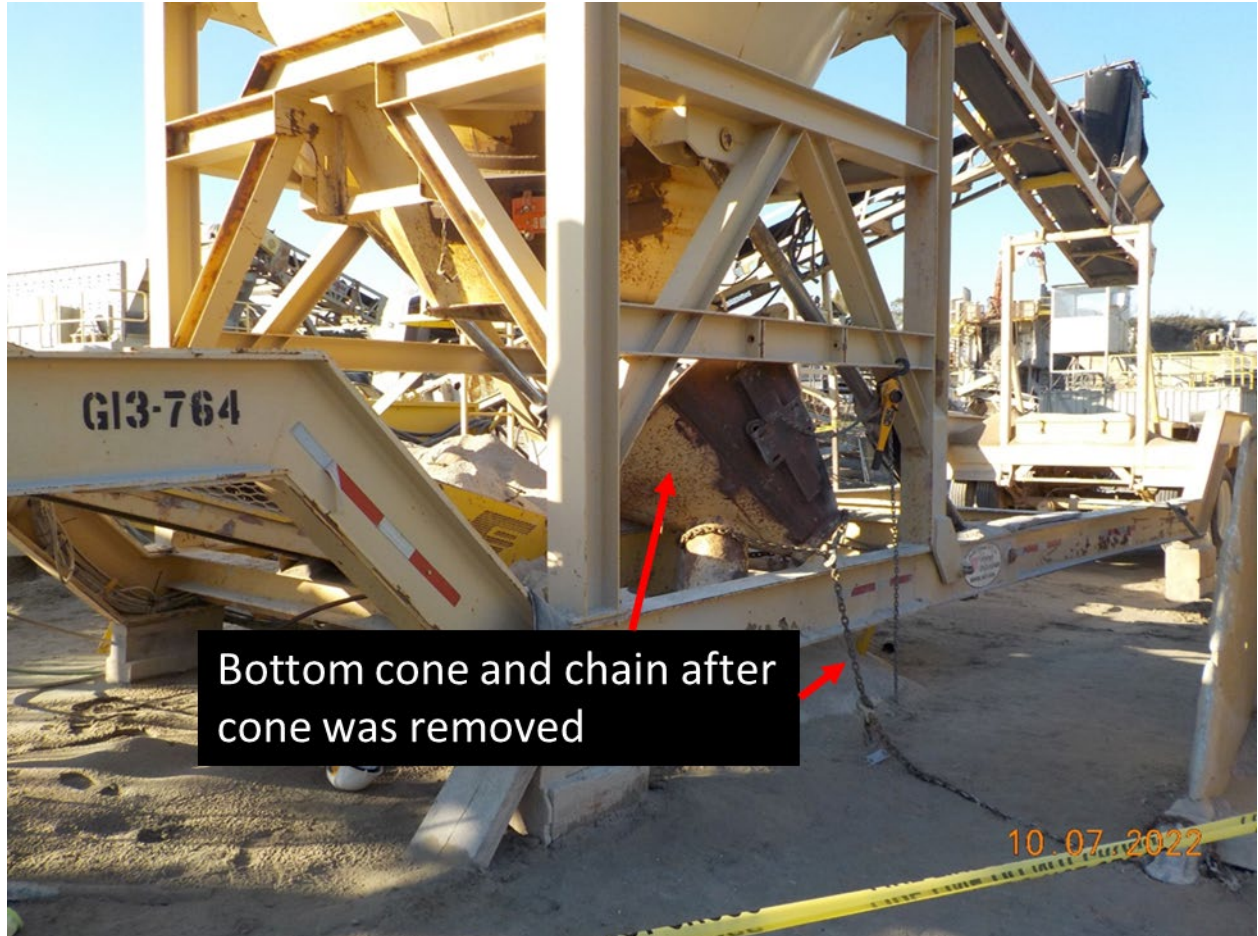
APPENDIX D – Air Separator Post-Accident

Arcadio Carrascoza, Plant Operator, and Eli Estrada, Haul Truck Driver, gathered a cutting torch set and began cutting the bolts off the cone at the bottom of the separator. Other miners working the area, including Melvin Gamez, Excavator Operator, heard the call for help on the radio and immediately traveled to the separator. As the cone was removed, Ovando-Gamez fell out the bottom of the air separator. Gamez immediately began cardiopulmonary resuscitation (CPR) on Ovando-Gamez.

Corrective Action: The mine operator developed and implemented a new written procedure requiring: 1) miners to wear a safety belt and line, and have a person, similarly equipped, available to tend the safety line where there is a danger of falling, and 2) that supply, and discharge equipment is locked out before entering a confined space. The miner operator trained all miners on the procedure.

Corrective Action: The mine operator developed and implemented a new written procedure for safely clearing blockages. The mine operator trained all miners on the procedure.
