REPORT OF INVESTIGATION

Fatal Powered Haulage Accident
August 25, 2025

Colt Rock and Lime, LLC - Scott City
Colt Rock and Lime, LLC
Scott City, Scott County, Missouri
ID No. 23-02459

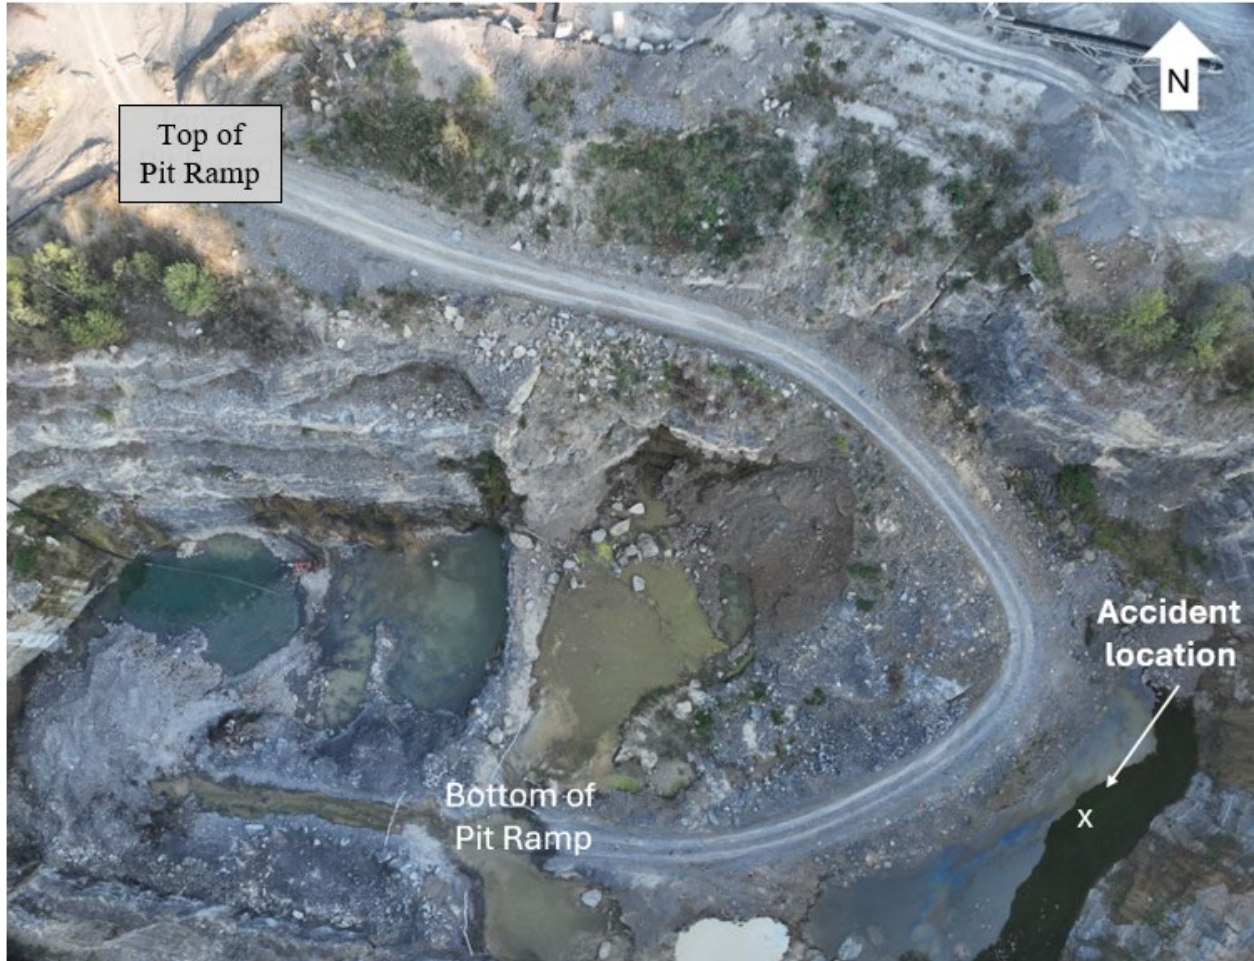
APPENDIX B – Aerial Photo of the Pit Ramp

The accident occurred on the road on the pit ramp used by mining equipment to travel in and out of the active mining pit. The pit ramp is constructed of rock and is an inclined road with a curve towards the bottom. See Appendix B for an aerial photo of the road and pit ramp. Investigators determined the road was in good condition, the height of the berms met MSHA's mid-axle height requirement. However, investigators determined the berms were overall inadequate because they were not capable of moderating or limiting the force of the haul truck with regard to traveling over the bank of the roadway. Investigators determined inadequate berms contributed to the accident.

The curve in the pit ramp did not exceed the haul truck's maximum turning radius of 45 degrees, which allowed the truck to navigate the turn without difficulty. The truck traveled approximately 350 feet down the pit ramp before it drove over the berm on the left side of the road and landed on its top in the water 39 feet below.

The mine operator had a mine-wide speed limit posted. However, the mine operator did not post any signs to mark the steep grade of the pit ramp or a speed limit reduction for this location. The grade measured between 8 and 14 degrees, with an average of 10 to 11 degrees. Investigators determined that the haul truck was traveling too fast for the road conditions on the pit ramp and that the lack of signage contributed to the accident.

Corrective Action: The mine operator installed signs for reduced speed, steepness, and curve in haul road.

Corrective Action: The mine operator has reshaped the berms of the pit ramp roadway to have a steeper berm.
