REPORT OF INVESTIGATION

Fatal Powered Haulage Accident
July 25, 2024

Hazleton Shaft
Atlantic Carbon Group, Inc.
Hazle Township, Luzerne County, Pennsylvania
ID No. 36-08766

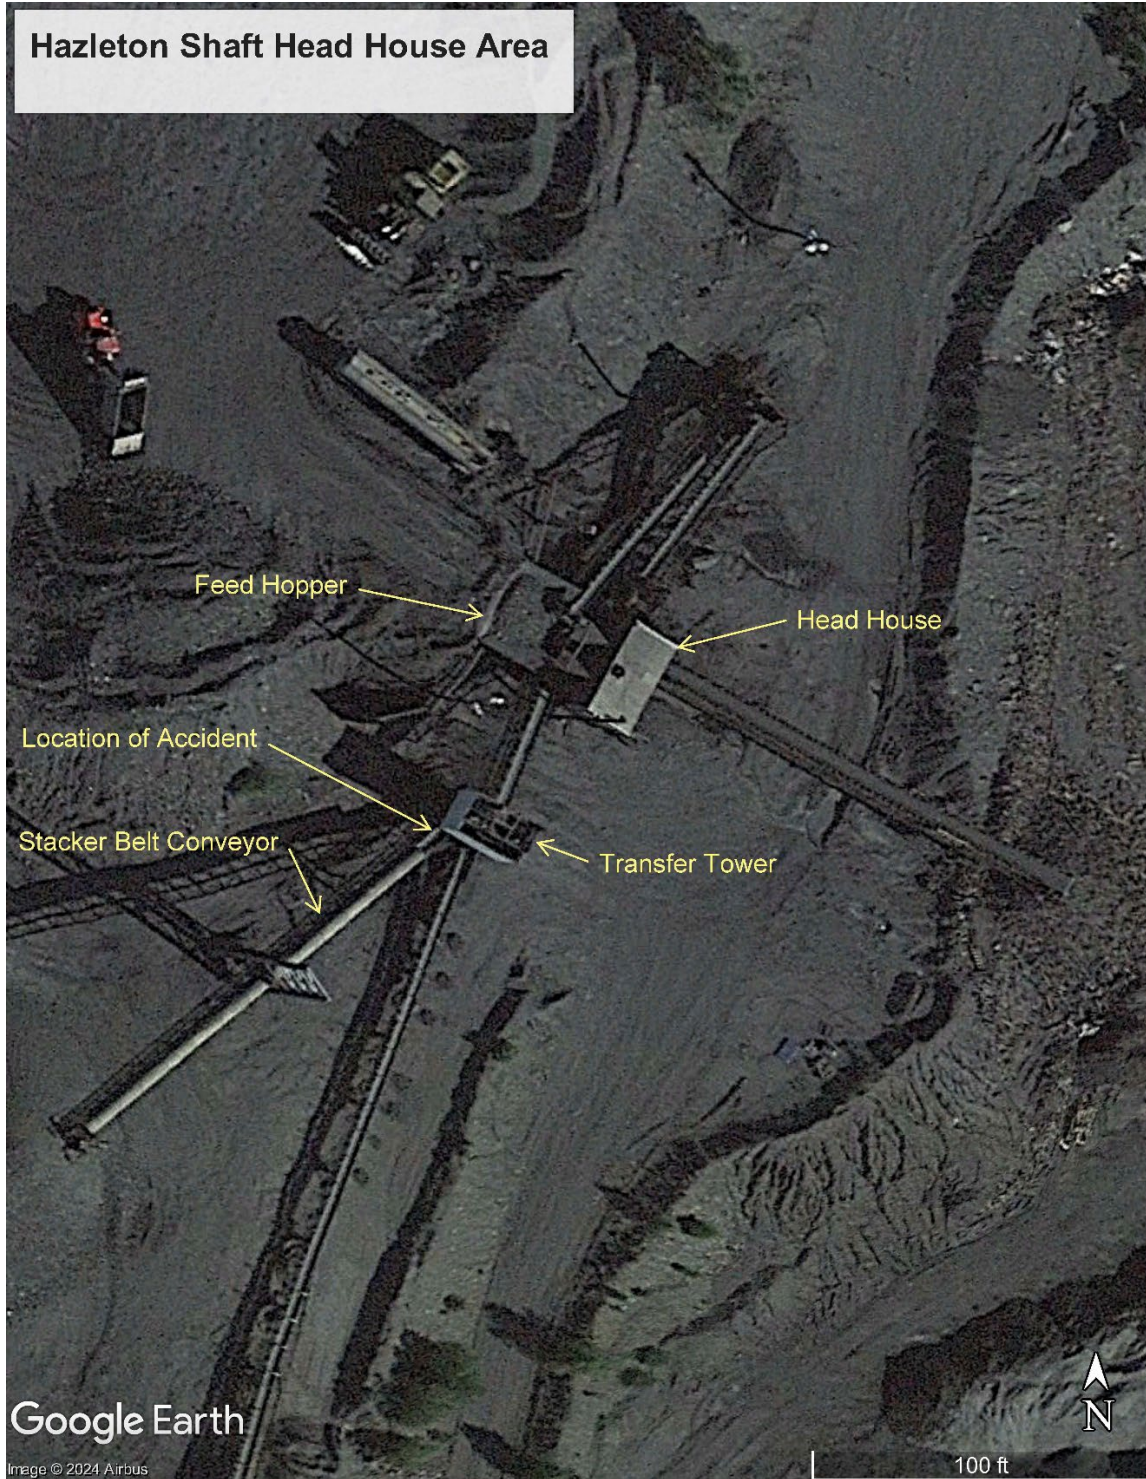
APPENDIX A – Aerial View of the Head House Area

Atlantic Carbon Group, Inc. owns and operates Hazleton Shaft. The mine is an anthracite coal processing plant in Hazle Township, Luzerne County, Pennsylvania. The mine employs 49 employees. The mine operates two, ten-hour shifts per day, five days per week. Trucks bring raw coal to the processing plant from other mines. Front-end loaders stockpile the raw coal at the head house where it is initially screened and sized. The head house is the primary mill. Miners manually remove wood and rock. Belt conveyors transport the coal from the head house to a transfer tower. A stacker belt conveyor transports the coal for stockpiling (see Appendix A).

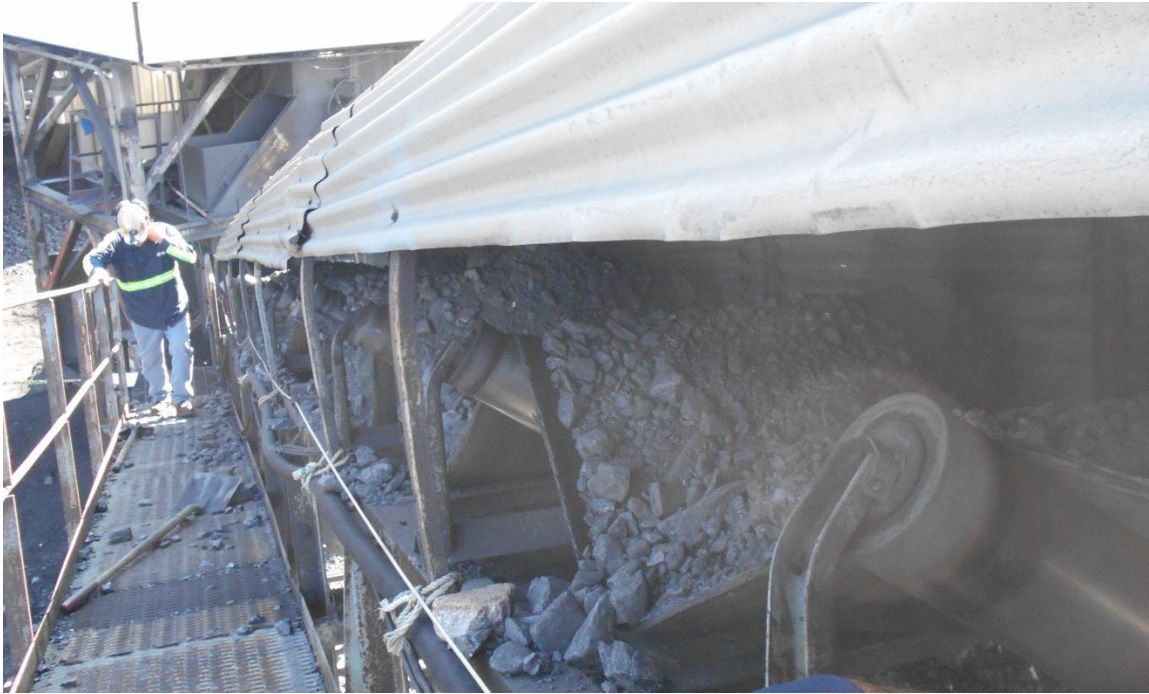
APPENDIX B – Inclined Stacker Belt Conveyor Loaded with Material

At approximately 9:30 p.m., Hirko saw Brotzman on the stacker but did not instruct him to get down. The stacker belt conveyor unexpectedly rolled backward. Petrole heard Brotzman shout as he tried to get off the moving stacker belt conveyor. Petrole reached out and grabbed Brotzman's hand. The material moving downwards on the stacker belt conveyor broke Petrole's grip of Brotzman's hand. The material pushed Brotzman downwards, into, and underneath the stacker feed chute and then engulfed him. Hirko immediately radioed "Miner Down," calling for all miners to report to the stacker to rescue Brotzman. Hirko radioed Richard Wentzel, Plant Operator, and told him to call 911.

Wentzel called 911 at 9:51 p.m. The Hazle Township Fire and Rescue Company and Lehigh Valley Emergency Medical Services (EMS) arrived at 10:01 p.m. and found Brotzman unconscious and unresponsive. Jeffrey Stock, Luzerne County Deputy Coroner, pronounced Brotzman dead at 11:10 p.m. The fire department required the stacker belt conveyor to be blocked from motion before extricating Brotzman (see Appendix B).

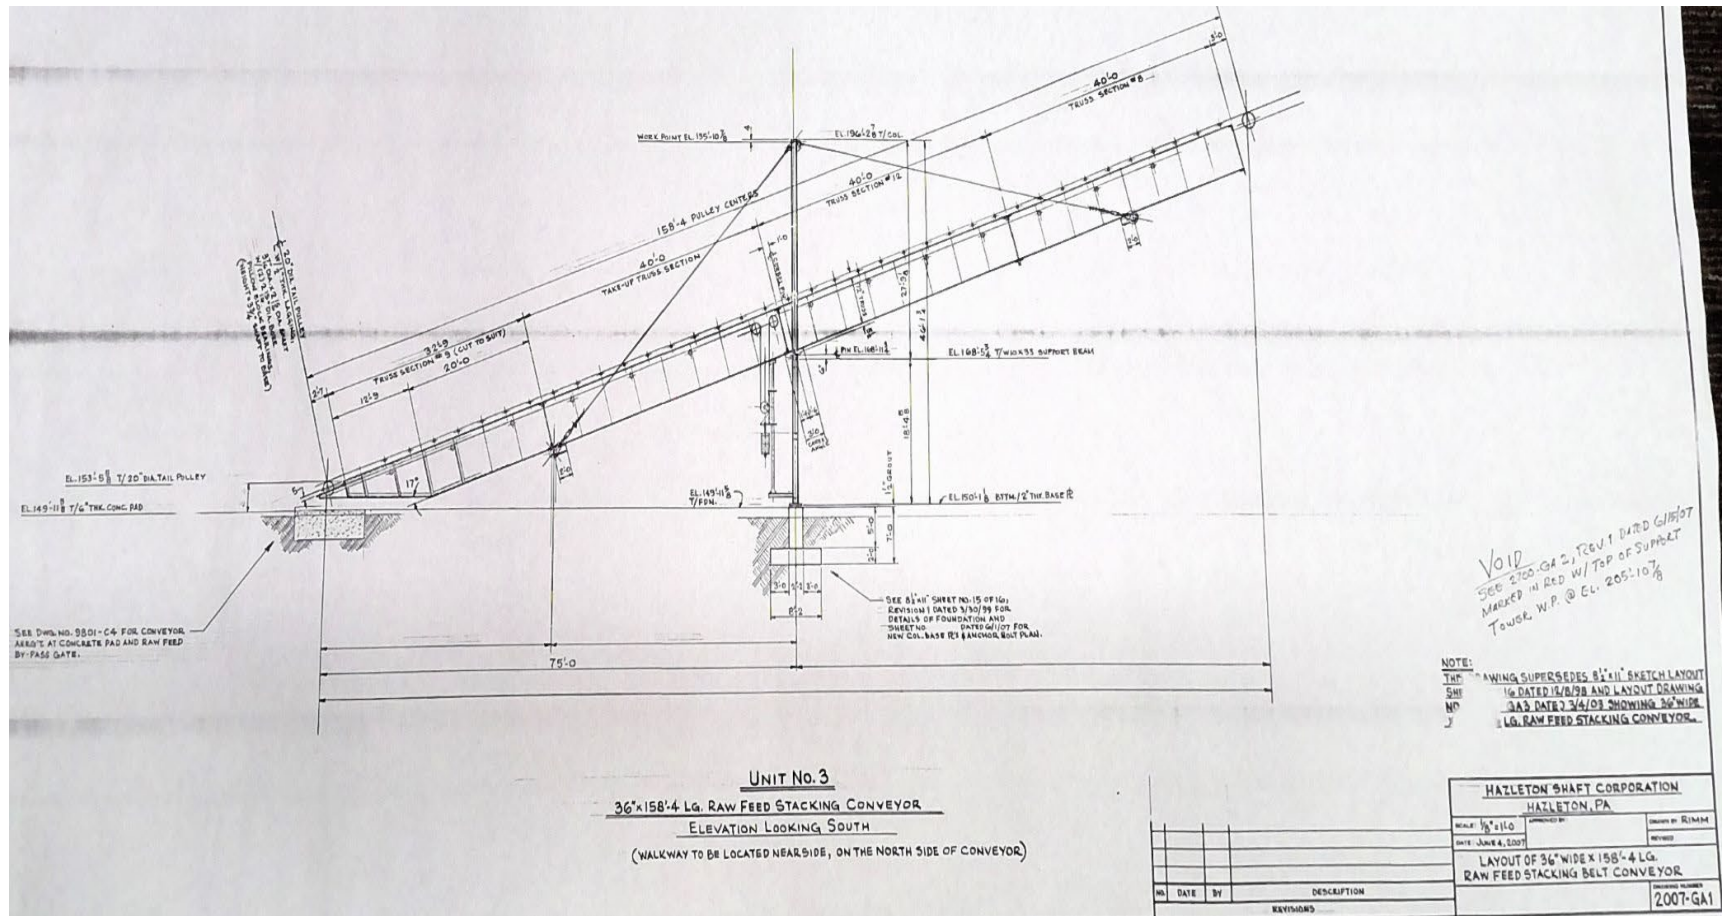
APPENDIX D – Inclined Stacker Belt Conveyor Design Drawing

The equipment involved was a stacker, 158 feet in length. See Appendix D for the stacker design. The stacker belt conveyor is 36 inches wide and driven by a 60 HP, 480 Volt AC induction motor. The electric motor transmits power to the Edwards Speed Reduction Gearbox with four, 5VX drive belts. The Edwards Speed Reducer Gearbox has a speed reduction ratio of 26.2:1. The stacker belt conveyor speed was calculated at approximately 350 feet per minute.

The mine operator was unaware that the stacker belt conveyor was not equipped with a backstop or brake device to prevent unintentional and hazardous movement of the stack belt conveyor. Investigators determined that a backstop or brake device would have been visible if installed on the drive unit of the stacker belt conveyor. The investigation team determined the stacker not having a backstop or brake device installed contributed to the accident.

2. Root Cause: The mine operator did not install a backstop or brake on the stacker belt conveyor drive unit to prevent the stacker belt conveyor from rolling backwards and causing a hazard to miners.

Corrective Action: The mine operator installed backstop devices on the stacker and trained miners on proper test procedures.
