MNMM Fatal 2008-18

- Falling Material Accident
- October 9, 2008 (Nevada)
- Gold Operation
- Welder
- 56 years old
- 21 years experience

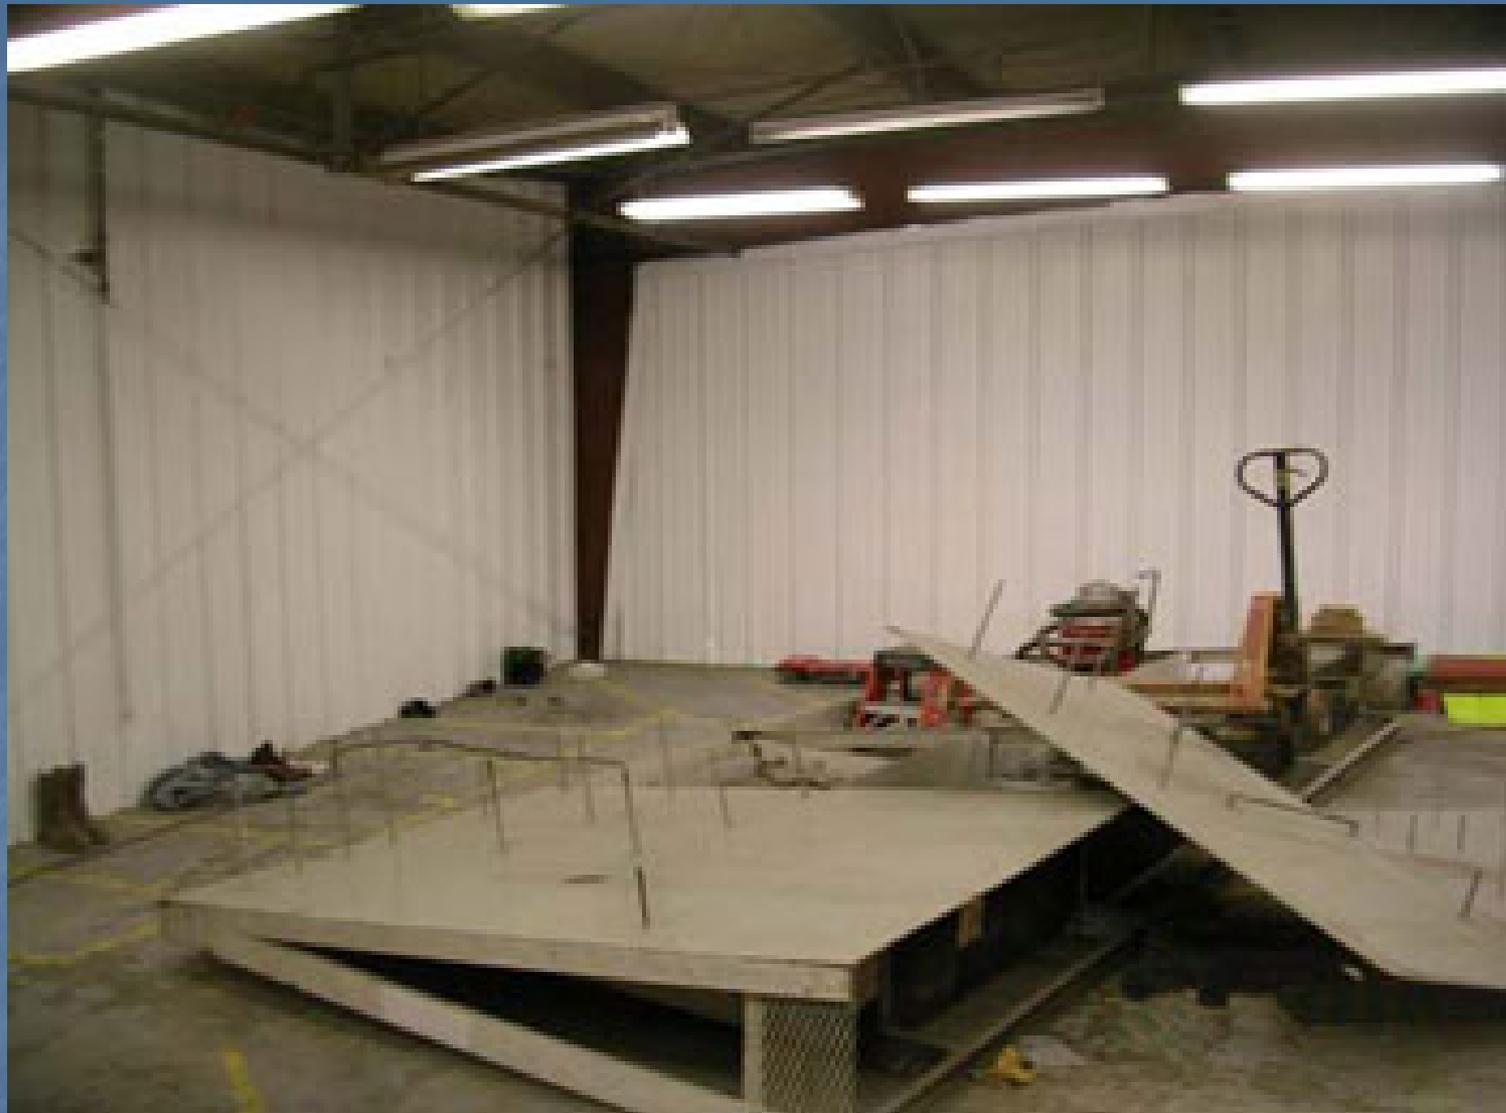
The victim was fatally injured when a tool rack fell on him. He and another miner were disassembling a tool rack in preparation to move it to a new truck shop. Three steel plates had been removed from the front section of the tool rack, placed on the shop floor and leaned against the tool rack. The weight of the detached plates caused the tool rack to rotate, slide, and topple onto the victim and the other miner, who was hospitalized and later released.

Management failed to establish policies and procedures to ensure that persons could safely disassemble the tool rack. A risk assessment to determine potential hazards and to establish safe work procedures was not conducted prior to performing the task.

- Establish and discuss safe work procedures. Identify and control all hazards to finish the job safely.
- Train all persons to recognize and understand safe job procedures before beginning work.
- Evaluate procedures to ensure all possible hazards have been identified and appropriate controls are in place to protect persons.
- Continually check for unstable conditions throughout the dismantling process.
- Secure or remove heavy objects that have the potential to suddenly or unexpectedly shift.
