MNMM Fatal 2009-05

- Machinery Accident
- February 19, 2009 (Puerto Rico)
- Crushed Stone Operation
- Carpenter/Laborer
- 61 years old
- 11 years of experience

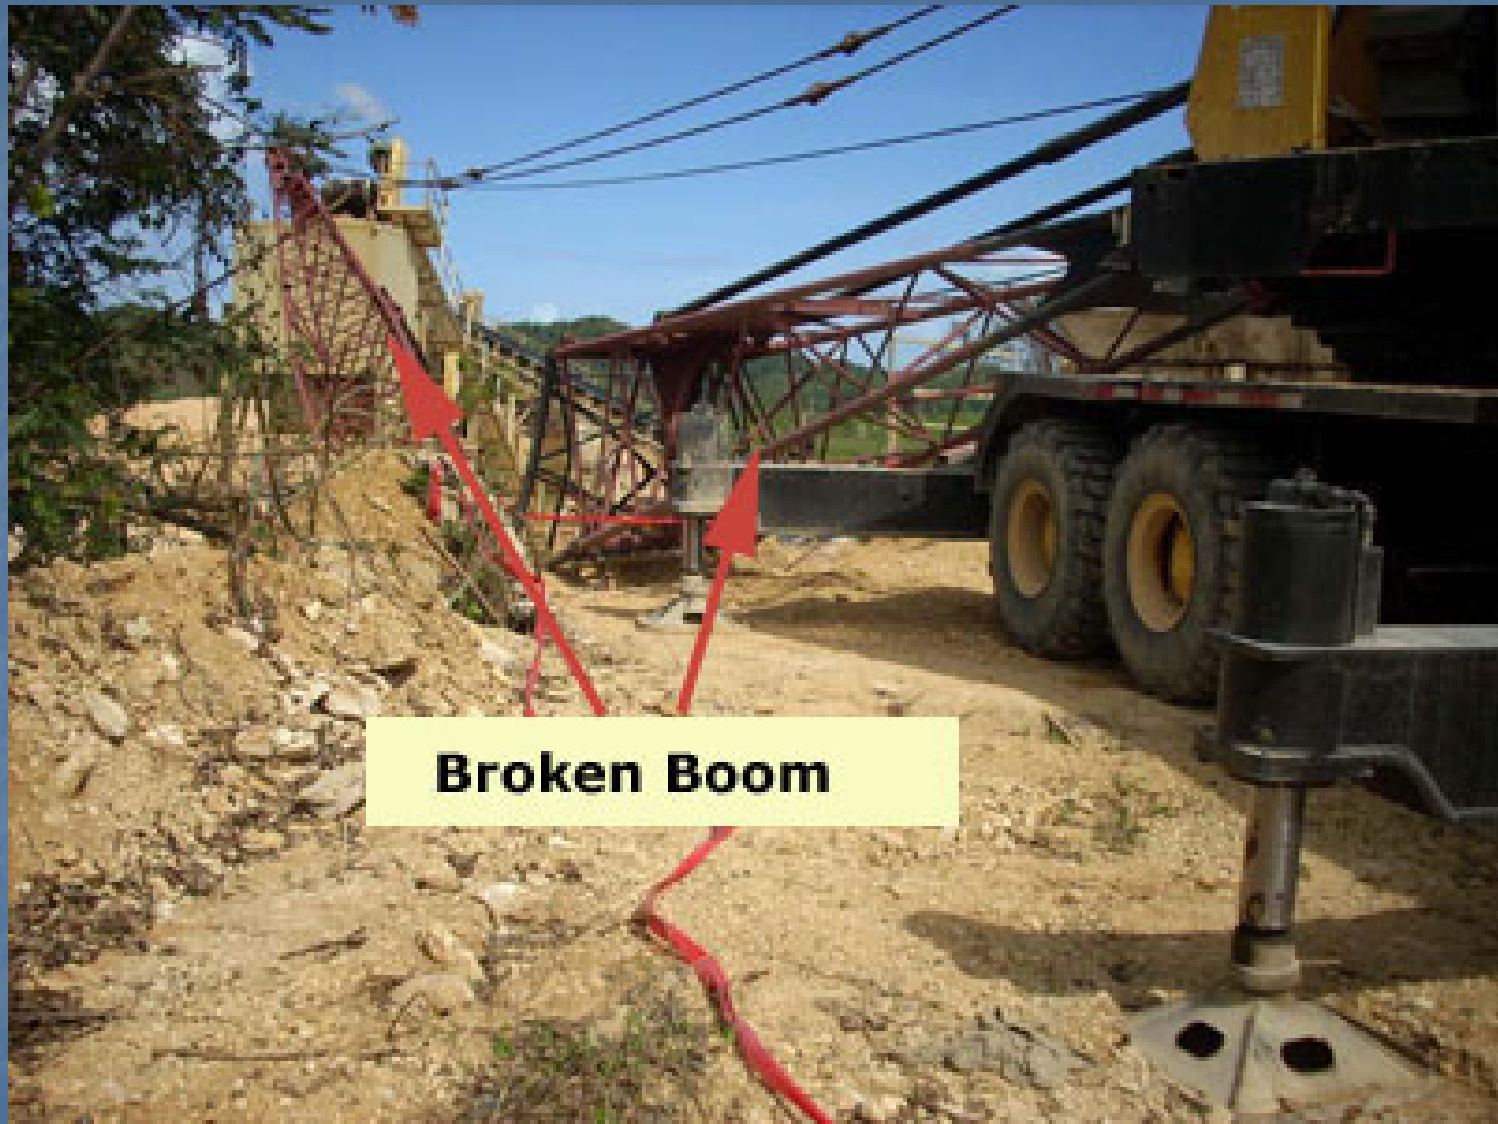
The victim was fatally injured when he was struck by the boom of a crane. The boom collapsed as the crane was lifting a crusher that was being removed as part of a demolition project at the mine. He was hospitalized and died on April 12, 2009, as a result of his injuries.

The accident occurred because the crane was used beyond the manufacturer's design capacity. The total lift exceeded the design capacity of the crane and the two wire rope bridles being used for the lift. The demolition crew failed to accurately determine the total weight of the lift. The crane was used to lift the crusher, but the crusher was not completely detached from its supporting structure. This resulted in a severe loading of the crane's boom. The crane was not properly leveled and oriented to prevent boom side loading. The load chart and boom lacings were not being properly maintained. Additionally management did not provide task training to the victim.

Broken Boom

Corrective Action: Management established and implemented procedures that require risk assessments to be conducted that identify and correct potential hazards associated with the task to be performed. Procedures were developed and implemented to ensure the safety of all persons working near the crane by determining the weight of material to be lifted and using the proper load chart to prevent the crane from being used beyond the manufacturer's design capacity.

Corrective Action: Management implemented a comprehensive training plan that covers all the hazards associated with all the persons performing tasks.
