MNMM Fatal 2009-13

- Machinery Accident
- July 2, 2009 (Pennsylvania)
- Dimension Stone Operation
- Mine Owner
- 52 years old
- 34 years of experience

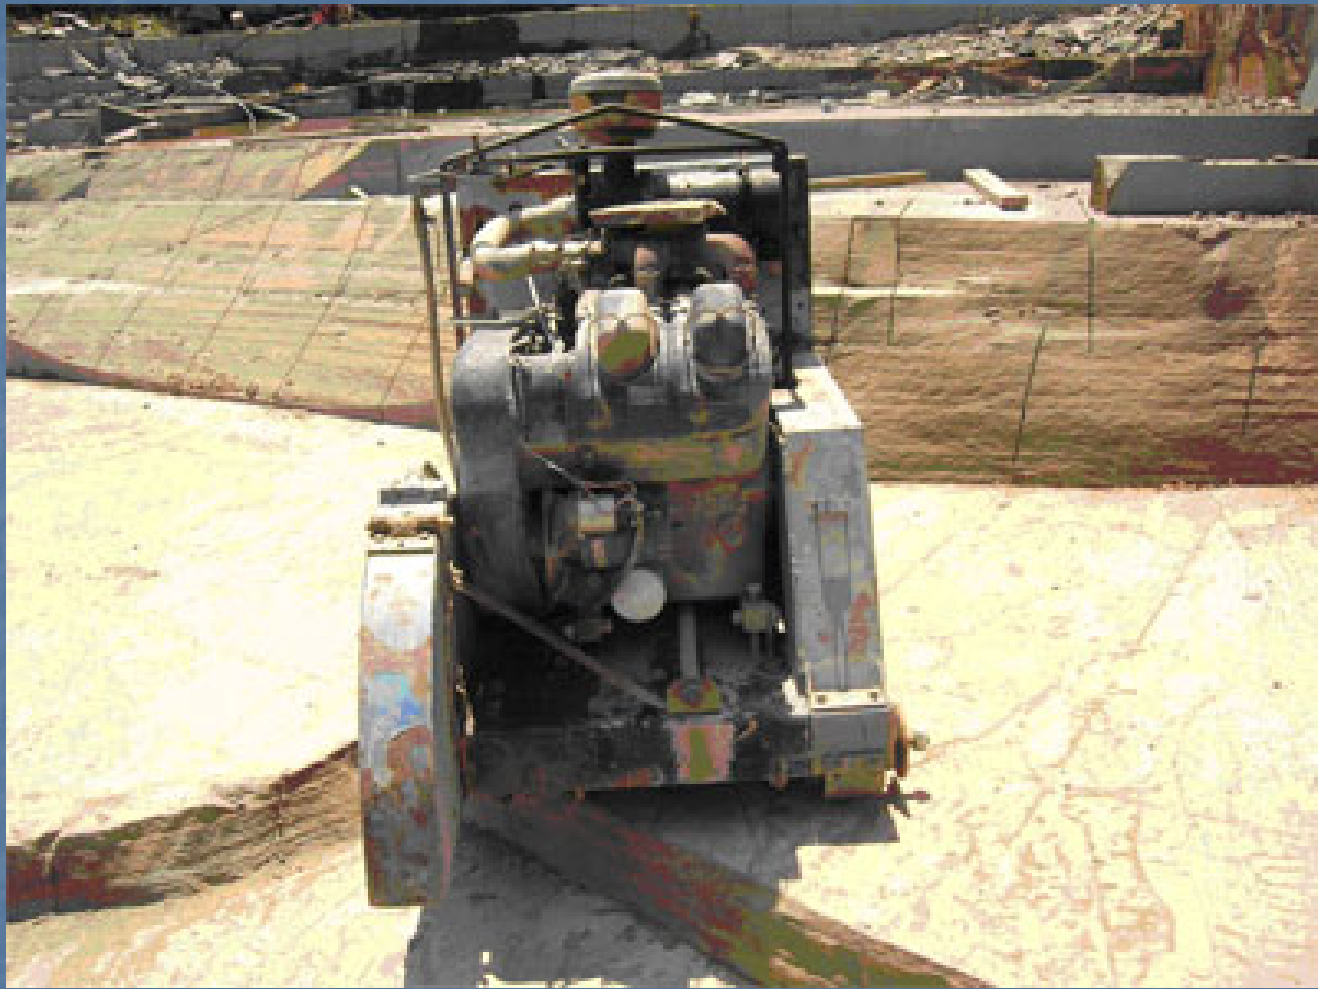
The victim was working alone and was cutting stone on top of a bench using a walk-behind concrete saw. Apparently, he was operating the saw near the edge of the bench when he tripped and fell. The victim and the saw went over the 9-foot ledge and the saw fell on him.

The accident occurred because management failed to ensure that a berm or barrier was installed along the highwall edge to prevent a fall of person or machinery from the bench.

Root Cause: *No procedures were in place for persons to safely operate a walk behind concrete saw on an elevated bench where there was a hazard of falling. No berms or guardrails were provided and maintained along the edge of the bench where a nine foot drop off existed.*

Corrective Action: *The victim was a sole proprietor and; therefore, the business terminated at the time of his death. Consequently, no corrective action was taken.*
