MNMM Fatal 2010-04

- Fall of Material Accident
- March 24, 2010 (New York)
- Surface of Salt Operation
- Contract Truck Driver
- 63 years old
- 15 years of experience

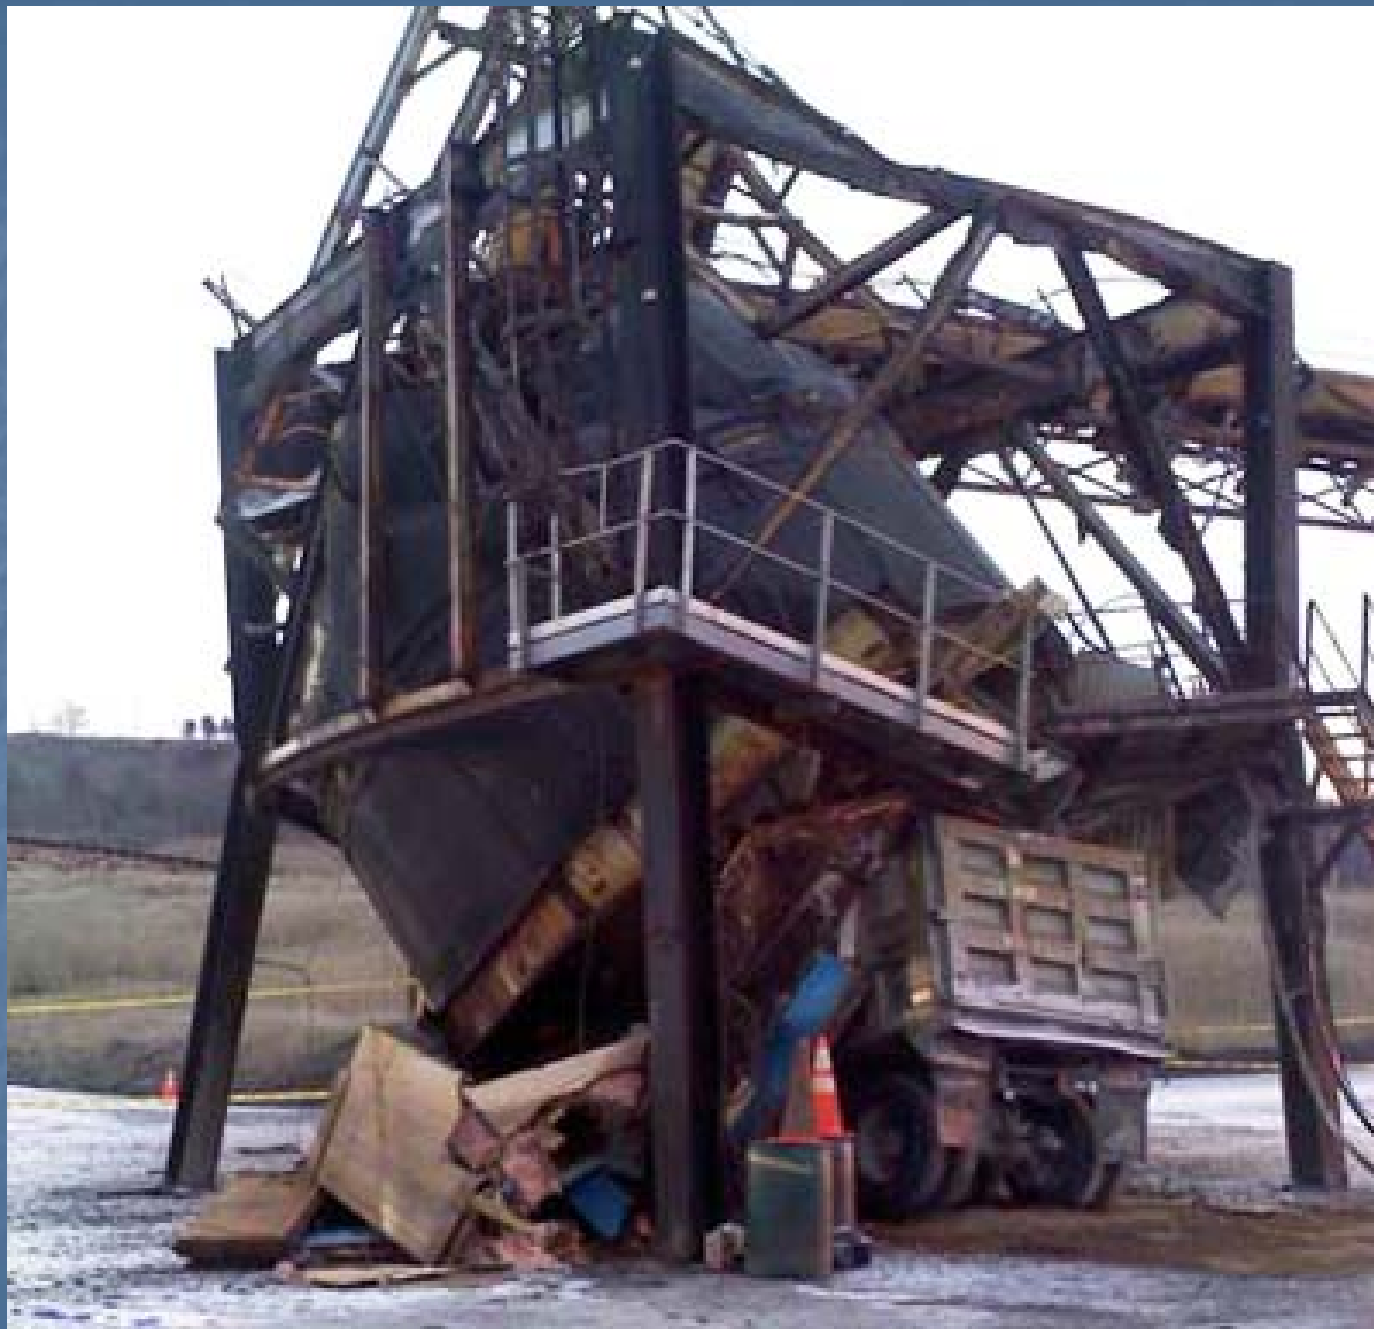
The victim was fatally injured while loading his truck under a 150-ton-capacity salt bin when the bin's supporting structure collapsed and the bin fell onto the cab of the truck. Another person was injured in the accident when the operator's booth that was located on the west side of the structure fell to the ground. The accident occurred because management failed to ensure that adequate inspections to properly evaluate the structure were conducted. Preventative measures were not addressed that would maintain the integrity of the steel supporting structure for the bin.

Root Cause: *Management did not ensure that adequate procedures were in place to properly evaluate and maintain the steel supporting structure for the bin.*

Corrective Action: *Management had consultant engineers conduct detailed evaluations of the existing surface structures to ensure the prompt corrective action of potential safety hazards.*

- Routinely examine metal structures for indications of weakened structural soundness (corrosion, fatigue cracks, bent/buckling beams, braces or columns, loose/missing connectors, broken welds, etc.).
- Keep corrosive material spillage/build-up removed from metal structures.
- Report all areas where indications of structural weakness are found.
