MNMM Fatal 2010-23

- Falling Material Accident
- December 23, 2010 (Florida)
- Crushed Stone Operation
- Contract Blaster
- 35 years old
- 12 years of experience

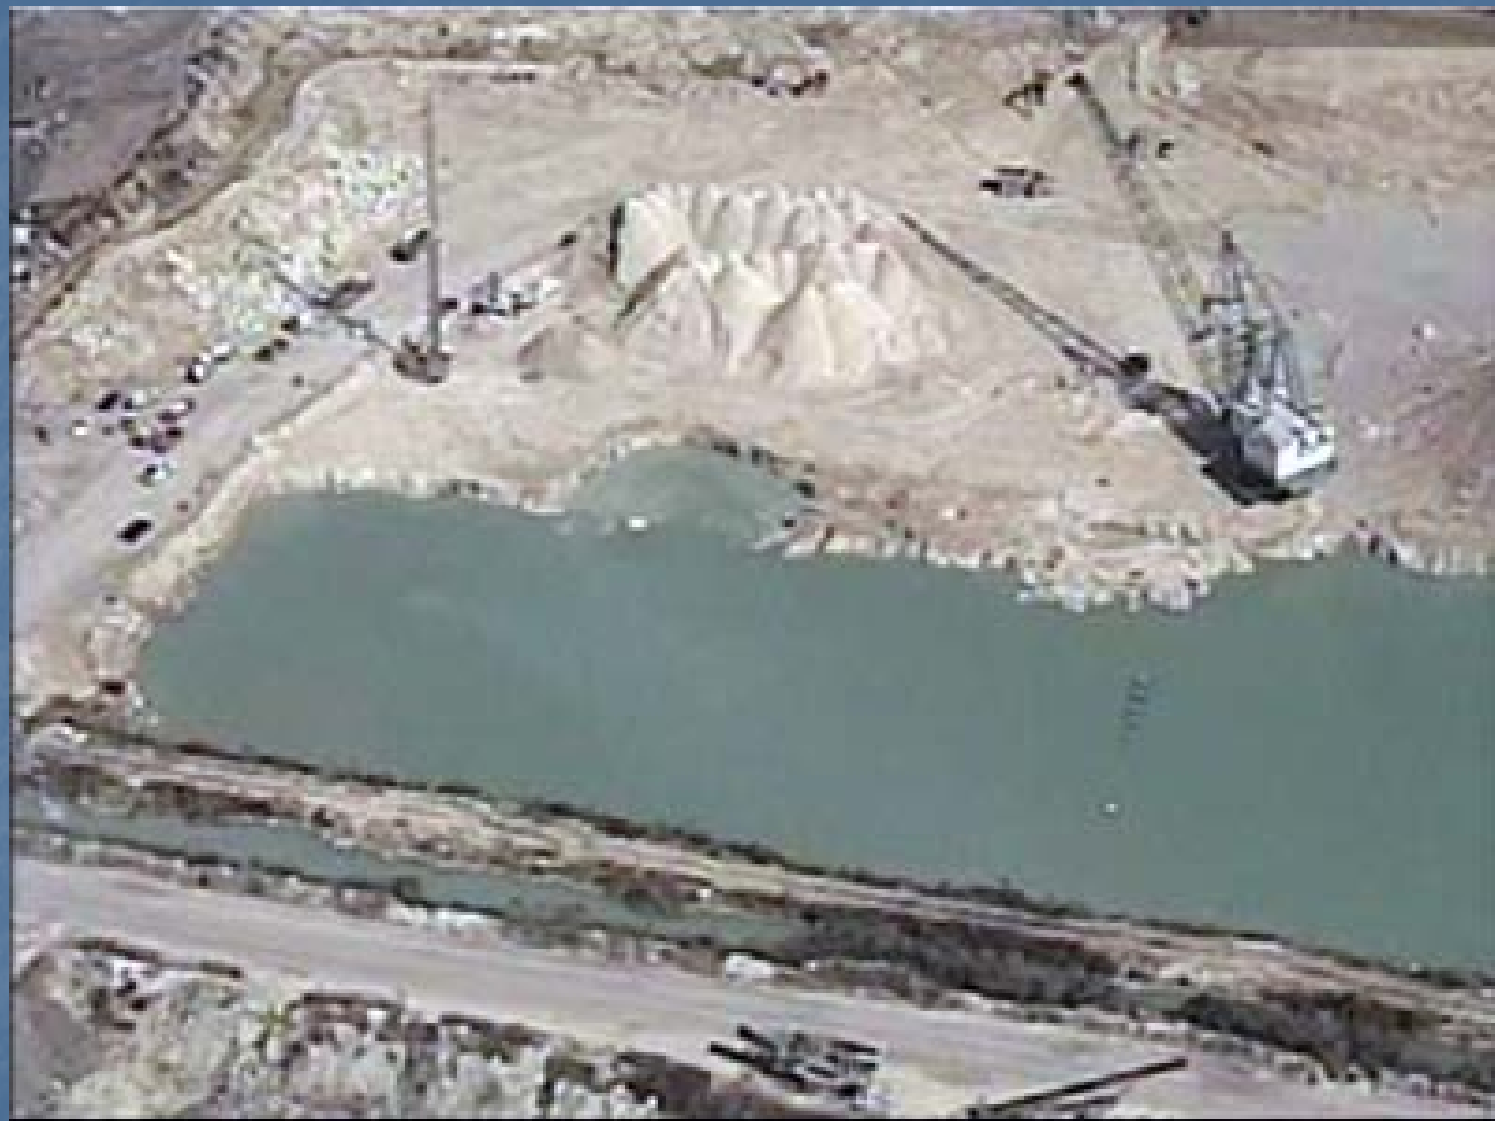
The victim was killed while conducting a post-blast examination. After firing a blast, he walked immediately to the blast site to examine the shot material. He was standing to the east of the shot material when the ground collapsed, engulfing him in the water filled pit.

The accident occurred because mine and blasting contractor management policies, procedures, and controls were inadequate. A large cavity had been detected in the drill pattern on December 17, 2010. However, neither mine nor contract management established any policies, procedures, or controls to ensure that persons could safely perform work at the blast site. The full extent of the cavity was not known before the blast was initiated.

Methods such as advance drilling and geophysical surveys, electrical resistivity, ground penetrating radar or other available methods were not used to identify subsurface cavities and voids. Effective workplace examinations to identify and correct all hazards were not conducted. No procedures were in place requiring a waiting period before persons conducted post-blast examinations.

Corrective Action: Mine management established Standard Operating Procedures (SOP) for detecting cavities that includes drilling to determine the full extent of any cavities detected.

Corrective Action: Blasting contractor management established Standard Operating Procedures for conducting blasting at the mine. These safe operating procedures address activities regarding loading the blast, conducting the blast, and conducting post- blast examinations.
