**Fatality #4 – March 24, 2010**  
**Falling Material -New York - Salt**  
**Cargill Deicing Technology a BU of Cargill Inc - Cayuga Mine**

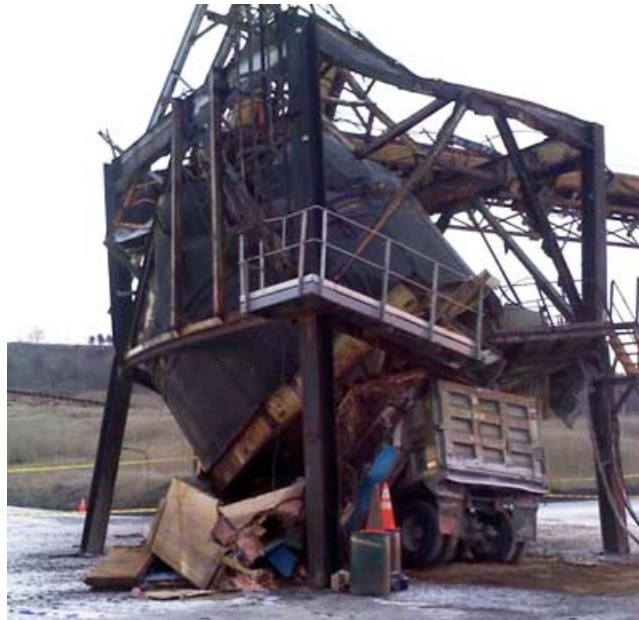
**METAL/NONMETAL MINE FATALITY** - On March 24, 2010, a 63 year-old contract truck driver with 21 years of experience was fatally injured at a surface area of an underground salt mine. The victim was loading his truck under a 150 ton salt bin when it collapsed, falling onto the cab of the truck. A second victim working in the area received serious injuries.

- Routinely examine metal structures for indications of weakened structural soundness (corrosion, fatigue cracks, bent/buckling beams, braces or columns, loose/missing connectors, broken welds, etc.).
- Keep corrosive material spillage/build-up removed from metal structures.
- Report all areas where indications of structural weakness are found.
