MNM Fatal 2011-09

Electrical Accident
September 13, 2011 (Washington)
Sand & Gravel Operation
Quality Control Person
38 years old
3 years of experience

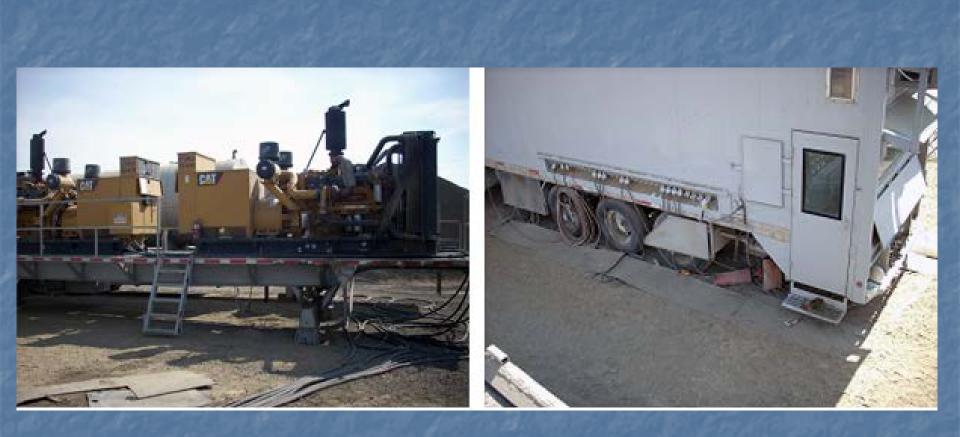
The victim was killed , while working on an energized electrical circuit. He was attempting to reverse the polarity on an energized power cable at a control trailer when he received a fatal electrical shock.

The accident occurred because management procedures failed to ensure that persons deenergize an electrical circuit prior to performing work on it. The system was not locked out, tagged out, or tested to verify it was de-energized.

Corrective Action: Mine management implemented a Standard Operating Program including a new lock out, tag out, and verification system for all of their portable operations. All persons have been trained regarding the new policies and procedures. A company electrician will be at the site any time a plant is set-up, taken down, or when electrical work is performed to ensure that all safety procedures are followed.
