MNM Fatal 2011-10

- Fall of Person Accident
- September 23, 2011 (New York)
- Sand & Gravel Operation
- Plant Operator
- 32 years old
- 10 years of experience

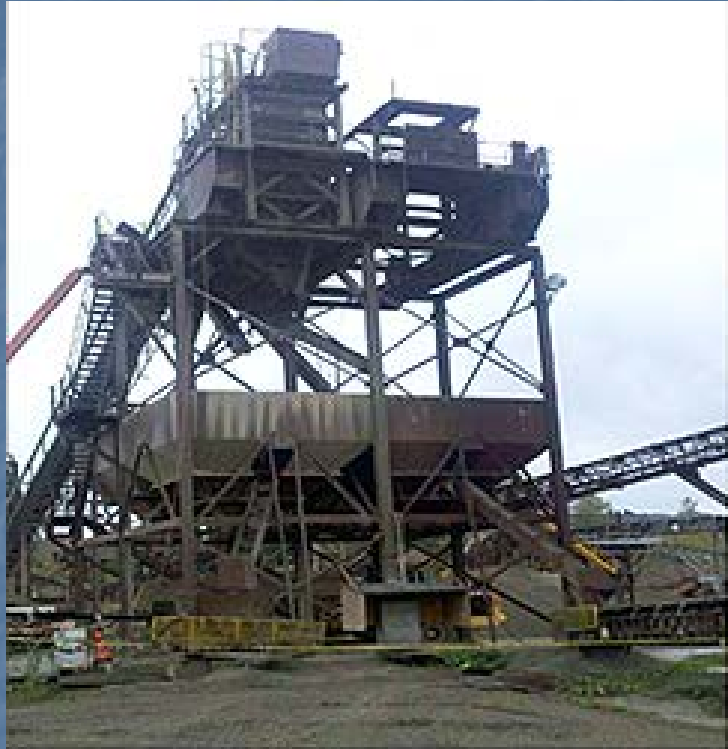
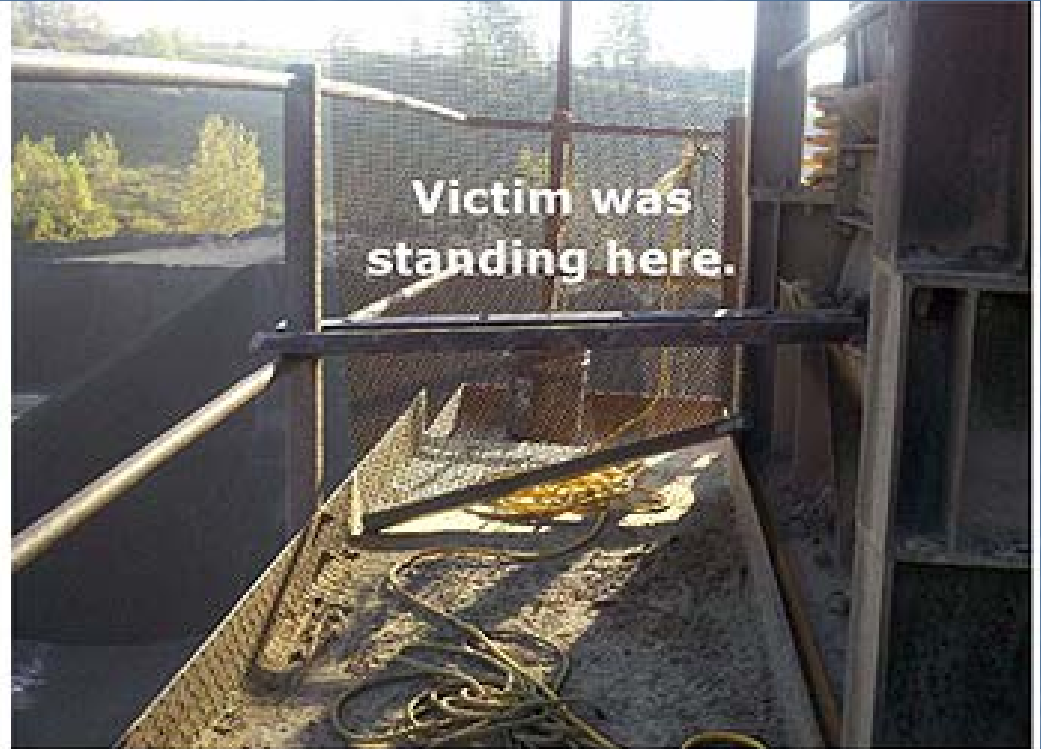
The victim was killed when he fell from a screen deck work platform 56 feet to the ground below. He was standing on two steel clamping bars that had been placed between the midrail of the protective rail surrounding the screen deck work platform and the screen structure to create a step. He stood on the step to reposition a screen. He was positioned above the confines of the protective railing when he slipped and fell.

(Accident scene re-constructed)

Root Cause: The accident occurred because management policies, procedures, and controls did not ensure that persons could safely perform maintenance on the secondary screen tower. The victim was having difficulty gaining the leverage necessary to remove the screen. To gain the needed leverage on the screen, he had to be positioned above the protective railing on the screen deck work platform. He was positioned above the protective railing on the screen deck work platform and was not wearing a safety belt and line where there was a danger of falling.

Corrective Action: Management established a written Job Safety Analysis (JSA) for the task of changing screens and trained all persons regarding these safe procedures. The mine operator also trained all persons in the use of fall protection where there is a danger of falling.
