MNM Fatal 2011-16

- Machinery Accident
- December 15, 2011 (Pennsylvania)
- Crushed Stone Operation
- Crusher Feed Controller
- 22 years old
- 14 weeks of experience

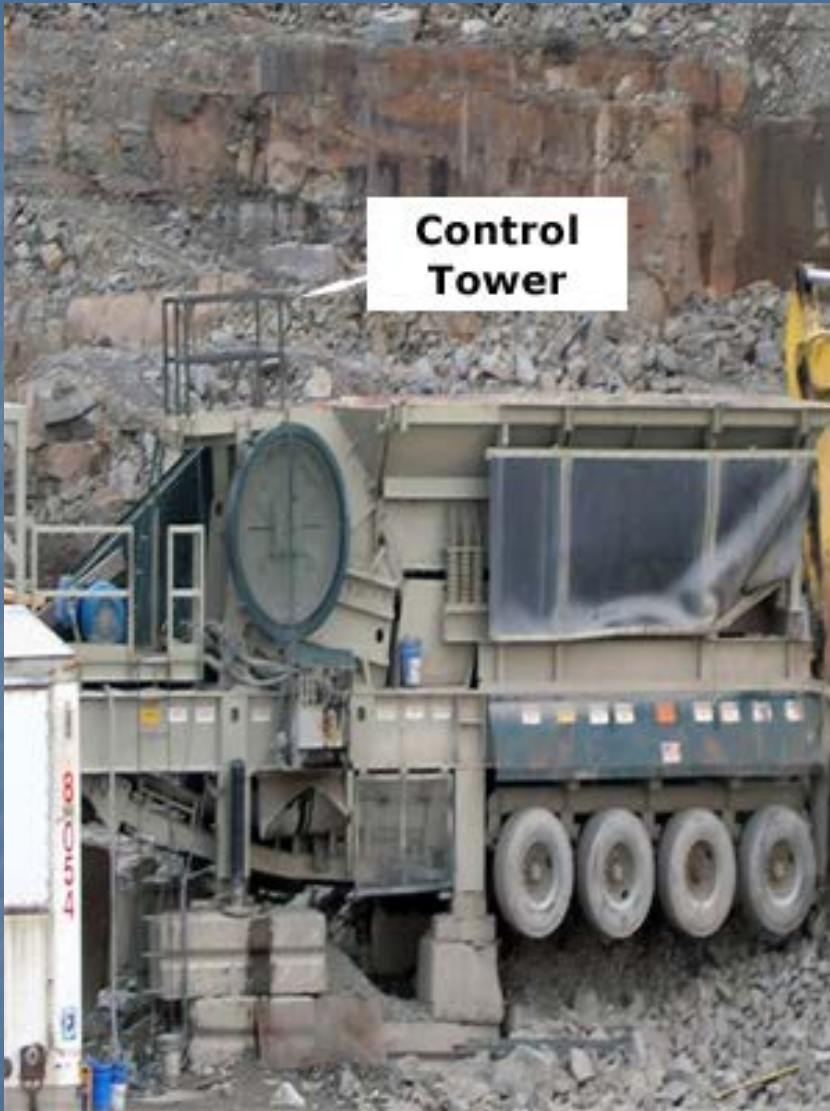
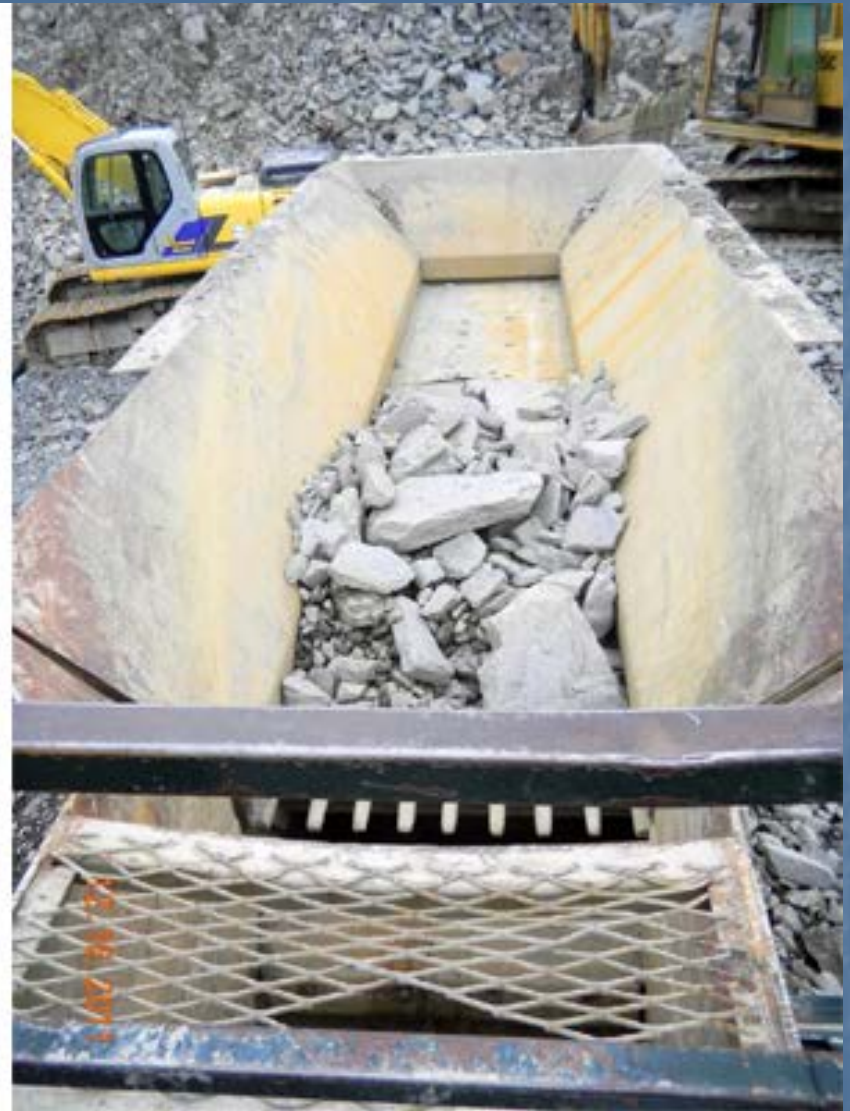
**Control
Tower**

The victim was killed when he fell into an operating jaw crusher. He was last seen standing on the viewing platform. He apparently climbed over the railing of the platform to access the vibratory feeder to clear jammed material close to the opening of the crushing chamber.

1. Crushing plants will be de-energized, locked and tagged out, and blocked against hazardous motion before work begins. The procedures address the hazards associated with the work to be performed.
2. A safe means of access will be provided to the feeder deck using a secured external ladder.
