REPORT OF INVESTIGATION

**Surface Nonmetal Mine
(Crushed and Broken Stone)**

**Fatal Machinery Accident
December 15, 2011**

**Damascus 535 Crushing
Damascus 535 Crushing
Lanesboro, Susquehanna County, Pennsylvania
MSHA I.D. No. 36-09824**

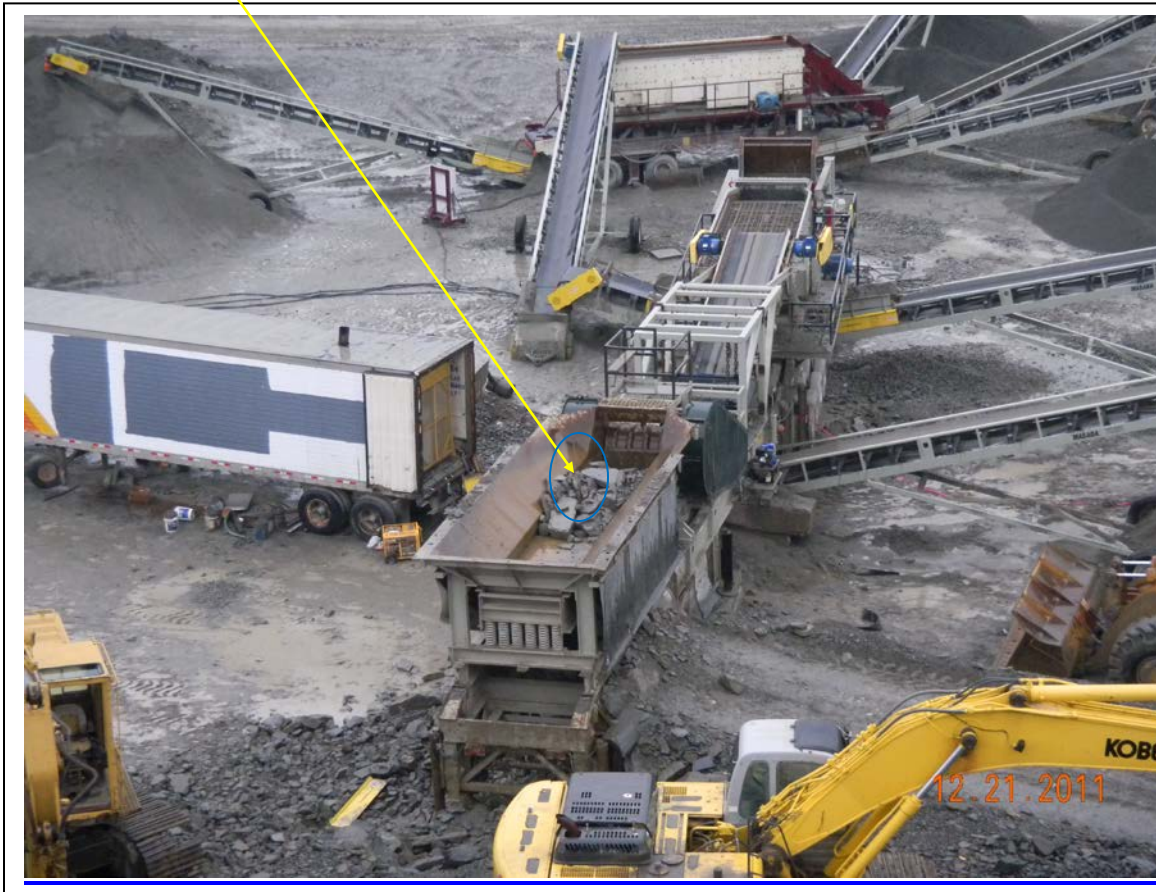
APPENDIX C

Wesley J. Sherwood Jr., Crusher Feed Controller, age 22, was killed on December 15, 2011, when he fell into an operating jaw crusher. Sherwood was last seen standing on the viewing platform. He apparently climbed over the railing of the platform to access the vibratory feeder to clear jammed material close to the opening of the crushing chamber.

The accident occurred at the primary jaw crusher of the portable crushing plant.

The victim was standing here

Root Cause: Management failed to ensure policies and procedures were in place to safely perform maintenance or other tasks on the jaw crusher. The victim left the confines of the protective railing system on the platform to access the areas adjacent to the jaw feed opening. Safe access was not provided or maintained to safely access the area.

1. Crushing plants will be de-energized, locked and tagged out, and blocked against hazardous motion before work begins. The procedures address the hazards associated with the work to be performed.
2. A safe means of access will be provided to the feeder deck using a secured external ladder.
