MNMF Fatal 2012-08

- Powered Haulage Accident
- May 28, 2012 (New York)
- Cement Operation
- Shift Operator
- 51 years old
- 13 years of experience

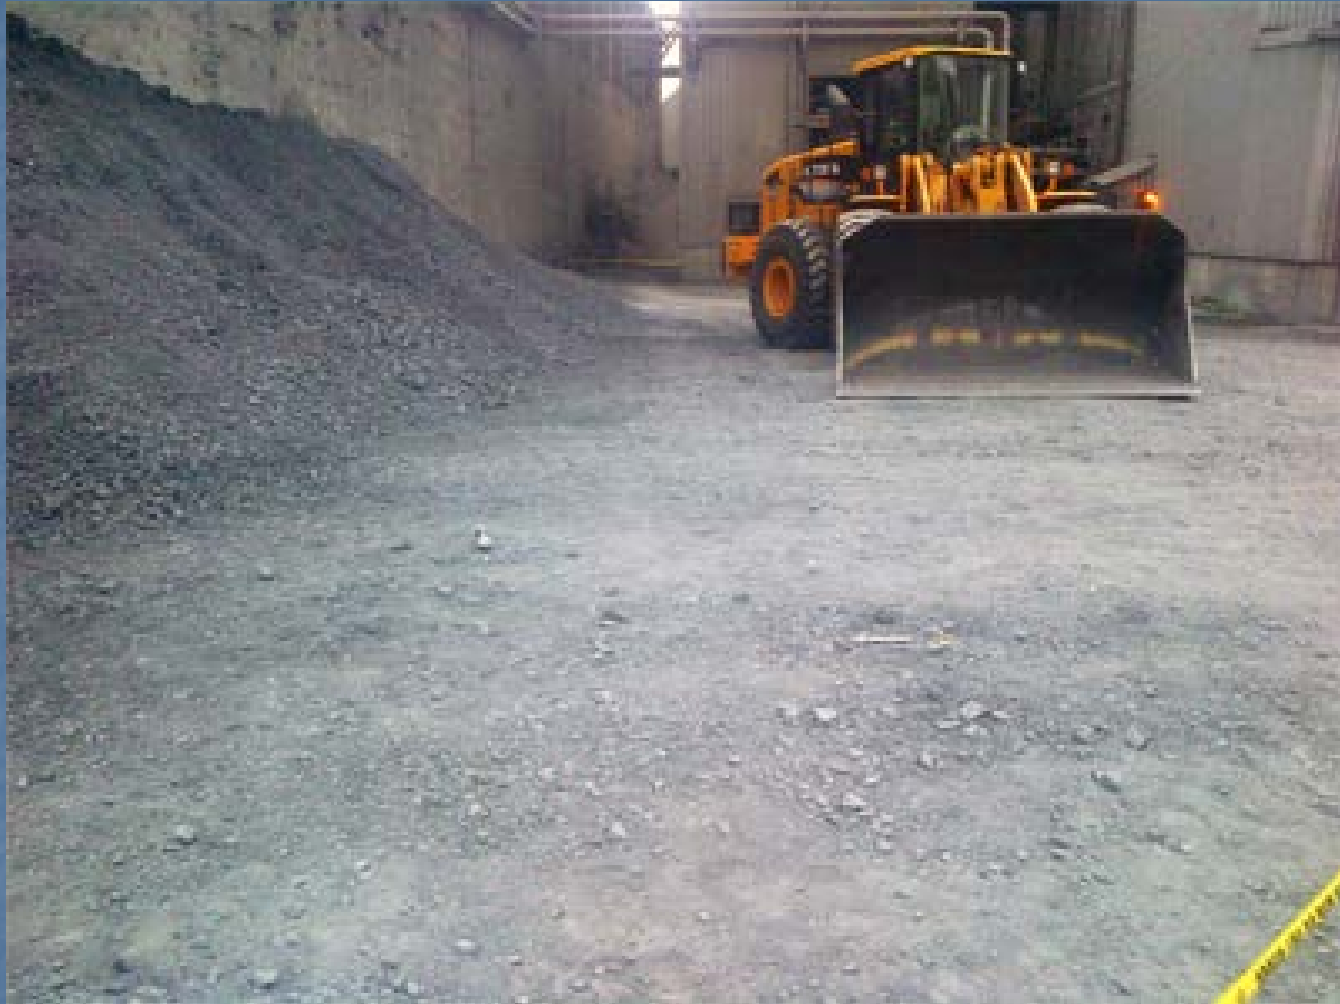
The victim was killed when he was struck and run over by a front-end loader. He was walking between the crane bay building No.19 and the No.1 finish mill when the accident occurred.

The accident occurred due to management's failure to ensure the operator of the front-end loader maintained control of the loader at all times, specifically while making a left hand turn when the victim was walking nearby.

ROOT CAUSE: Management policies and procedures failed to ensure the operator of the front-end loader maintained control of loader at all times while the loader was in operation, specifically while making a left hand turn when the victim was walking nearby.

CORRECTIVE ACTION: Management established safe operating procedures for mobile equipment operators when operating mobile equipment in close proximity to both pedestrians and other vehicles. All mobile equipment operators were instructed in these safe operating procedures.
